# DETERMINATION OF OLD AND NEW DEFORMATIONS AT KÜCÜK AYA SOFYA (LITTLE HAGIA SOPHIA) MOSQUE IN ISTANBUL BY PHOTOGRAMMETRIC METHODS AND AN ATTEMPT OF THEIR INTERPRETATION

CIPA XIX<sup>th</sup> International Symposium Anatalya 2003

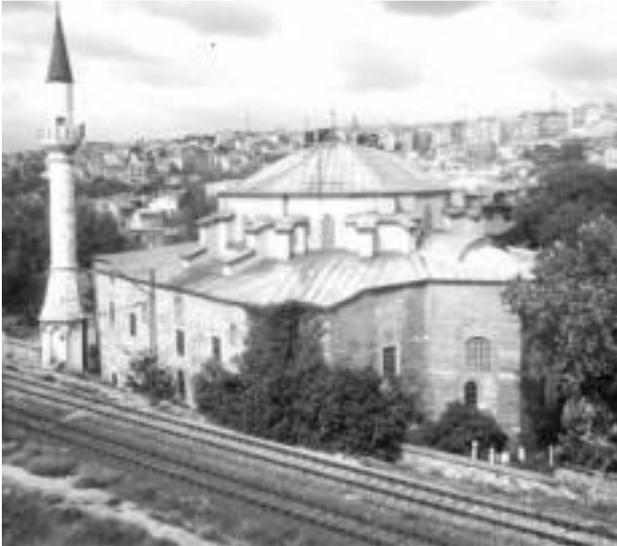
One of the major problems can be seen directly: the main railway on the European side of Istanbul which was built between 1870-1890 runs directly along the south side of the building in a very short distance of only a few meters. The traffic on this railway is very heavy today: trains are passing in 10-minutes intervals the building.

Figure 1. General view of KAM and railway

On the one hand the railways vibrations act directly at the structure of KAM; on the other hand there is a compression of the soil beneath the rails. Such a compression may disturb the situation of the groundwater especially the drain off. In that context some further explanations shall be given: the height of KAM over sea level is only a few meters because the building was erected in a distance of about twenty meters to the old town wall which was built next to the seaside. Today there is a big street on a filled ground between old town wall and coastline. At the other (northern) side of KAM the terrain rises up to the place where the hippodrome was found in historic times. That situation and the compression of the soil are reasonable for problems concerning the groundwater.

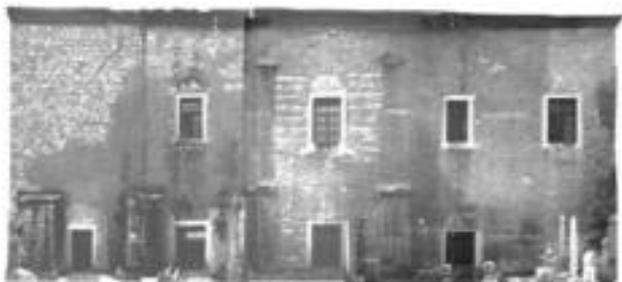
In the second example we see an orthophoto of the north wall of KAM generated by some photogrammetric images. This orthophoto shows 1500 years of changing, repairing of problems and damages: recording with the help of visualization. Such an orthophoto can be a hot spot of information and a very great help for the work of experts dealing with such old monuments. Let us have a detailed look at the situation of the central north side. There we will find some evident hints to conclude that the building entrances have changed.

Figure 6. North side of KAM

To find an answer to the open question of the original location of the Peter-and-Paul-Basilica to which KAM was connected an important hint could be the deformations of the four big pillars on the southern part of the octagonal centre. Their upper parts show a great deviation from the vertical in radial direction while the four pillars on the northern part stand straight. This leads to the conclusion that in times of construction a static stabilizing mass of any sort of building had adjoined to the northern wall of KAM.

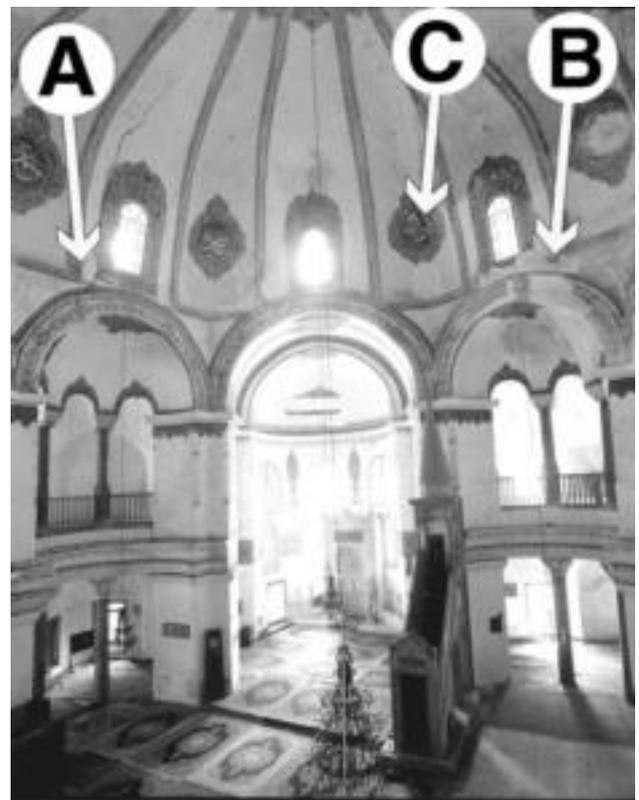
The third example gives a first impression of the various cracks in the building especially in the octagonal centre. The dome of the KAM – later discussed in detail but now have a first look at figure 13 – consists of sixteen different segments, eight segments curved only in one direction with a window in it for the light and for static reasons and eight stronger segments curved in both directions in an alternate order. At the sides of the windows next to the border between the different segments there are theoretically weak points in the construction of the dome, in reality there are a lot of cracks. In the following we concentrate at two cracks of the described type: the first and most prominent crack (A) in the north east of the building starts in the dome in a height above the windows and passes through the whole building inside and outside. Crack (B) in the south west of the building is the symmetrical pendant and in some way the static answer of (A). The third crack (C) is a little bit untypical before it runs through the middle of a double curved segment above one of the big pillars. Figure 7 shows the context of the three discussed cracks.

Figure 7. Location of the discussed cracks

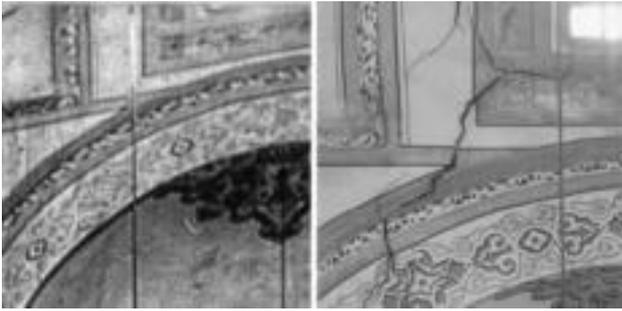
In figures 8-10 we show zoomed details of images taken at different times and we see the changings of the three cracks from the point of view of quality: two of the cracks can be seen today but they didn't exist or they were hidden at former times, one crack could be seen years ago but today it is plastered. To have a look at the changing of two of the cracks (A und C) from the point of view of quantity some photogrammetric studies were performed: measurements were performed on images taken in the years 1979 and 2002 with the help of an analytical photogrammetric system (WILD AC3), some photogrammetric blocks were adjusted by the bundle-method. At this way the

changings of the two cracks in the last 20 years were determined: crack (A) and (C) opened more than 1 cm.

Figure 8. Crack (A): left: before 1908  
right: in the year 2002

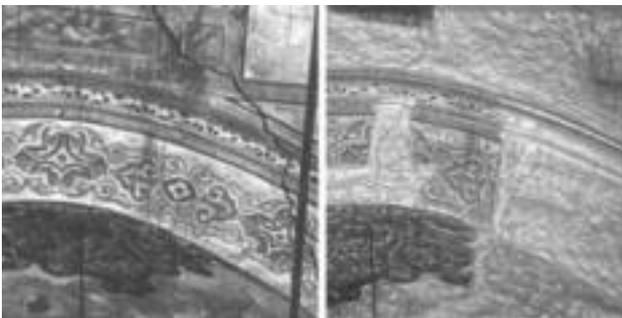
Figure 9. Crack (B): left: in the year 1968  
right: in the year 2000

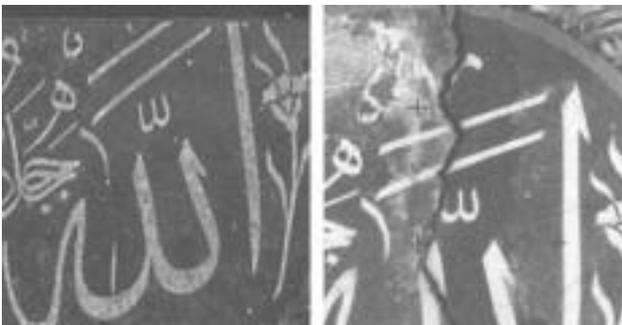
Figure 10. Crack (C): left: before 1908  
right: in the year 2002

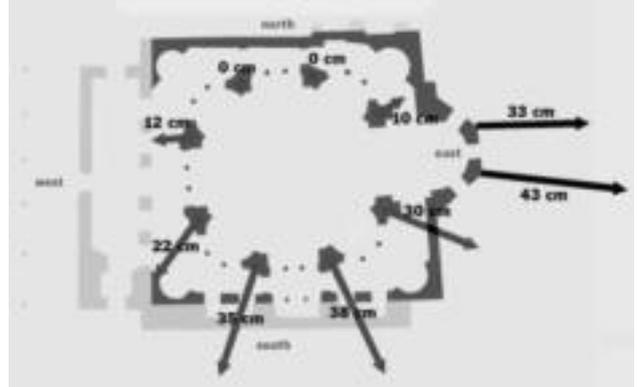
Different photogrammetric studies suggested that the whole apse of KAM is declined due to the vertical. Therefore some images were measured and a bundle adjustment was calculated. The result can be seen very good at the front wall of the apse in the east of the building: the height of the front wall is about 10,5 m, the deviation from the vertical at the top of the wall is about 45 cm, cf. figure 11. It seems that the whole apse is not in a vertical equilibrium.

images of each pillar were measured. The results of the bundle adjustment are shown in figure 11. The four pillars at the north side are in balance, the four at the south side are inclined due to the vertical with a deviation in radial direction of 30-40 cm, the height of the pillars is about 9,5 m. These deformations of the pillars result from the horizontal strength of the dome. It may be the static equilibrium from the beginning of the building. The question of asymmetry of that equilibrium stays unanswered.

Figure 11. Deformations at the top of the pillars and the front wall of the apse

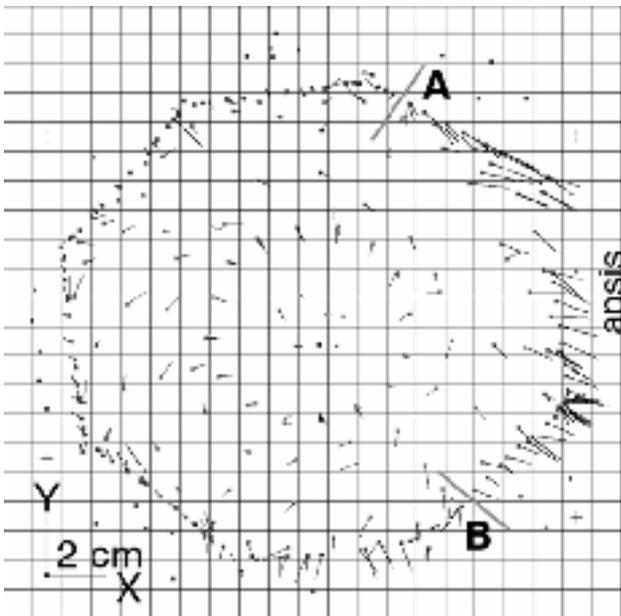
Figure 14. Deformation vectors of the dome, xy-plane, grid: 1 m, Cracks (A) and (B) signed

After extensive common analysis of the two blocks and looking at the real situation of the cracks some points west of the cracks in the lower and physically less disturbed regions of the dome were chosen for the connection of the two blocks with the help of the s-transformation in the free adjustment. Three dimensional deformation vectors were projected to the xy-plane, see figure 14, and to the xz-plane, see figure 15. It is not surprising that the part of the dome in the east between the two discussed cracks (A) and (B) had completely moved about 1 cm in direction of the apse before the whole apse seems to be out of balance. The height of the dome had sagged about 2 cm maybe as a consequence of the horizontal moving of a part of the dome but the definite analysis will just be possible with some more information to be find in the future. From static point of view the cracks – especially (A) and (B) – are very important elements for a definite analysis. The question of the time linearity of the moving is unanswered, next time we will look for a third bundle-block of the year 1998, one year before the big Izmit – earthquake.

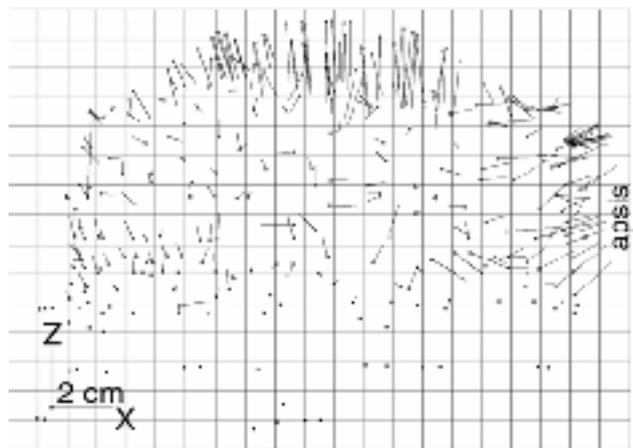
Figure 15. Deformation vectors of the dome, xz-plane, grid: 1 m

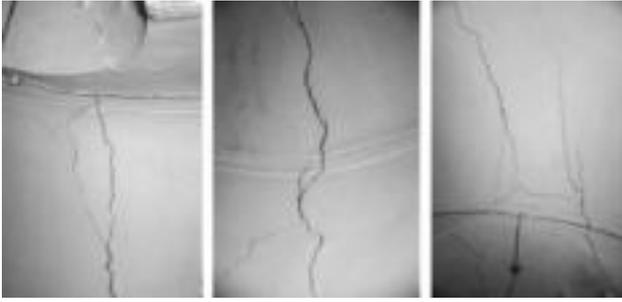
The shocks of the last big so called Izmit-earthquake in Turkey (in august 1999, magnitude 7,4) gave reason for some additional damages in the KAM which can be documented with photographs and photogrammetric images, look at the examples in figure 16. Some of the damages are really new but most of them are hidden before or placed at the weak points of the building well known to the experts, in figure 17 we see an example of that theory: with the help of digital image processing it could be shown, that the defect of the piece broken in 1999 was known some years before, the piece was once more renovated in former times.

Figure 16. Damages of the earthquake in august, 1999

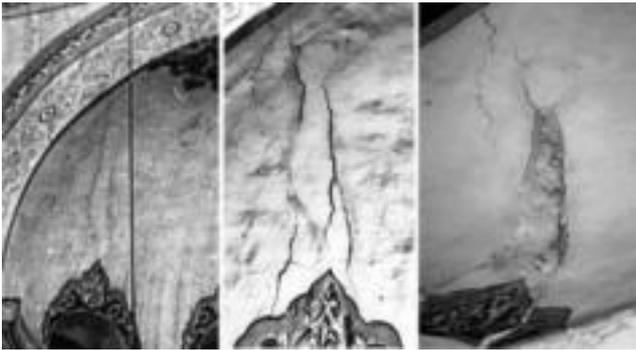
Figure 17. Damage of the earthquake 1999 (right), same situation 1979 (middle) and earlier than 1908 (left)
