TOPOGRAPHIC AND PHOTOGRAMMETRIC STUDIES OF THE BEARING STRUCTURES OF THE CAPPELLA DEI PRINCIPI OF FLORENCE

L. Bianchini, G. Bartoli, I. Chiaverini, F. Costantino, D. Ostuni
D.I.C. Dept. of Civil Engineering, University of Florence, Italy

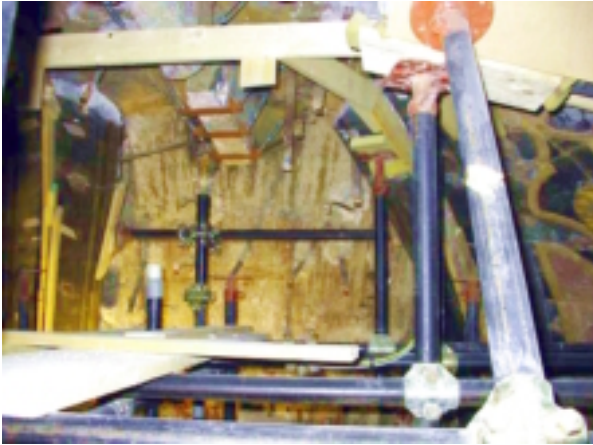
The fixurative picture survey was carried out with the aid of any old and new measuring systems, but for some critical situations only direct measurements from the scaffoldings were possible. As a result from the surveys a sliding of the key stone arches was discovered in sector 3 and 5.

This sliding has been emphasized by a constructive error of an incorrect wedge shape of the key stone.

Figure 1. A sliding of the key stone arches as discovered in sector and

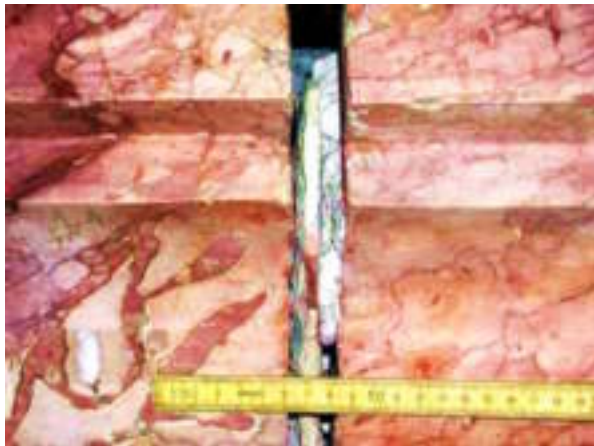
Figure 2. A kind of large crack on marble covering

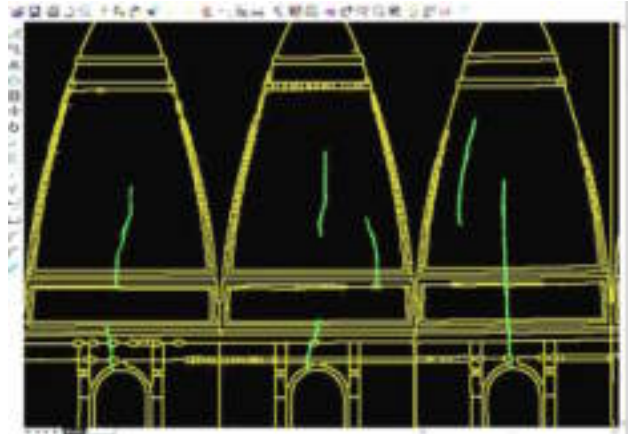
Recent inspections about the actual crack system status were focused to verify the *drum* and the *dome* situation; the fissures system appears regular and quite symmetric on the surfaces.

In the main structural septa of the *chapel* the fissures begin in the middle of the *gable roof* and stops on the *drum*; on the other empty structural zones the fissures on the *gable roof* are longer and continue just to the key of the *arconi*.

Figure 4. Dome roof crack map

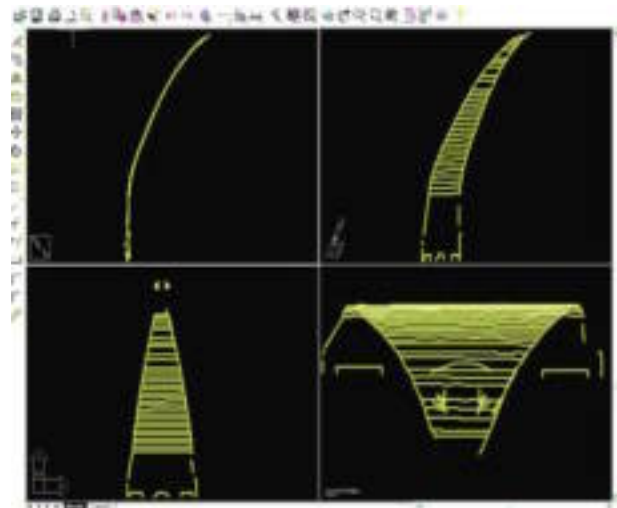
To investigate other structural hypotheses a specific stereophotogrammetric close range survey was then planned in order to acquire the geometric cylindrical shape of the *gable roof* of the dome in the Triumphant Christ fresco sector. Resulting 3D data show only slight irregularity; no structural concavities or convexities were found. (fig.17)

Figure 5. Photogrammetric survey of dome roof
