DOCUMENTATION OF THE ARCHITECTURAL CHARACTERISTICS OF A HISTORICAL HOUSE

S. Buyukkilic¹, M. Hamamcıoglu-Turan¹, F. N. Kul¹

¹Izmir Institute of Technology, Faculty of Architecture, Department of Architectural Restoration, Urla, Izmir, Turkey

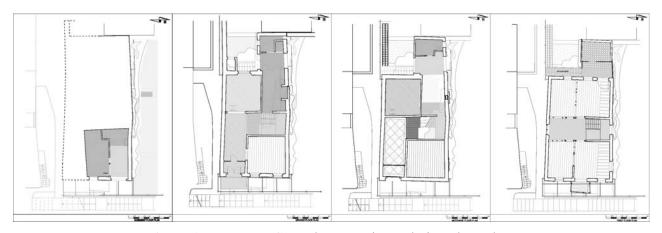
Figure 1: Basement, Ground, Mezzanine and First Floor Plans

The case study house which is a modest scaled urban building (6.8x14 m) and composed of a main mass, a service mass and a rear courtyard has two main and two partial stories. Its main stories are ground floor and first floor. Its partial stories are basement floor and mezzanine floor (Figure 1). There is a narrow axis (2.5 m) and a broad axis (4.3 m) on the ground floor. There is a hall on the narrow axis and a room at the end of this axis. There is another room on the north of the hall and it is on the broad axis. In turn, a staircase, kitchen and toilet are behind this room on the broad axis. This staircase provides relation between ground floor and first floor's halls. There is a courtyard at the back and an additional staircase here. At the first floor, there is a hall which is surrounded by four rooms. Two of the rooms are on the street side and the others on the back side. There is a projection expanding one of the rooms on the east to the street direction and a terrace at back which is reached from northwestern room and also by the staircase at the courtyard. The basement is used for storage, where as a toilet is present on the mezzanine floor.

As a result of the examination of the functions, spaces were grouped as main spaces, service spaces and circulation spaces (Table1). Rooms, the terrace and the courtyard are main spaces. Halls and staircases are circulation spaces. The kitchen, toilets and storage spaces are service spaces. Living spaces are on the ground floor and sleeping spaces are on the first floor. On the ground floor, the room oriented to the street maybe the guest room, and the room oriented to the courtyard and neighboring the kitchen might be the dining room. On the first floor, the room with the projection might be the main bedroom. The courtyard has close relation with the service mass. So, it can be used for food preparation, laundry, dining etc.

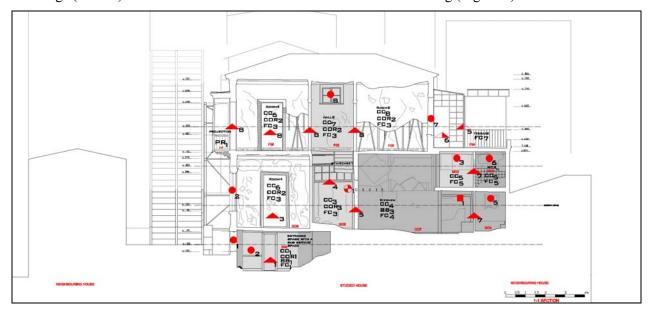
Figure 2: Longitudinal Section

There are fifteen types of architectural elements: ceiling coverings, cornices, projection, exterior doors, interior doors, windows, staircases, pilaster, chimney, fireplace, sinks, bench, toilet, baseboards, floor coverings (Table1). Architectural elements are shown on a section drawing (Figure 2).
