PHOTOGRAMMETRY AS A TOOL TO RECORD A HISTORIC BUILDING AT RISK

Tsioukas, V.¹, Alexandri, V.^{2*}, Karayannis C.G.², Chalioris, C.E.²

KEY WORDS: Architecture, Surveying, Photogrammetry, Close Range, Reconstruction

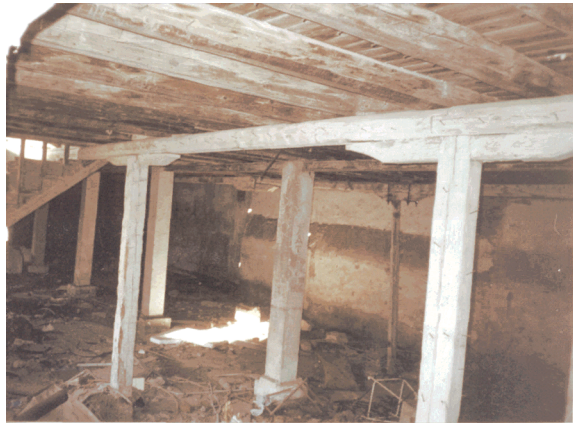
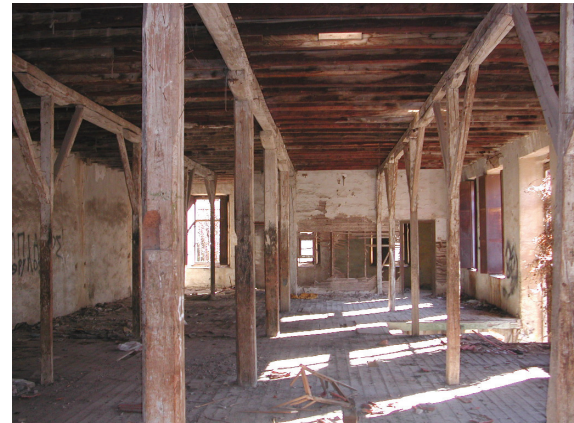
Figure 2. Images of the buildings situation before the restoration started

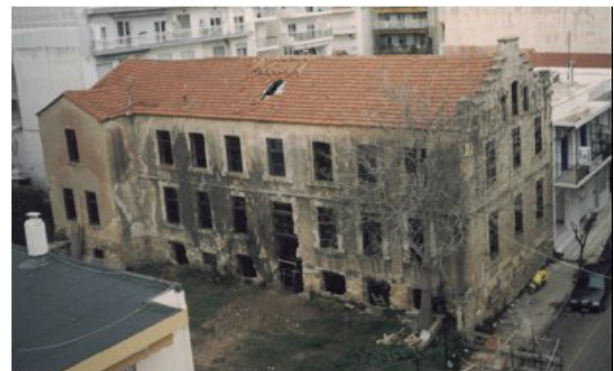
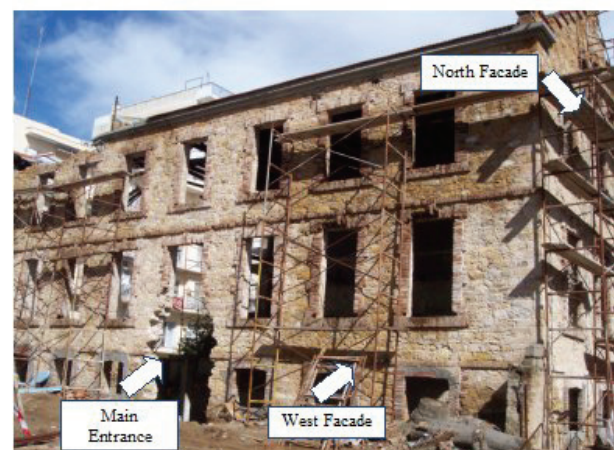
Figure 4. South – western view in 2003 (top). General view of the tobacco storehouse after the collapse (bottom)

The masonries sustain ageing, damages, external and internal cracks. The main entrance, at the west façade (figure 4) due to its inappropriate opening has become very dangerous for any one who wants to enter in the building. Moreover, the upper part of the masonry (ridge made of concrete), sustain serious damages and cracks, whereas at some points has collapsed part of the roof.

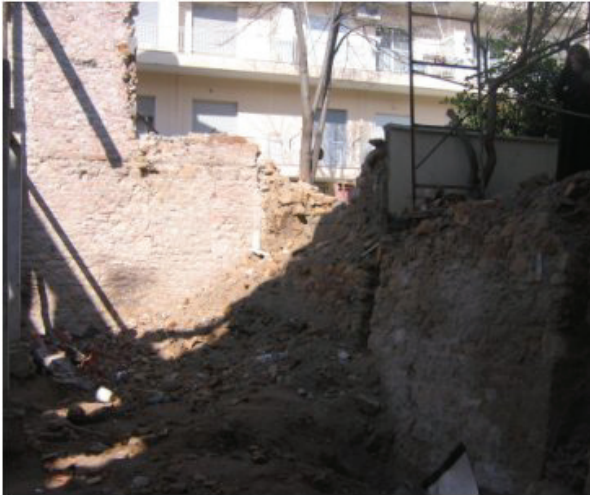
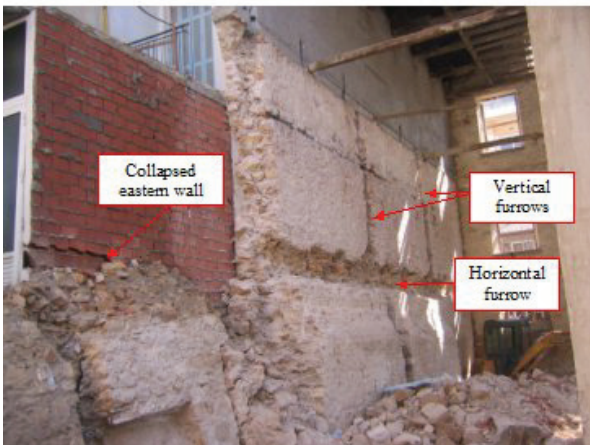
damages and thieveries. During the years 2004 -2005, the interventions for its rehabilitation began but they were suddenly stopped because of a partial collapse (part of the eastern and north wall together with a part of the roof collapsed) of the building (figure 5).

Figure 5. North – eastern corner of the building (top) and eastern (blind) wall (bottom)

The masonry that sustains the bigger damage is the eastern one. There are three vertical and one horizontal groove on the internal part of the wall. During the interventions, those grooves were meant to be the position of the columns (vertical groove) and the position of the beam (horizontal groove).

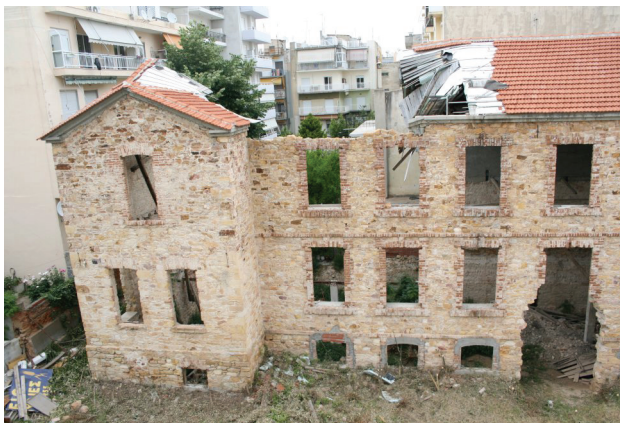
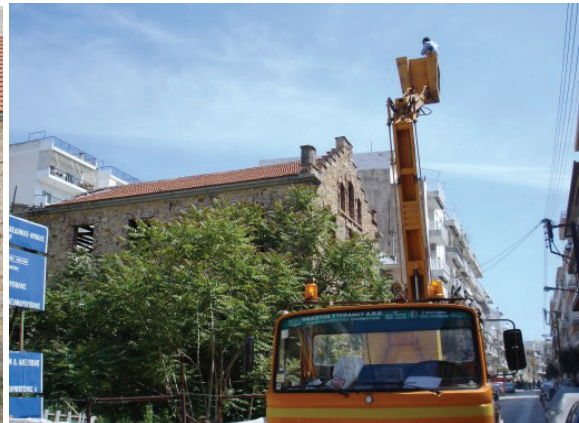
1. Its static situation was not appropriate to ensure a safe stay of the engineers inside or around of it during the recording process since its roof could collapse without warning within minutes
2. Due to its long time abandonment, a big part of it has been covered by high vegetation and also a big part of the debris was not removed after the accident (figure 6).

Figure 6. Current situation of the structure. Part of the roof has collapsed while the debris has not been removed yet (left). For the better photographic documentation a special crane vehicle has been used (right).

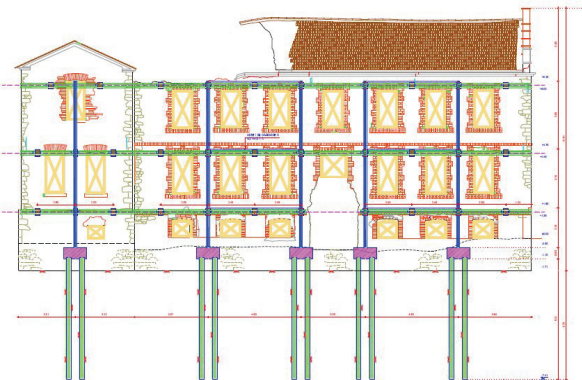
Figure 10. View of the steel towers at the western façade

The main problem was the support of the façades of the building in order to prevent horizontal (seismic) displacements. In this way, the people who work inside and outside of the building are not exposed to the danger of a potential collapse. After taking into consideration the geometry of the building, the urban character of the project, the free space inside the building plot, the neighbouring buildings and finally the seismicity of the region, a system of support of the façades (western, northern and southern façade) was chosen. Nine, vertical, steel towers (two at the northern façade, five at the western and two at the southern) will be placed outside of the building, in touch with the façades (figure 10). At the east, due to the adjacent of the building with a block of flats the installation of a tower is not permitted. These steel constructions bind the building from the

outside as well as the inside. The towers will have 8.75m height and will be removed after all the project of the support of the building is completed.

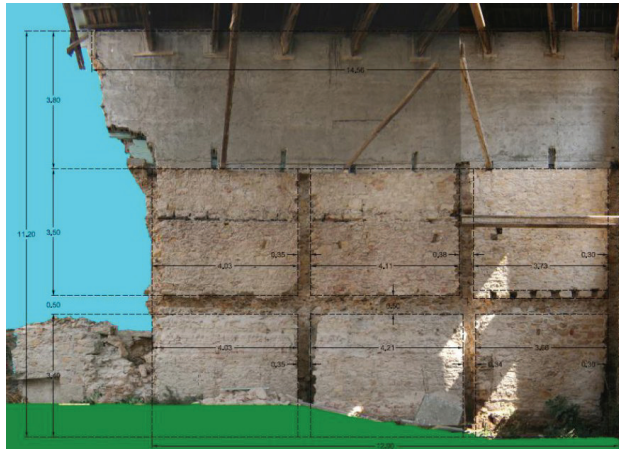
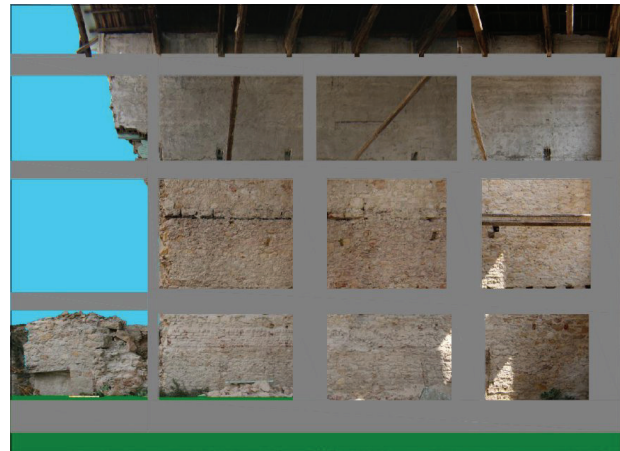
One of the challenging parts of finding the solution for the support of the semi – collapsed building was the eastern masonry whose part has collapsed, because as it is mentioned before, at the east there is no space for placing a steel tower. The detailed orthoimage of the masonry provided all the necessary information about the width and the depth of the grooves. Moreover, the structural engineer was able to measure the exact distance between the wooden trusses of the roof, the height of the masonry and the height of the remaining wall (figure 11).

Figure 11. Necessary information about the eastern masonry obtained by the orthomosaic (left) and the view of the eastern masonry after the completion of the support (right)

In order to fill the grooves and strengthen the masonry, shotcrete with dry mix process will be used. Reinforced concrete columns and a beam at the horizontal groove will be constructed at the places of the vertical grooves. Those structural features are going to be part of the new internal structural system of the building, made by reinforced concrete. The height of the columns is 11.20 m. At that height, a beam will connect them and it will bear the loads of the roof. At the horizontal groove, the dimensions of the beam will be 50x50 cm.

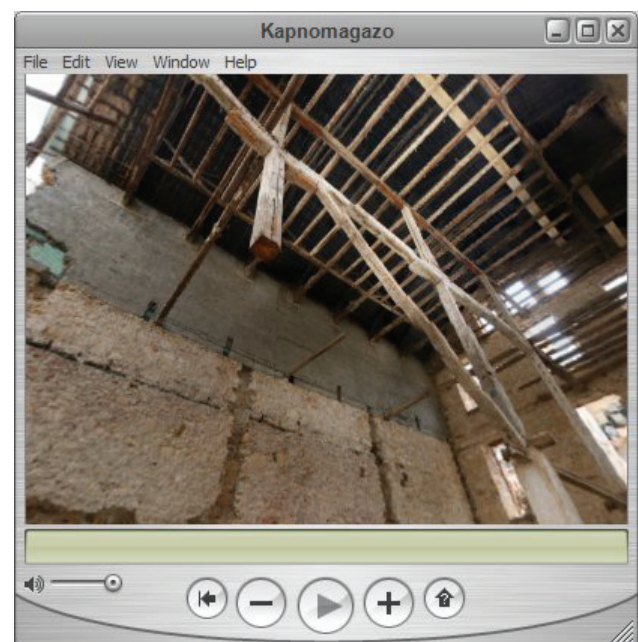
The building, after the collapse, consists of the perimeter remaining masonry walls, two columns per floor and a part of the roof. During the interventions in 2005, the wooden floors and the columns were removed. The floors used to function as diaphragms and as connections that restrain the perimeter masonry walls of the building. The six columns that remain (two of them are made of concrete) can't bear the load of the roof. In fact, some columns literally are hanged from the roof, making the environment of work risky and rather dangerous (figure 12).

Figure 12. Interactive spherical panorama
