DOCUMENTATION OF THE STRUCTURAL CHARACTERISTICS OF A HISTORICAL HOUSE

F. Uygun¹, M. Hamamcioglu-Turan¹, F. N. Kul¹

Izmir Institute of Technology, Faculty of Architecture, Department of Architectural Restoration,
35430 Urla, Izmir, Turkey

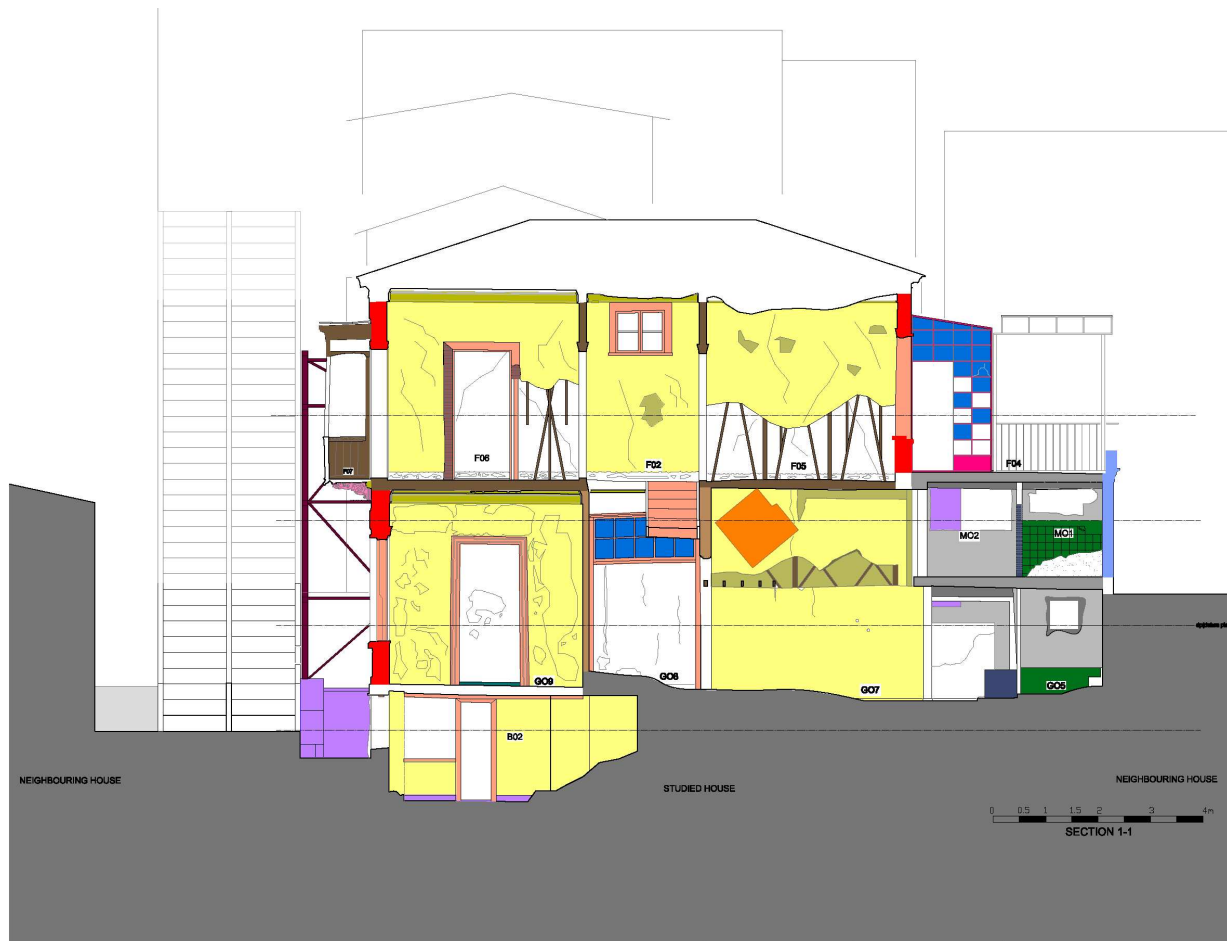
Figure 1: Map illustrating the structural characteristics

The data gathered in the field survey was used for producing 2D drawings of the case study house, the maps and 3D model regarding the structural characteristics. Subsequent to 2D drawings, an analysis table was developed for evaluating the structural characteristics of the house. Defining the concepts of the analysis table took several issues into consideration: First, the building elements were labeled as wall, floor and roof covering, etc. Then the role of each element was considered and three different types were identified: structural, finishing and architectural elements. Finally, sub-groups of each type were identified according to their construction technique and material usage*. Each structural concept was illustrated with a different color on the scaled drawings is shown with a different color (Figure 1). AutoCAD 2007 was used to produce 2D conventional drawings and maps.

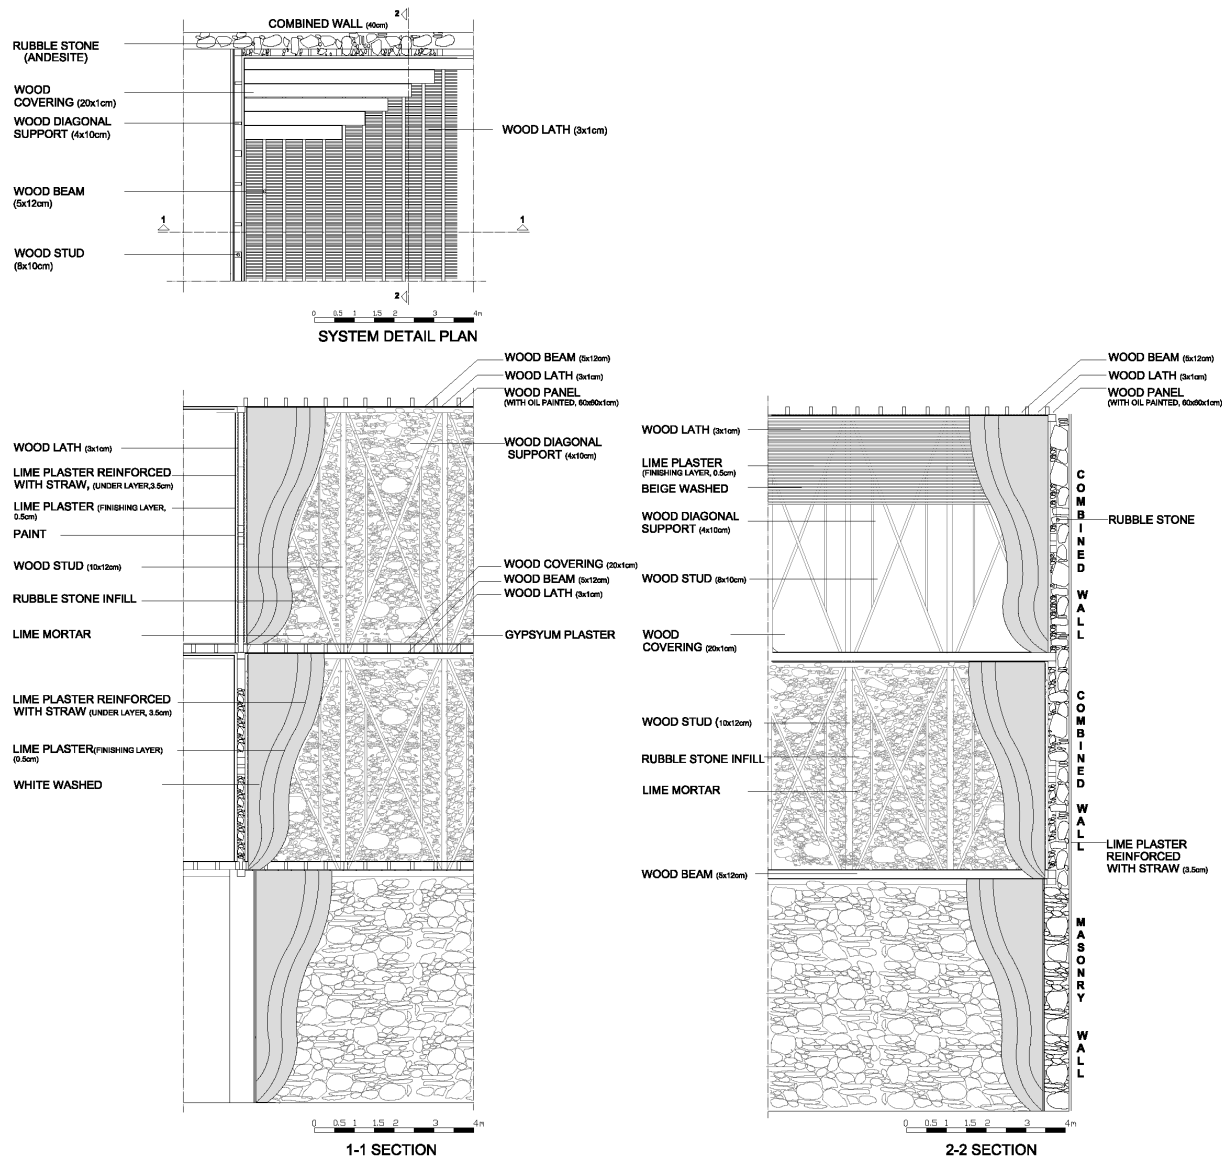
Figure 5: Structural system detail

3D-modelling technique was preferred to illustrate the details of the structural system and the possible sequence of construction. The parts whose finishing material was missing were thoroughly observed and the data gathered from different locations in the building was combined to produce the system detail (Figure 5). In turn, this detail drawing does not illustrate a specific part of the building, but it gives analytic information about characteristics of the primary structural and finishing elements. This information was further emphasized with the production of the analytic 3D Model. The sequence of the construction was illustrated with four views from the 3D model. The software used for modelling is Archicad 12 and Artlantis.studio.2.0. First, the structural and finishing elements were modelled as 3D elements in Archicad 12. Then, these elements were brought together differently in four models to present the possible sequence of the construction. Each phase was transferred to Artlantis.studio.2.0. In Artlantis, the appropriate textures and colors which were selected similar to the original features of the materials are added. Lastly, a photo was captured with the same camera viewpoint in each model (Figure 6).
