## **THE WINDOWS OF HISTORICAL BUILDINGS IN KIRKLARELİ/TURKEY: CHARACTERISTICS AND PRESENT CONDITIONS**

İ. Yüksek<sup>a</sup>, N. Erdoğan<sup>b</sup>

**KEY WORDS: Windows, Traditional Houses, Degration**

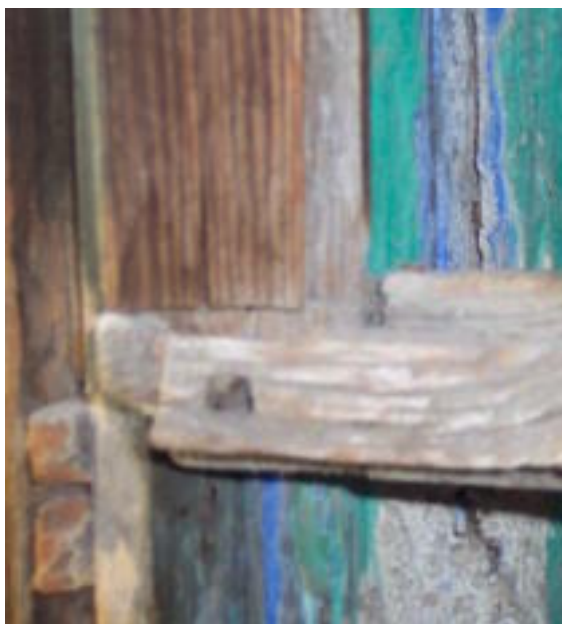
- When timber is subjected to prolonged climatic conditions such as rain, snow, temperature changes, oxygen in air, direct or indirect ultraviolet radiation or winds, it undergoes cross-sectional shrinkage. As a result of this, the diameters of wooden pegs diminish threatening the stability of the joints. The looseness in joints is the cause of falling casements and window glasses (Figure 1).

Figure 1. Wear and tear on the window casements and jamb.

Particularly, wooden pegs with longer diameter could be used for better stability, in place of the smaller ones utilized to join the elements of window casements. If necessary, the joints could further be reinforced by a transparent glue.

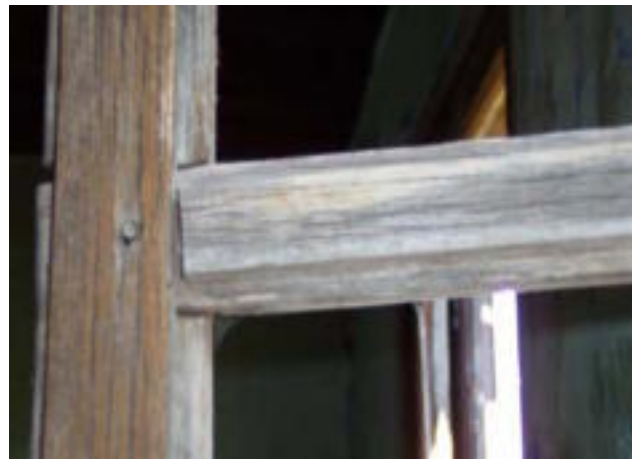
- Timber undergoing cross-sectional shrinkage loses its knots with time. As a result, the material is exposed to atmospheric conditions and, starting around the damaged part, decays much faster.
- The climatic conditions give rise to cracks on the timber surface which in time split. The rain water entering through the cracks and split parts dampens the timber. This enhances the development of fungi and termites. When the joints develop gaps upon shrinkage, particularly the window casements lose their stability (Figure 2).

Figure 2. Splitting along the connection points in the casements and surface cracking

The hollow spaces formed by falling knots could be filled with a filling paste obtained by mixing wood shavings from sturdy trees with varnish. Here it is important that the kind of tree from which the shavings are obtained be compatible with the type of woodwork of the structure.

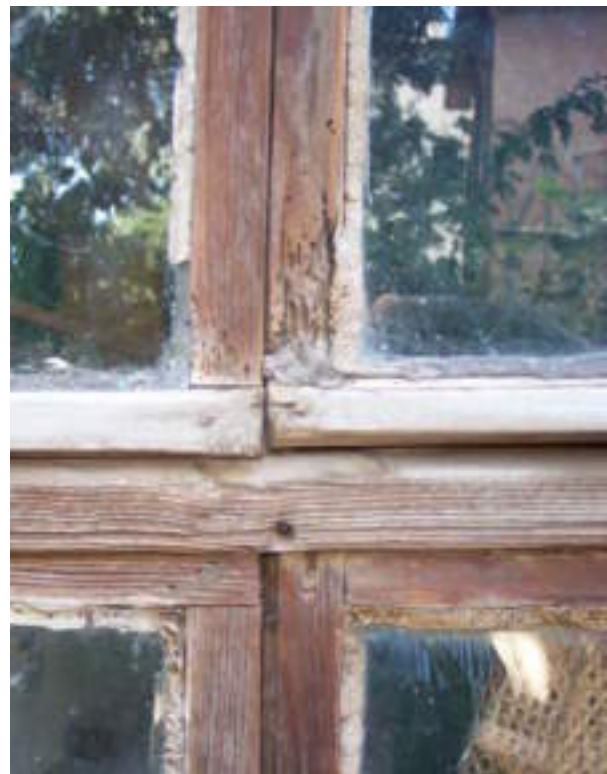
The climatic conditions are more effective in timber decay during spring time; whereas, summer timber is sturdier and less prone to decay. The fibers near the surface become fluffy and rough, crack and fall off because of continual swelling and shrinkage. Timber affected this way exhibits damaged annual rings and exposed fibers. (Figure 3)

Figure 3. Insect damage to the window casements and textural damage

- The woodwork in these houses is not thick enough and is subject to a lot of ultraviolet radiation. This fades the color of the material over a period of time. If no protective measures are taken the wood is bound to lose its natural color and becomes dark brown. (Figure 3)

- The wood-boring termites which live on the wood are the biological creatures that cause greatest damage. Most of these stay inside until they are fully grown. The tiny holes on the surface through which they fly, the inner tunnels, termite dusts and their remains are only detected by the void sound produced upon hitting the material with a hammer (Günay; 2002). As seen in Figure 3, part of the wood is about to be destroyed. Other dangerous living creatures are the fungi. They particularly originate on window sills where moisture is most dense and spread out from there. Fungi which settle in damp wood produce perpendicular cracks which enlarge and disintegrate the wood into small cubical pieces, eventually resulting in its complete decay (Figure 3).

Termites and fungi could be eliminated by vacuum spraying with chemicals and injection of a pesticide through the termite holes. The revival of parts that can be saved should also be possible by cellulose absorption. The areas that have decayed completely could be removed and be replaced by kiln-dried and pesticide-treated pieces of wood obtained from a compatible tree.

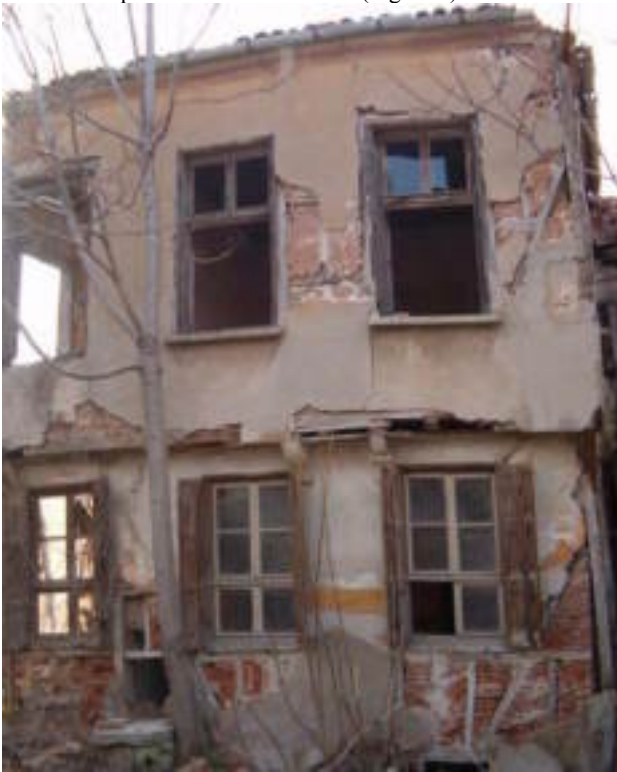
- Damage for various reasons to load-bearing structure of the building affects the upper and lower rails upon which the window rests, as well as the side posts causing the window to lose its stability. Along with this, the material covering the façades of the building also begins to crumble and fall and the frames become exposed to external effects (Figure 4).

Figure 4. Decay in the timber frame structure

As to measures to be taken against natural damage, it does not seem feasible to restore merely the windows of a structure that has lost all of its other elements. Therefore, these structures should be restored as a whole.
