BASILICA OF SAINT PETER MARTYR FROM VERONA IN S. ANASTASIA (VERONA): STRUCTURES GEOMETRIC SURVEY AND PHOTOGRAPHIC CAMPAIGN FOR THE PRESERVATION PROJECT

C. Campanella^{a-b}, M. Tessoni^b, S. Bortolotto^c, E. Ciocchini^d, F. angheri^e

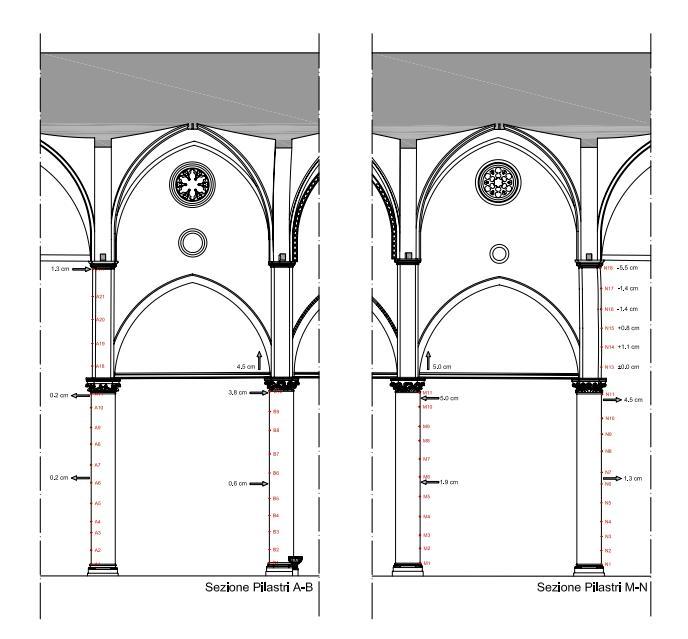
Figure 7. Geometric draughting of columns' out of plumb

The results of these surveys confirmed our first impressions on the eventual out of plumbs of the first columns towards the transept, though pointing out other problems regarding the state of the wooden chains longitudinal to the nave, which have a delta of approximately 15 centimeters between the first and the last one. Also the transversal chains, placed at a higher level than the longitudinal ones, show misalignments in the range of 8 to10 centimetres and a borderline case at 17.

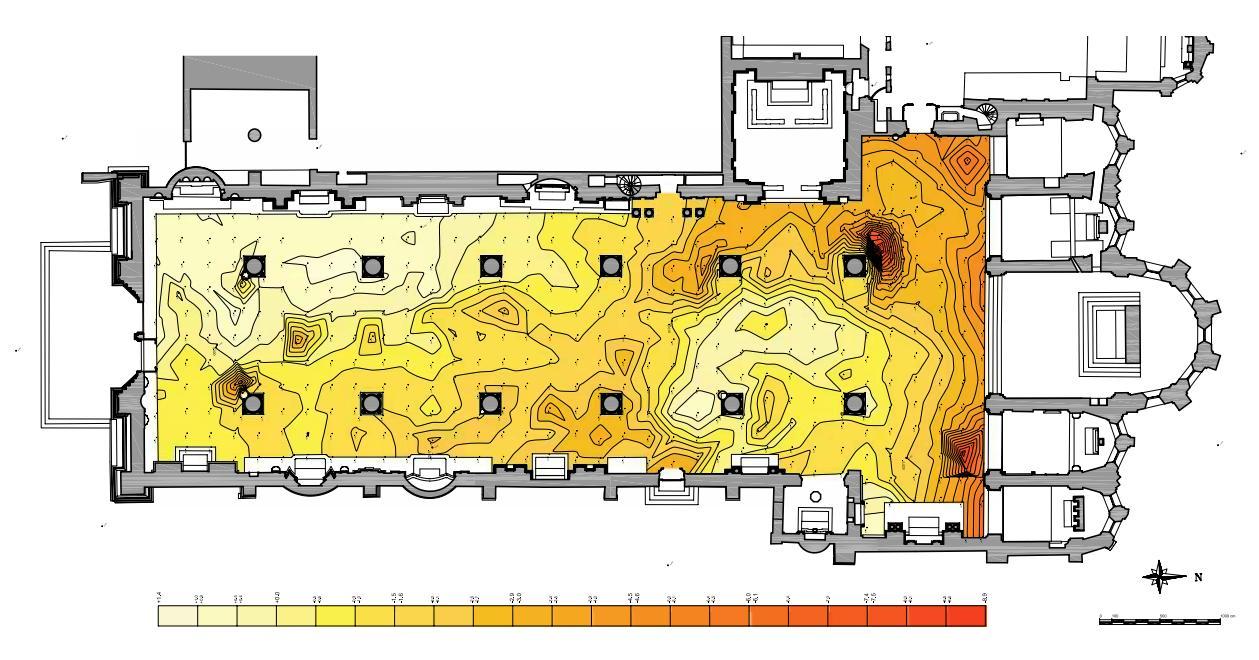
Figure 8. Altimetric data of the flooring with grid of over 500 points

The altimetric state of flooring has instead resulted nearly constant, with a slight inclination, of approximately 2 centimetres, towards the presbytery, but with important depressions in the order of 10 centimetres localized in the transept area.
