ADVANCED METHODOLOGIES FOR SURFACE ANALYSIS : METHODS, COMPARISON AND MONITORING OF THE MOSAIC SURFACE FLOOR OF THE ST. MARK'S BASILICA IN VENICE

KEY WORDS: 3D, Analysis, Comparison, Laser Scanner, Mosaic

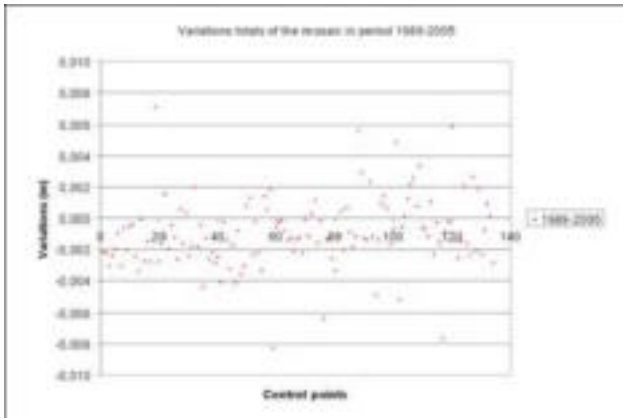
Figure 5. Total variation of the narthex floor in the period 1989-2005

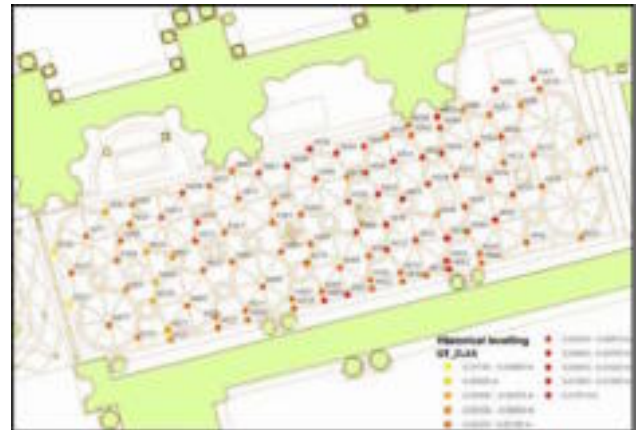
Figure 8. Comparison between the level height of the 2005 and extracted height from the data laser scanner (historical points)

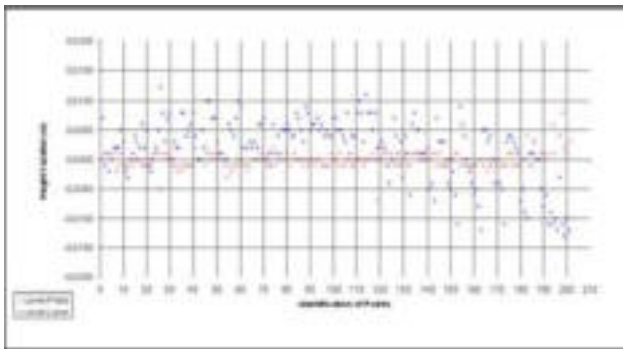
Figure 6. Photogrammetric control points. In ordinate are given the values of the remainders between of level height and DTM generated by photogrammetry and laser system.

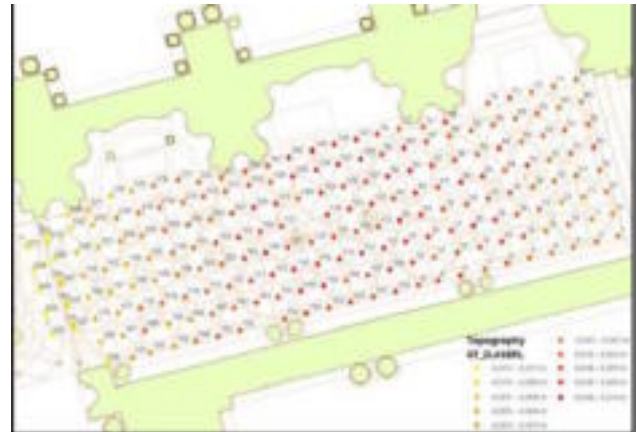
Figure 9. Comparison between the level height of the photogrammetric check points and the extracted height from the lattice (generated from the data laser scanner)

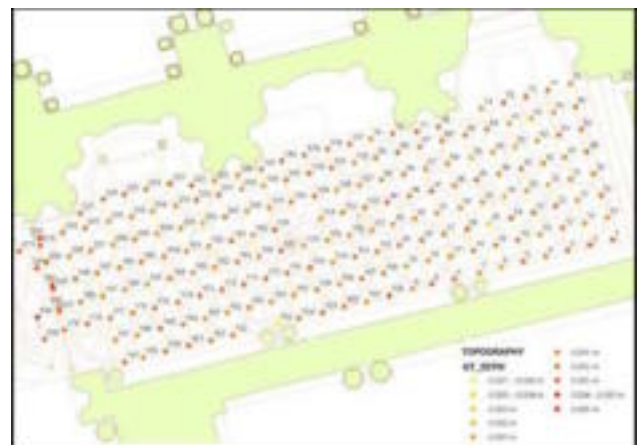
Figure 10. Comparison between the level height of the photogrammetric check points and the extracted height from the photogrammetric DTM (generated by automatic image matching)

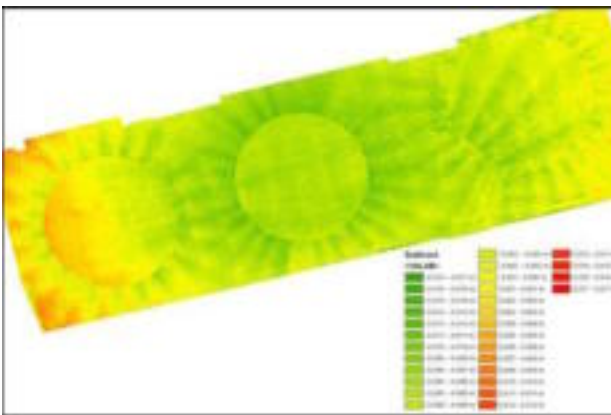
Figure 13. Raster calculator from ArcInfo: the image represents the difference between the DTM photogrammetric and laser

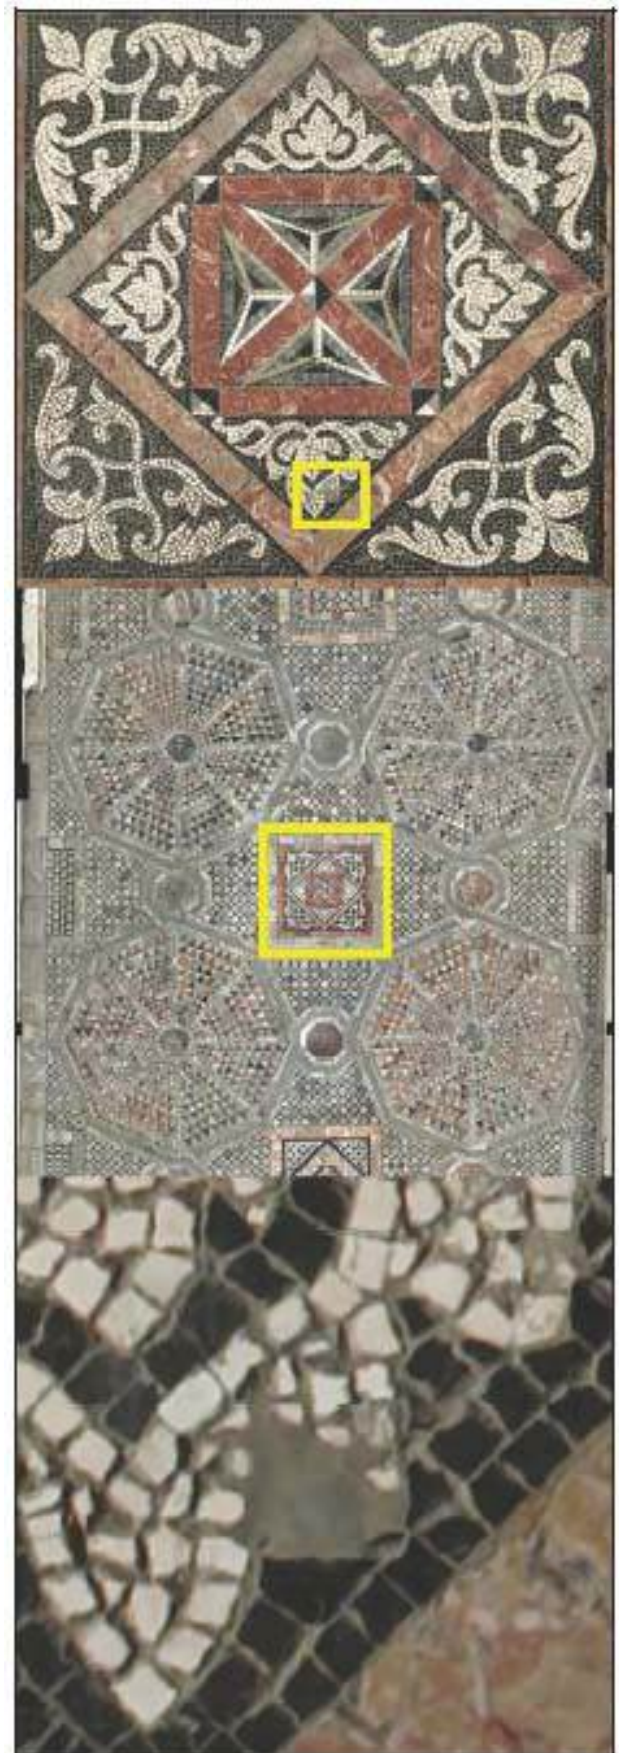
Figure 15. The orthophoto of narthex with particular (scale 1:10 and 1:1)
