INTEGRATION OF 3D LASER SCANNING, PHOTOGRAMMETRY AND THERMOGRAPHY TO RECORD ARCHITECTURAL MONUMENTS

KEY WORDS: Thermal imagery, Laser Scanning, Photogrammetry, Sensor integration, Cultural heritage recording

2. CASE STUDY: DJIN BLOCK N° 9

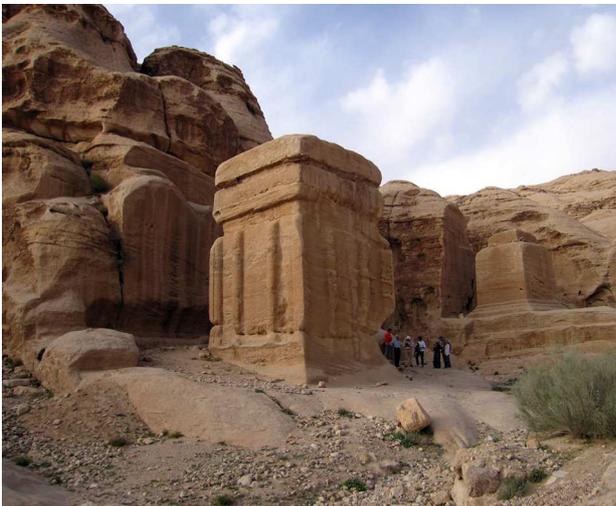
Figure 1. Djin Block N° 9 (in the centre) and Djin Block N° 8 (on the right)

Our study is centered in on monument no. 9 (Figure 1), one of the three Djin Blocks that are found just before the main entrance to the Siq (a narrow and deep gorge). It is about 9.8 m high, with a square horizontal plan with each vertical each

facade measuring about 5.5 m wide. The four facades are similarly carved, while the roof is flat and hollowed out, probably serving as a grave. A row of inset stones forms a cornice running all around the block from all facades.

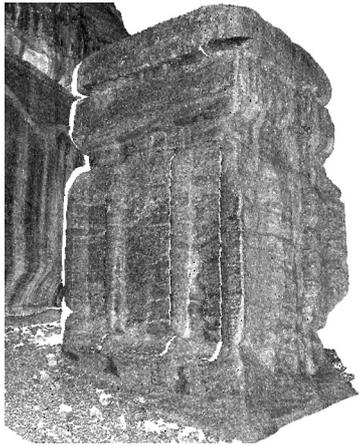
Figure 2. Intensity-based point cloud from the scanner. View of one single scan

A total of eight natural control points were measured with the reflectorless total station to relate the geometry among the different sensors. Regarding laser scanning, a total of seven scans from five different positions were acquired to ensure good coverage of the monument as well as sufficient overlap among the different scans from the different scan sites. Images from the scanner were in colour but at low resolution, and show important radiometric differences due to changing lighting conditions during the data acquisition. Figure 2 displays the points with their intensity values; Figure 3 shows the coloured point clouds of the scanner after registration.

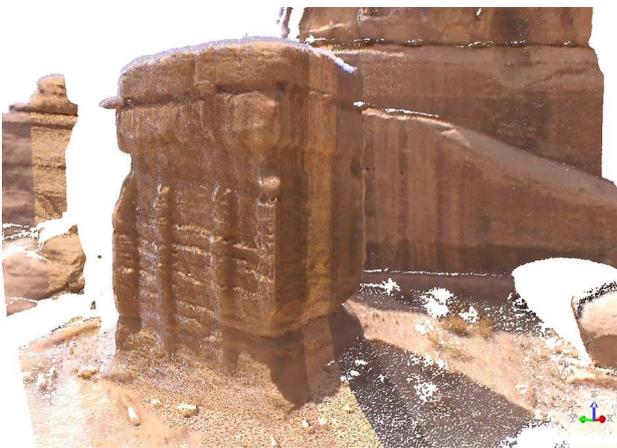
Figure 3. Point clouds coloured from the scanner, view after registration

The point cloud processing phase began by referencing all the raw data captured from each scanner position to a single object coordinate system. The residuals of the registration process were better than 4 mm in XYZ coordinates. Additionally, some filtering was carried out in order to eliminate noise in the point clouds on the surfaces of the Djin Block.

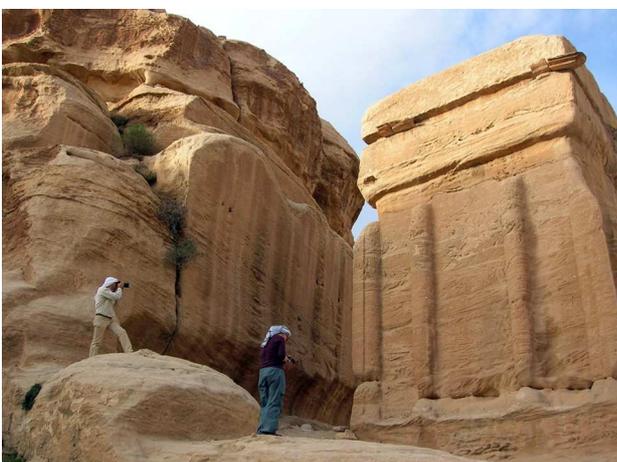
Figure 4. Data acquisition with visible and thermal sensors

Thermal images were also taken from various surrounding sites at different times of the day to get maximum thermal contrast on the monument itself. Figure 4 displays an instance of the image acquisition process on site, meanwhile Figure 5 shows a sample of the visible and thermal imagery without processing. Additionally, detail thermal images were taken on part of the monument affected by weathering effects.

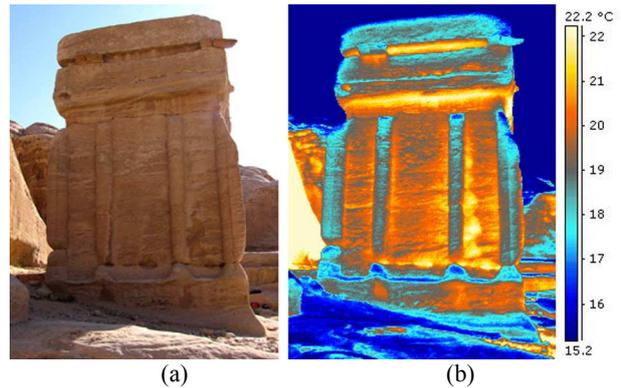
Figure 5. Djin Block No. 9 Western façade (a) Visible image; (b) Thermal image taken at 08:36

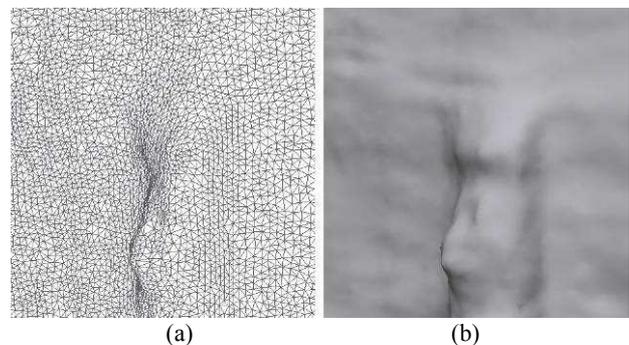
Figure 6. Detail of the 3D model: a) Wireframe; b) With lights on.

Meshing involves data triangulation to build a unique surface over the object. The 3D triangulation mesh results lacked topological errors. Moreover, tiny holes due to hidden areas were filled. The final 3D model of the Djin Block No. 9 consisted of 780,000 triangles. Figure 6 shows the mesh of the 3D model in two modes, wireframe, and with lights on.

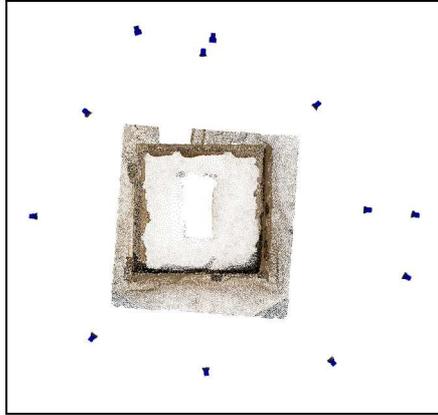
Figure 7. Top view of the visible camera positions surrounding the tomb

Bundle adjustment was performed to determine the exterior orientation parameters of the twelve visible images used to model the tomb. Figure 7 displays the planimetric distribution of the visible images around the Djin Block No. 9. The three top camera positions were taken up from the mountain next to the tomb to be able to document its five sides, including the top.

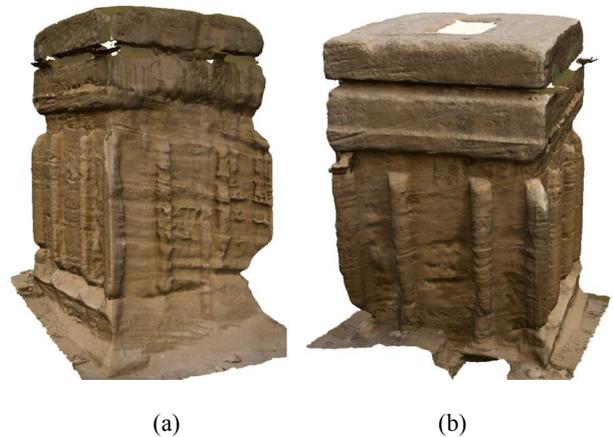
Figure 8. Overall photorealistic model of the Djin Block No. 9 (a) western and southern sides; (b) northern and western sides

Besides the piecewise geometric transformations of the imagery to fit the whole 3D model following the collinearity equations, some radiometric transformations were carried out to remove the slight changes of lighting and reflections during image capture. Following this procedure, a homogeneous photorealistic model in 3D can be built up to guarantee maximum reliability in the visualisation of the state of the monument (Fig. 8).

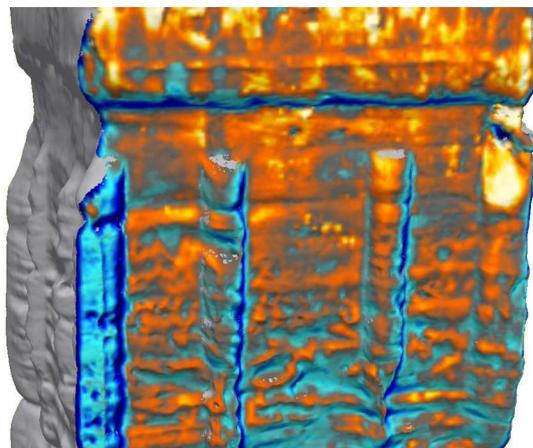
Figure 9. Detail of the thermorealistic model of the Djin Block No. 9. Eastern side

In a similar way as was used applied to build the photorealistic model, the thermal imagery was also draped onto the 3D model yielding 3D thermorealistic models (Fig. 9).

The thermorealistic model over the 3D model allows an analysis of the monument from a different points of view due to the combination of 3D information and thermal infrared data.

Moreover, the thermal information provides an effective way to display the sequential layers of rock as well as the rich ornamentation chisel the sandstone (cf. the central part of Fig. 10b). This last statement is even enhanced after analysing the 3D thermorealistic model (cf. central part of Fig. 9). This kind of information is negligible on the visible image as well as on the photorealistic model.

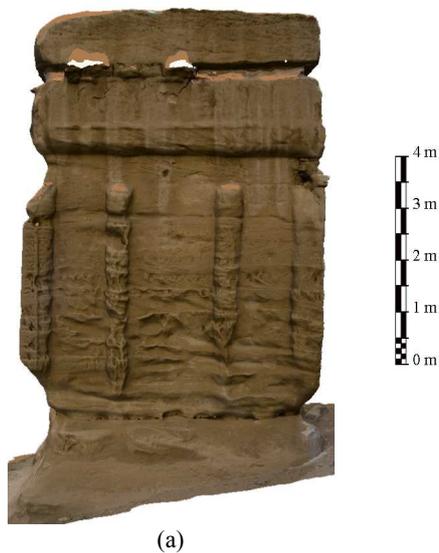
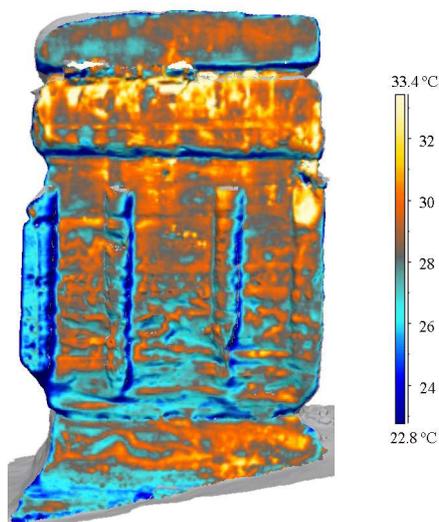
Figure 10. Eastern side orthographic views of the Djin Block No. 9: (a) Visible orthoimage; (b) Thermal orthoimage at 08:15

In general, the coldest areas (around 23 °C) point out areas in shadows when the images were taken. Areas around 26 °C in the lower middle part of tomb represent either extreme loss of material (lower middle part), borders or materials different composition of minerals (top). Areas around 30 °C show either minimum erosion or moisture. Hottest areas around 33 °C (in white) represent detachments or porous materials.

There exist differences in the state of the conservation of each side. For example, the eastern and southern sides are more eroded due to the higher exposition to climatic effects such as sun, raining and wind. The medium-grained sandstone is mainly the water capillarity effect (after entering the tomb through the open top cover) and, last but not least, wind.
