METHODS FOR DATING HISTORICAL BUILDINGS AND VERTICALITY CONTROL OF THE BARONALE PALACE AT AVIO'S CASTLE (TN)

C. Campanella^{a-b}, A. Michela Tessoni^b, S. Bortolotto^c, A. Macchi^d

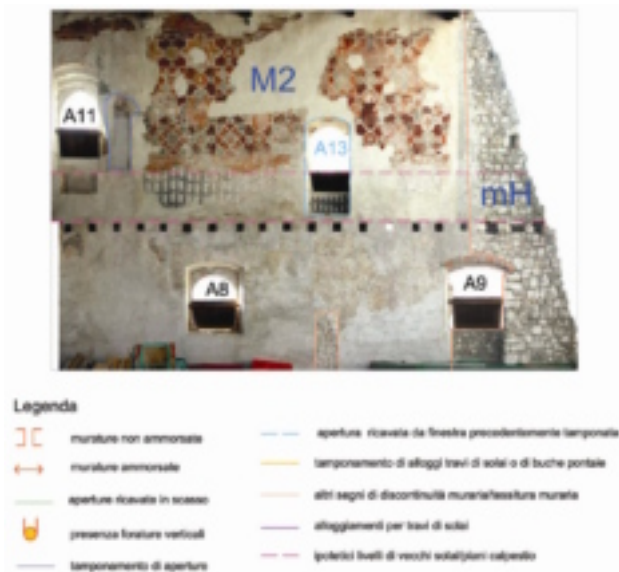
Fig. 1. Example of table showing analysis of internal walls' stratification; south wall, upper floor.

The first phase of the work led to the compilation of "Tables of stratigraphic analysis" for each external and internal wall, and to the registration of both wall construction techniques and apertures' details (doors and windows) of the Palace.

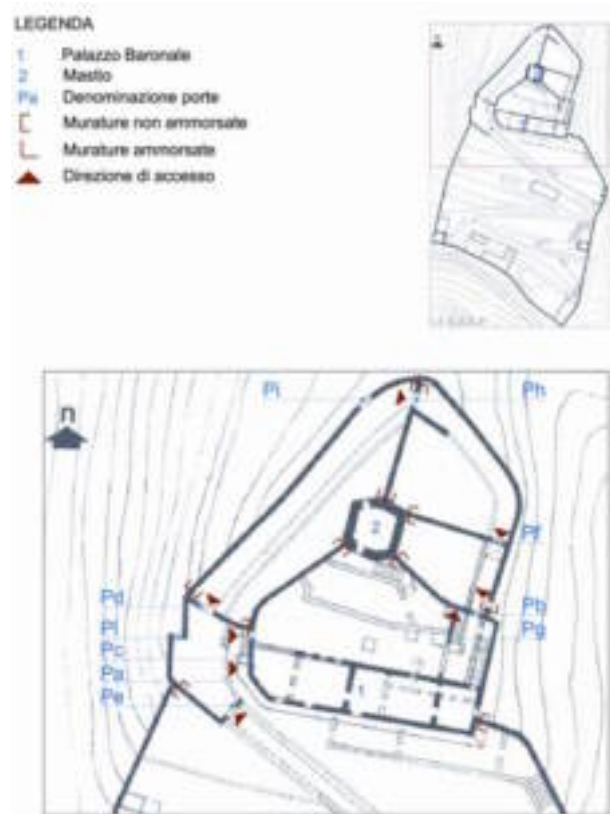
Fig. 2. Example of table showing analysis of perimeter walls' stratification; northern walls.

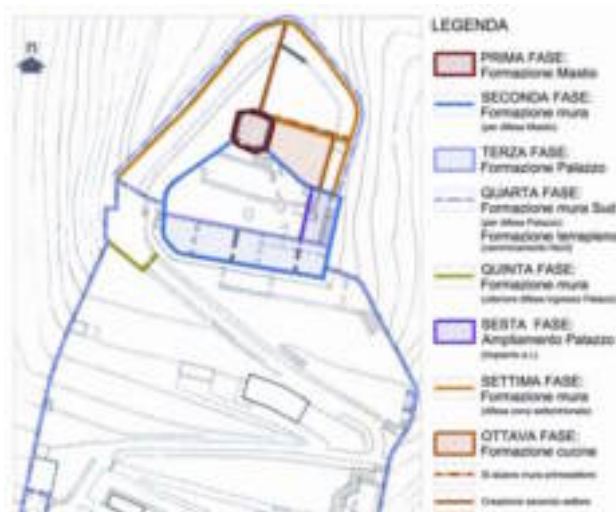
Fig. 3. Example of table showing analysis of perimeter walls' stratification; northern and southern walls.

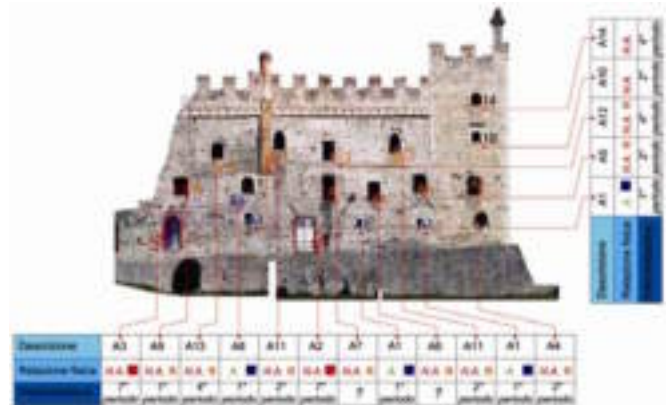
Fig. 4. Legibility of stratification and chronology; southern external elevations.

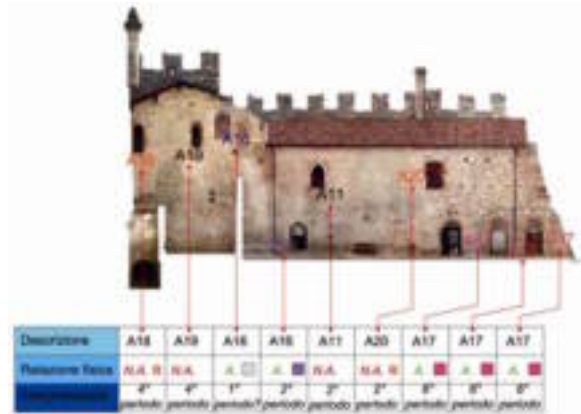
Fig.6. Legibility of stratification and chronology; northern external elevations.

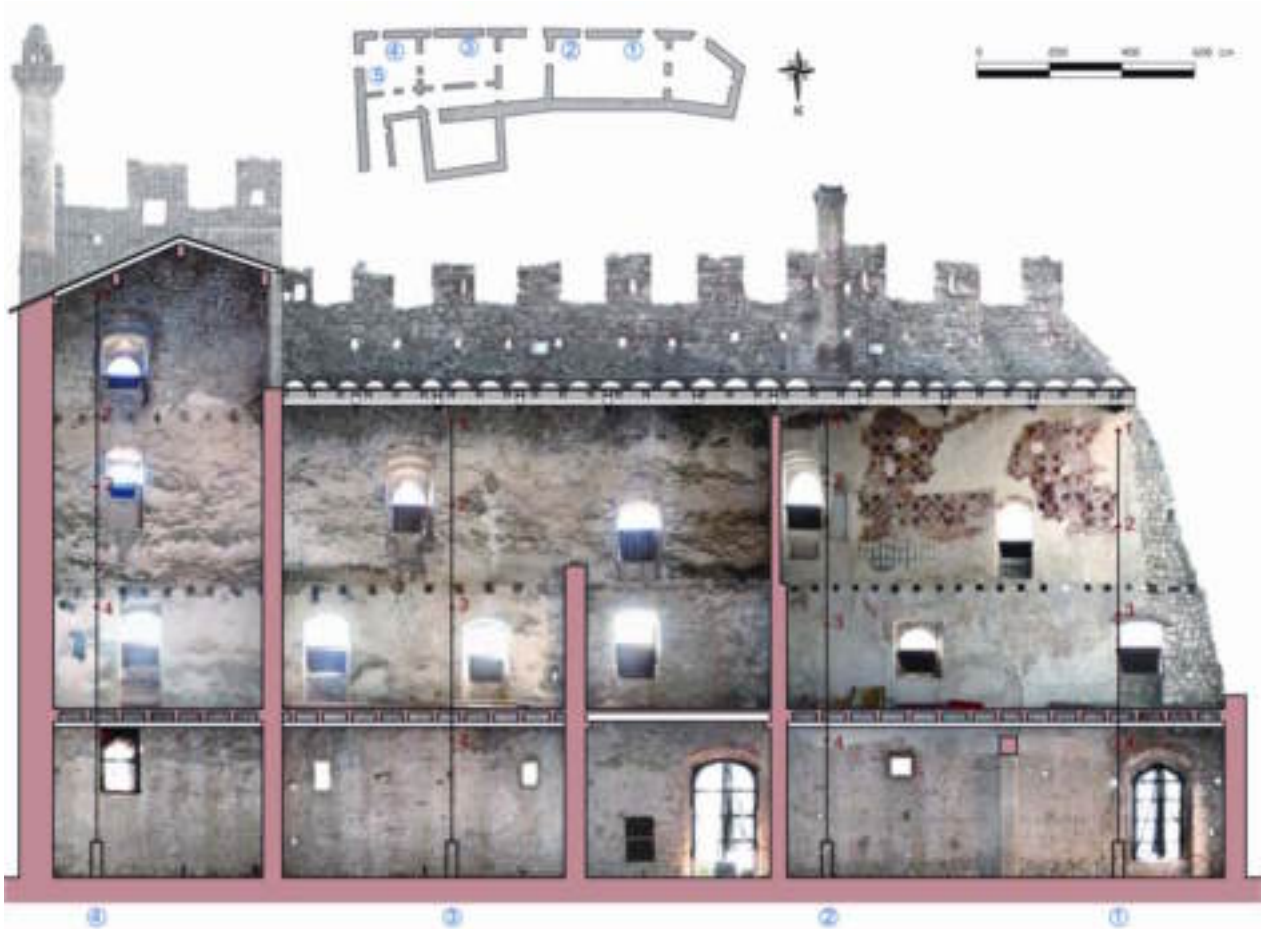
Fig 8. South wall's section: setting of stations 1,2,3,4

Therefore the control has involved 22 points disposed in 5 sections set up with fixed markings (small centers) strictly connected to the walls at different heights. On these points' heights 5 small pillars in reinforced concrete have been built at

ground level, with adequate foundations, where some 5/8" width connection slabs have been placed, purpose-made to rigidly fix the topographic instrument (integrated station).

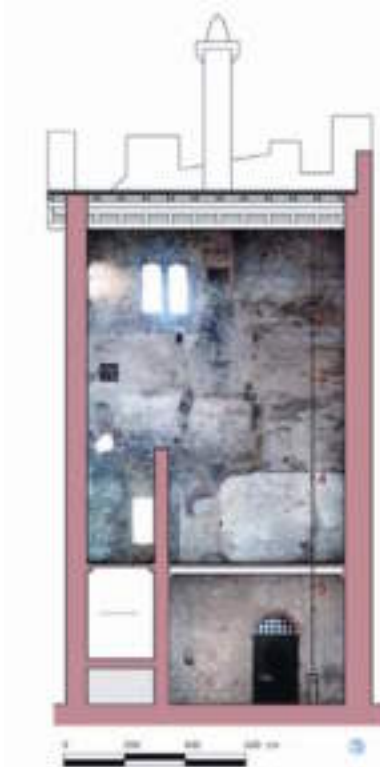
Fig.9. East wall's section: setting of station 5.

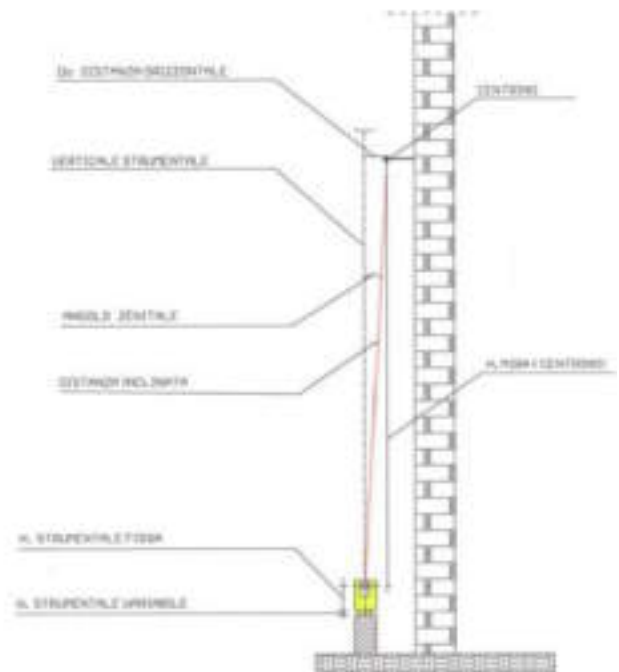
Fig.10. Verticality control survey's outline.

This way, the topographic instrument is always connected in the same exact place for each different control carried out. Once the instrument has been placed – accurately centering the spherical, toric and electronic bubble, it's possible to measure the inclined distance going from the center of the instrument to each small center, the instrumental height in an accurate way using callipers, and the zenith angles, in left circle CL and right circle CR positions, respectively. These measurements have been repeated at least twice, changing the instrumental height by working on screws so as to get a series of independent measures. With simple trigonometric formulas, the D_0 distance between the instrumental vertical and each small center was calculated. Measuring this distance every three months for each small center, we got the partial, total and annual variations. These variations, through time, give the size of the analysed walls' displacement.

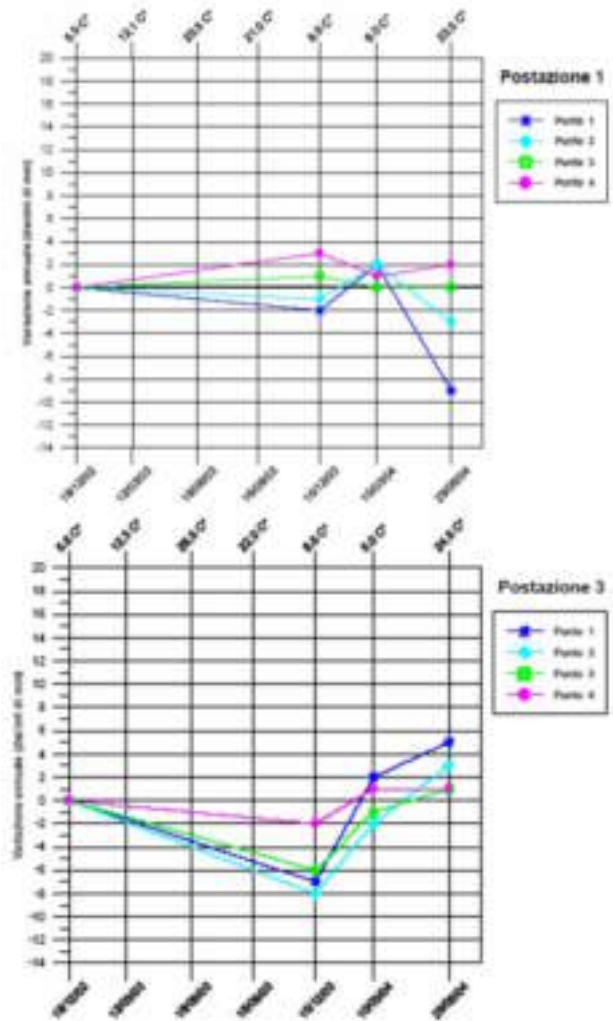
Fig. 12. Annual variations' (V.A.) chart.

The A.V. value determines the shifting of each small center from its previous position, that is, resulting from the previous year's control. Since both the environment and temperature conditions (variations in the range of 2 or 3 C°) result from these measures, the corresponding A.V.s can be considered as practically purified of the effect of the previously mentioned cyclic phenomena. This is also strengthened by the residual values found, which are quite low, especially for each station's lowest points, except for station n.1, where the highest point had a significant residual value. Moreover, comparing positions n. 1,2,3 's shifting lengthwise, at the highest points (south side of the castle), A.V.s' residual values of opposite sign are found, suggesting that a distorsion is probably taking place (regarding this matter, a distorsion on the upper part of the castle's south wall can be easily seen). In order to confirm this effect, it would be necessary to monitor the walls for a longer period of time.
