## LOW COST DIGITAL PHOTOGRAMMETRIC TECHNIQUES FOR 3D MODELIZATION IN RESTORATION WORKS. A CASE STUDY: St. DOMINGO DE SILOS' CHURCH (XIVth CENTURY, ALCALA LA REAL, SPAIN).

J. Cardenal<sup>a</sup>, E. Mata<sup>a</sup>, M. Ramos, J. Delgado<sup>a</sup>, M.A. Hernandez<sup>a</sup>, J.L. Perez<sup>a</sup>, P. Castro<sup>a</sup>, M. Torres<sup>a</sup>  
(jcardena, emata, jdelgado, acar0, jlperez, pjcastro, mtorres)@ujaen.es, magdaramos@wanadoo.es  
<sup>a</sup> Escuela Politécnica Superior University of Jaen. Spain, Las Lagunillas s/n 23071 Jaen (Spain)

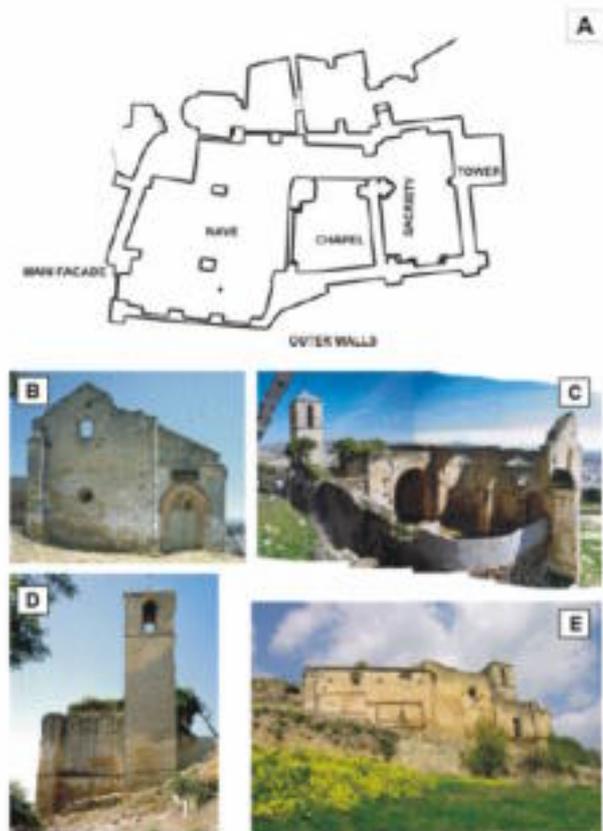
Figure 1. A: Ground plan of Santo Domingo de Silos' Church; B: Main façade, south side; C: South-western side (belfry, nave, arches and access to the chapel are visible); D: Bell tower and north wall; E: Panoramic of east walls.

The study of the rib vault that covers the chapel (Figures 1 and 4) was made by zenithal shots organised in three parallel strips (5 photos per strip), with a CANON D30 camera. This chapel has an asymmetrical plan (between rectangular and trapezoidal) of 6 x 7 m and a height between 3.5 m (at the rib springing) and 7 m.

Besides, a full 3D model of the church (with higher metric quality) has been carried out with the commercial programs 3D StudioMAX© and Autocad© (Ramos, 2005). The ground plan of the model has been taken directly from surveying (Figure 1). The profiles of the main walls, arches, etc have been digitized from the rectified images and mosaics. These profiles have been oriented and inserted in their correct position in the ground plan, so, an initial wireframe model has been obtained. Then, the generated profiles were converted in surfaces. (Figure 11). Both sides of the walls, defined by the surfaces, have been assembled to create 3D solids (Autocad©).

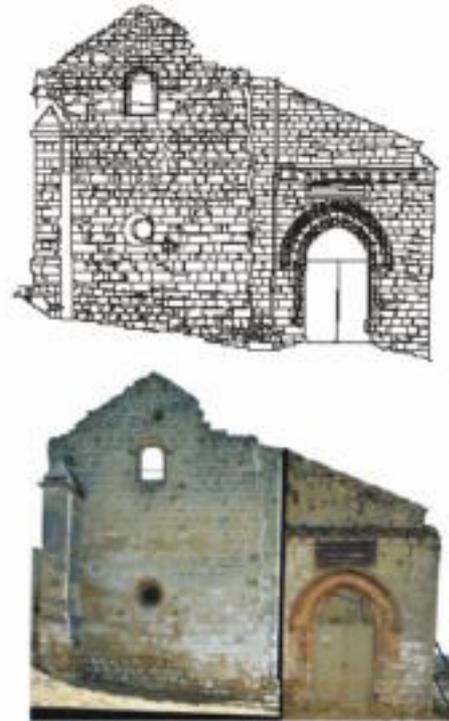
Figure 2. Elevation view of the main façade and mosaic of rectified images (Canon D30 Digital Camera).

Combination of a metric camera (UMK 10/1318) analytical plotter and normal case has been used in the main façade and main external walls (in the east side). In these cases both elevation drawing lines and rectified images mosaics were done (Figures 2 and 3).

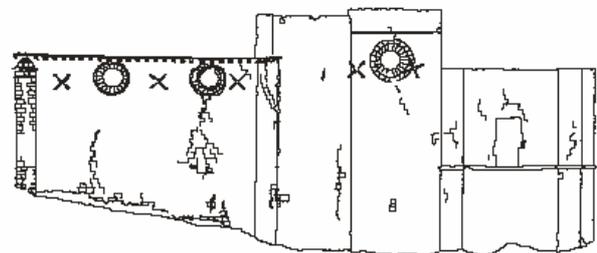
Figure 3 illustrates the architectural lines, cracks and indications of main disorder in the walls in the east side. These walls show large deformation, with a dangerous trend to collapse. In fact, the walls have ties and they are shored up.

Figure 3. Elevation view of the walls in the east side.

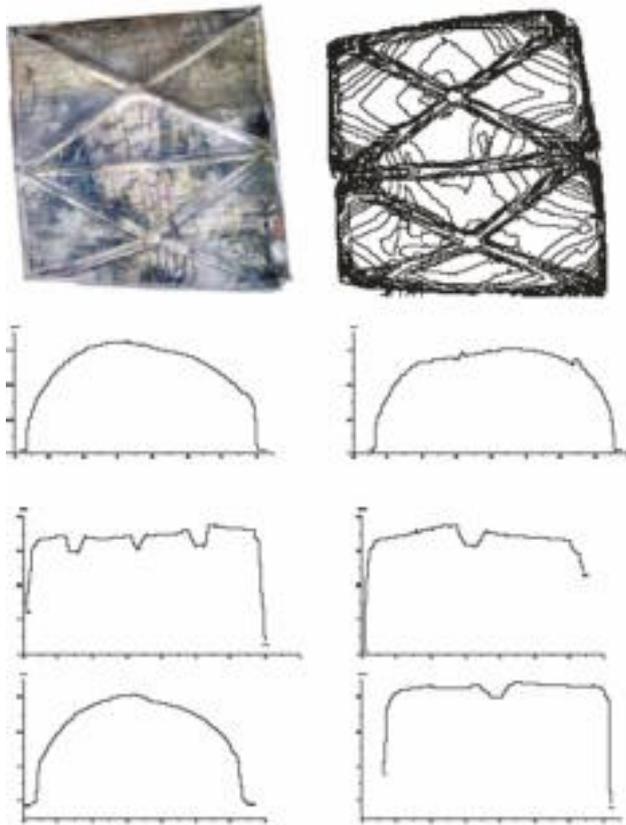
A digital surface model (DSM) of the vault was created using matching techniques and manual edition in a DPW (Socet Set®). The DSM post spacing was 0.025 m with a total of 76500 points. This DSM allowed a contour map of the vault with an interval of 5 cm and subsequent profiles of main sections of the vault. These sections and contour map have illustrated clearly the large deformation of the vault, which at present is near to collapse. Finally, an orthophotograph (3 mm GSD) was created (Figure 4).

Figure 4. The Orthophotograph, contour map and main profiles showing the deformation in the chapel vault

A special case is the 3D model of the vault. In the full 3D model this part has been simplified and the vault surface was generated from the upper parts of the walls profiles of the chapel. Anyway, a detailed 3D of the vault was obtained from both the DSM and ortophotograph (Figure 4) with the TerragenTM. Some additional final products were generated for visualization purposes, such as some walkthrough movies in the inner of the church and anaglyphic images (Figure 15). The anaglyphic

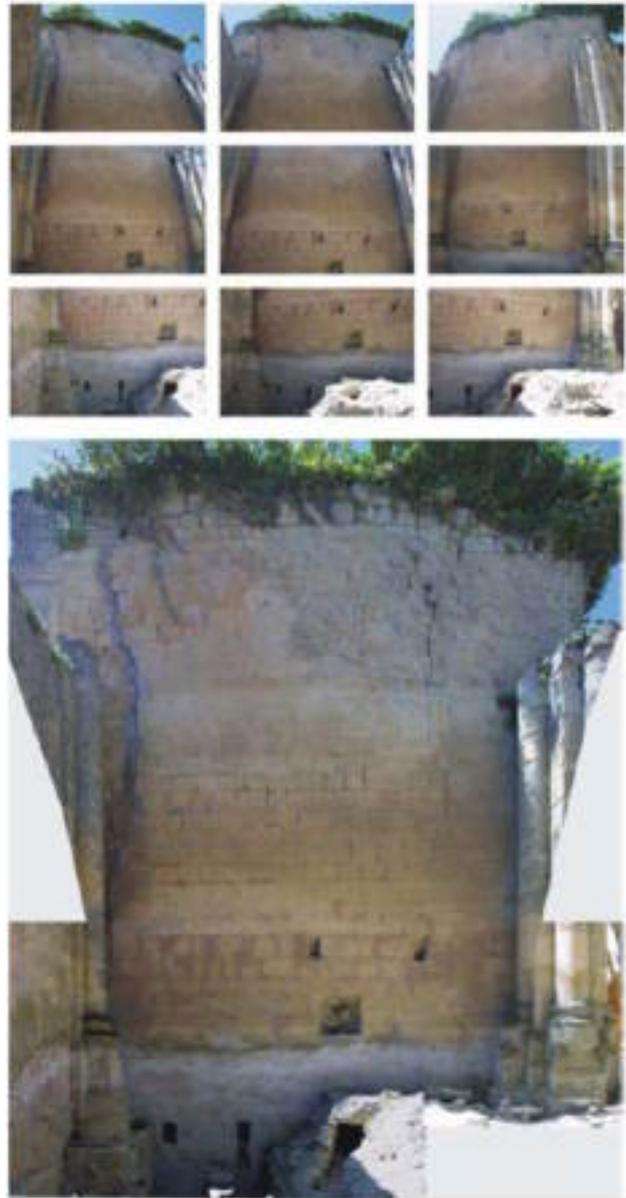
Figure 5. Original images from Canon D30 and mosaic of rectified images in the south wall of the sacristy.

Then the model was exported to 3D Studio MAX© where the textures, taken from the rectified images, were added to give the photorealistic look. Some details have been modelled separately and then assembled in the full model. For instance the figure 12 shows the 3D model of a column in the sacristy modelled previously with Photomodeler©. This column is located in the wall sacristy shown in the figure 5. The full 3D model and partial view of the church are shown in figures 13 and 14.

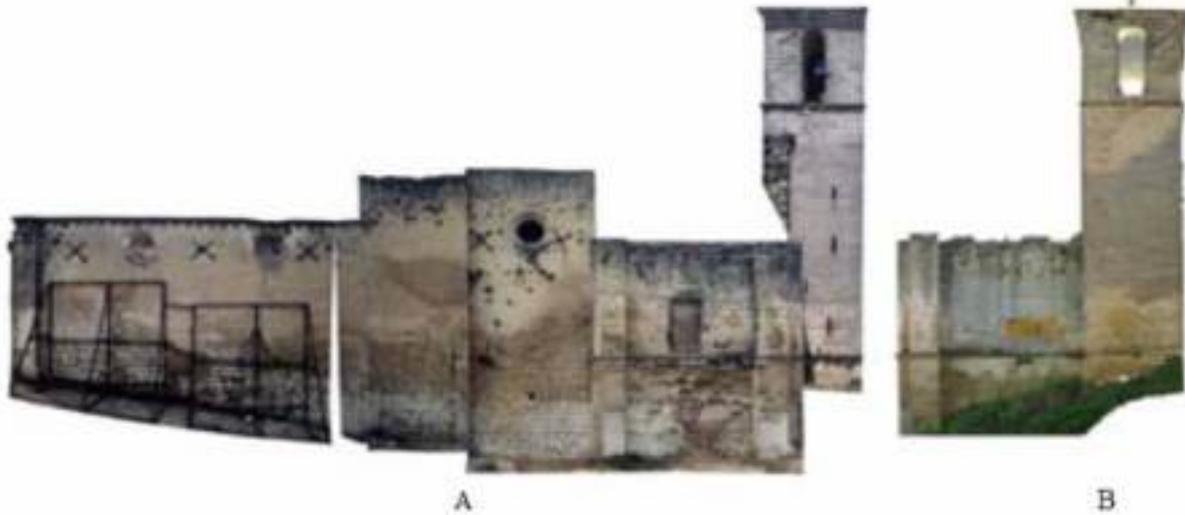
Also the UMK images have been used for image rectification mosaics. So in outer walls (east and north sides) all available cameras were used. Figure 6A shows a mosaic in the outer east walls with UMK and Hasselblad (tower) photographs. Rectified single images from the different walls (with several orientations) were mosaicking. Planes were projected onto a surface parallel to the belfry west side. Figure 6B shows the north side walls (Canon D30) and belfry (Pentax camera).

Figure 6 A: Image rectified mosaic of outer east walls and belfry. B: Image rectified mosaic of outer north walls and belfry. East side walls show large deformations in the projected surface.

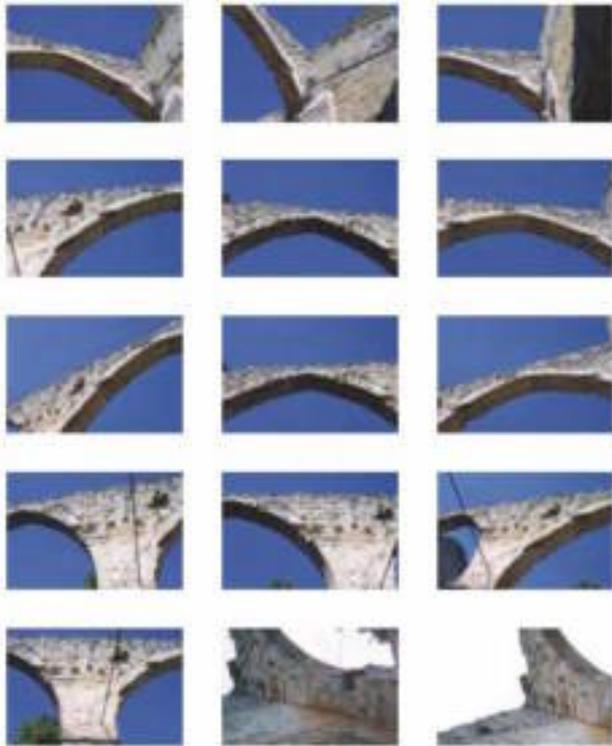
Figure 7 shows a selection of highly oblique photographs employed in the bundle adjustment to solve the upper section of the rear arches. Workplace limitations made extremely complicate the measurement of control points due to excessively inclination of sight. So, most part of control points was by means of photogrammetric network densification.

Figure 7. Photographs upper part of rear arches in the nave.  
Camera Canon D30 and 35 mm lens.

In other areas of interest, some complications appeared. So, in the arches crossing the nave (Figure 7), space limitations and height of the arches made necessary large number of photos (Figures 7, 8 and 9). Besides, in some parts of the arches the photos had to be highly oblique. These conditions added

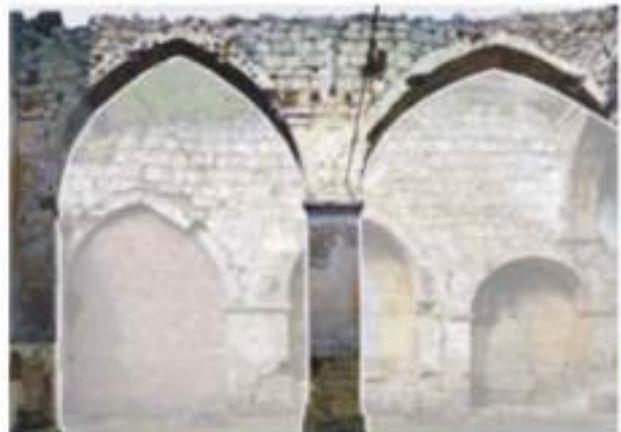
The rectified images mosaic of the rear arches is illustrated in Figure 8.

Figure 8. Images rectified mosaic of rear arches in the nave

In both Figures 8 and 9 images of the nave walls have been

added in the background only for visualization.

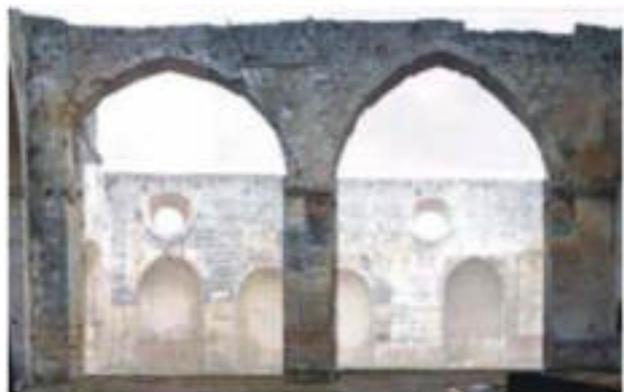
Figure 9 shows the front side of the arches. In this case stereopairs with the Canon D30 were taken. Because limitations at the right side impeded the use of stereopairs, the right pillar was covered by convergent photographs. In the left part of the mosaic the deformation of walls and arch is noticeable. Thus this arch is leaning toward the chapel.

Figure 9. Images rectified mosaic of front arches in the nave.

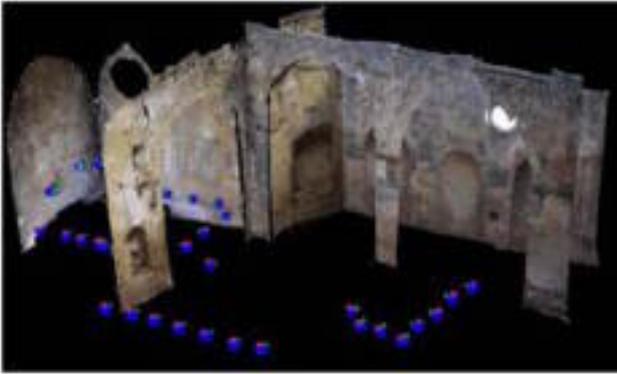
Figure 10. Partial 3D model of the church. Left chapel wall and vault textures have been suppressed to allow the visualization of the camera positions inside the chapel (screen capture from Photomodeler©).

modelling parts of the church (Shapecapture© and Photomodeler©). This modelization was only at visualization level (WRML files) but not for metric applications. An example is shown in the Figure 10.

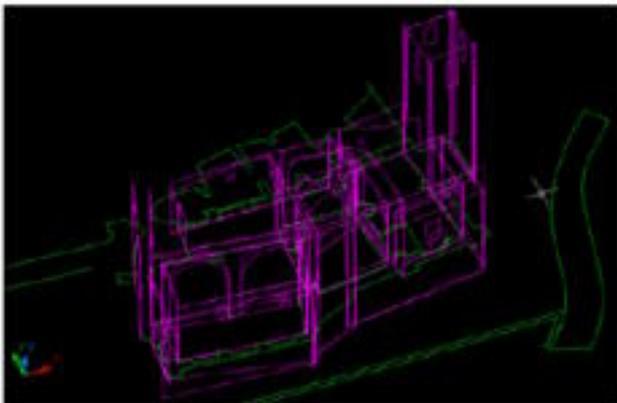
Figure 11 Initial 3D wireframe model with the ground plan and the walls profiles.

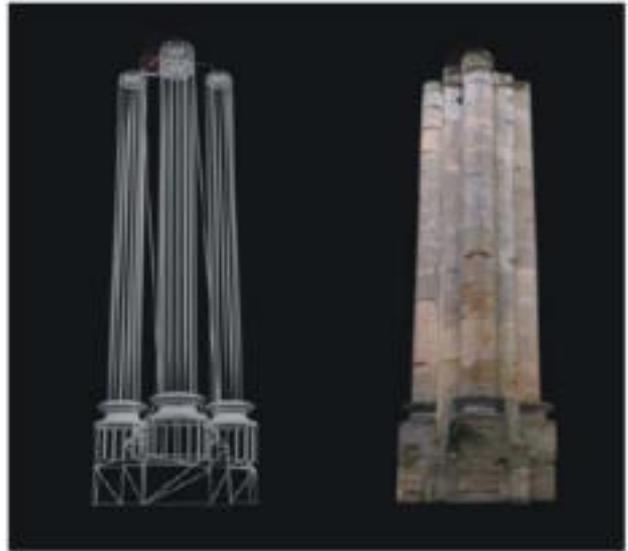
Figure 12 Wireframe and solid (with photorealistic textures) of the column of the sacristy.

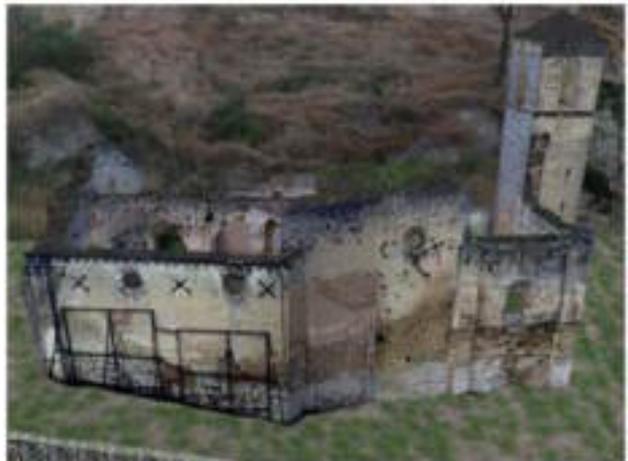
Figure 13. Full 3D photorealistic model of the church.

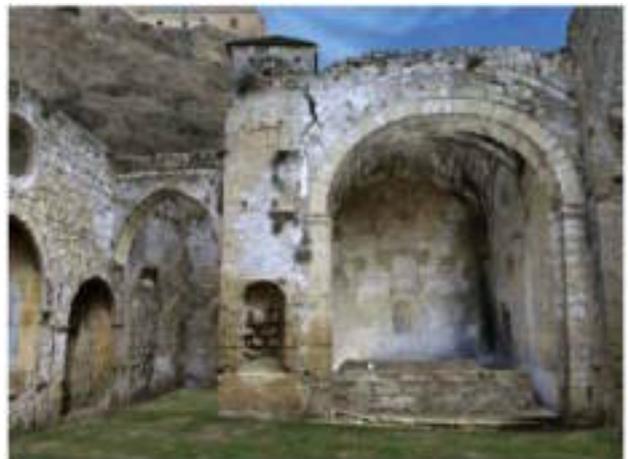
Figure 14 View of the 3D of the church. The textures are mapped from the rectified mosaics. View from nave to chapel.

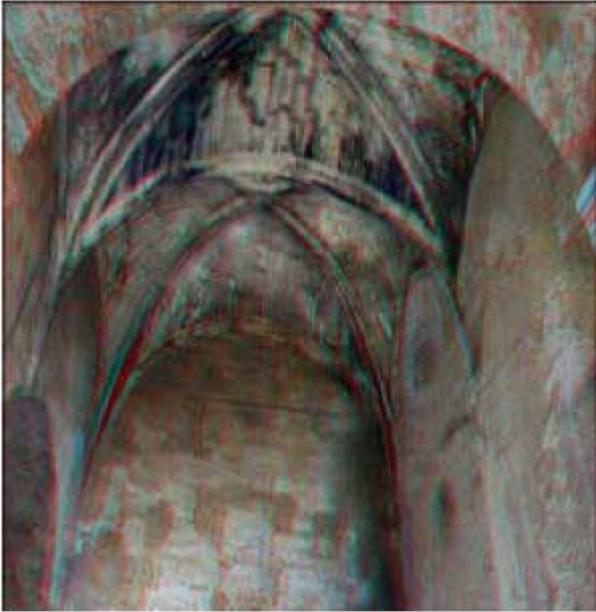
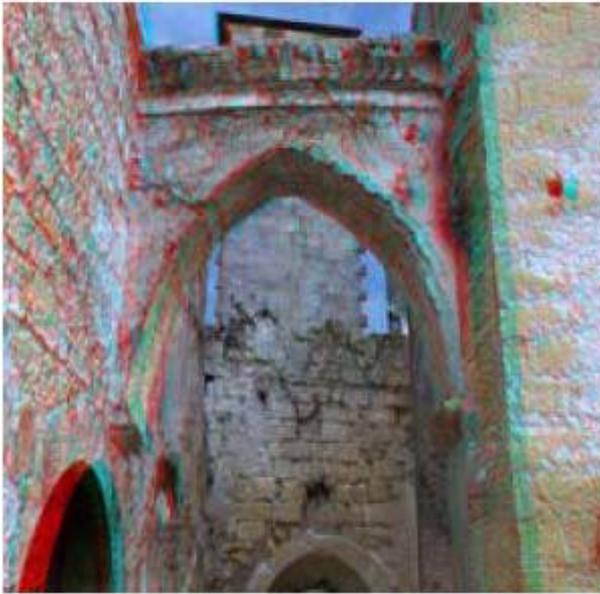
images were made from stereopairs obtained from the 3D model of the church. The combinations of colour channels have been made with Photoshop©.

Figure 15 Examples of anaglyphic images: vault in main chapel (above); and access to sacristy (below).
