CONTEMPORARY ART IN MILAN SQUARES KNOWLEDGE AND PRESERVATION

V. Castoldi

Accademia di Belle Arti di Brera – via Brera 28 Milano - e-mail: vcastoldi@libero.it

The article summarizes a study on the present conditions of the three monuments.

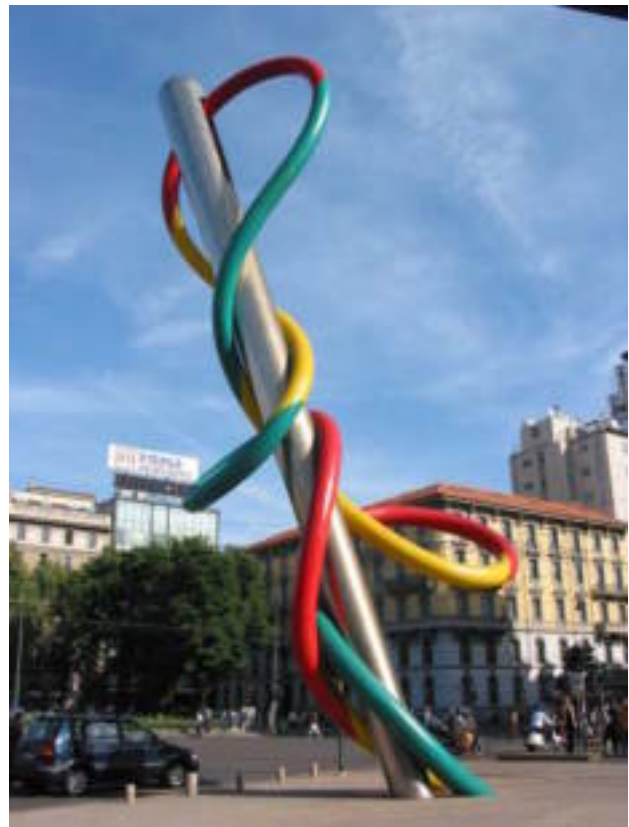
'Needle, and Thread'

Brushed stainless steel sections are connected to form the 'needle', which is filled with light cement to provide statics. The 'thread' and the 'knot' are composed respectively of eleven and five sections made of two external Fiberglas layers,

painted with polyester gelcoat and polyurethane enamel, and an internal polyurethane layer.

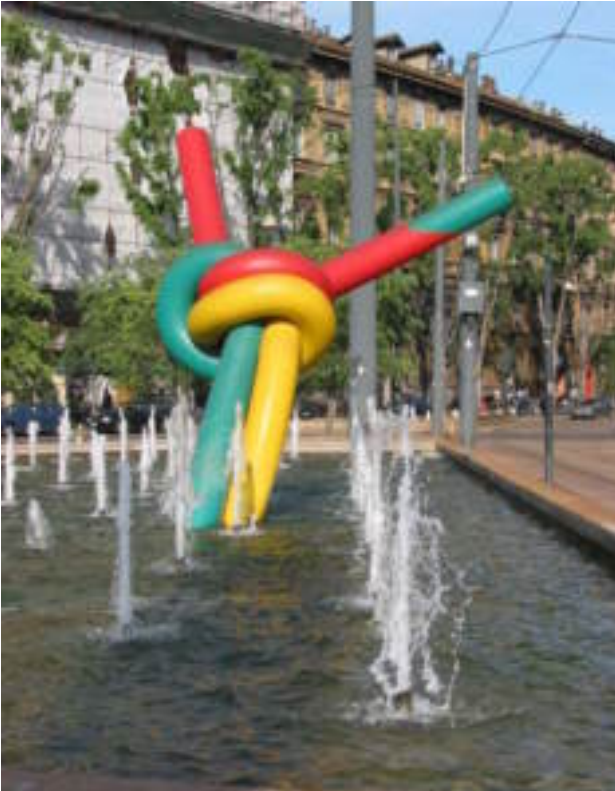
'Knot'

No maintenance activity has been carried out since then. The horizontal surfaces are now covered by a blackish layer caused by urban pollution; however, the alteration is only superficial, as the sculpture is exposed to the rain, which periodically 'cleans' them. A calcareous layer can now be seen by the naked eye on the 'knot', where the water sprays the surfaces, evaporates and forms the calcium carbonate scaling (Vigliano, 1995). The parts of the monument immersed in the fountain basin are now covered with algae.

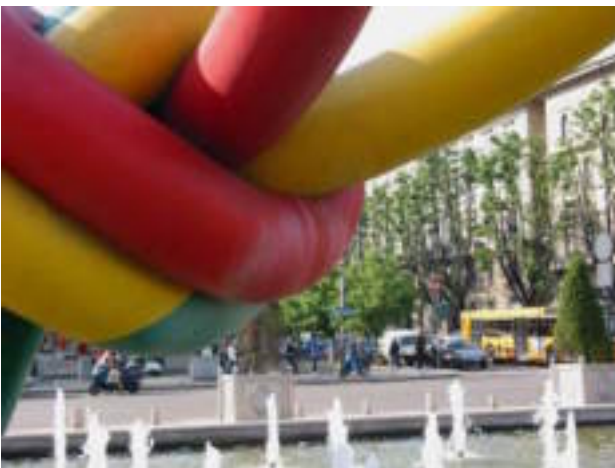
The calcareous layer on the 'knot'

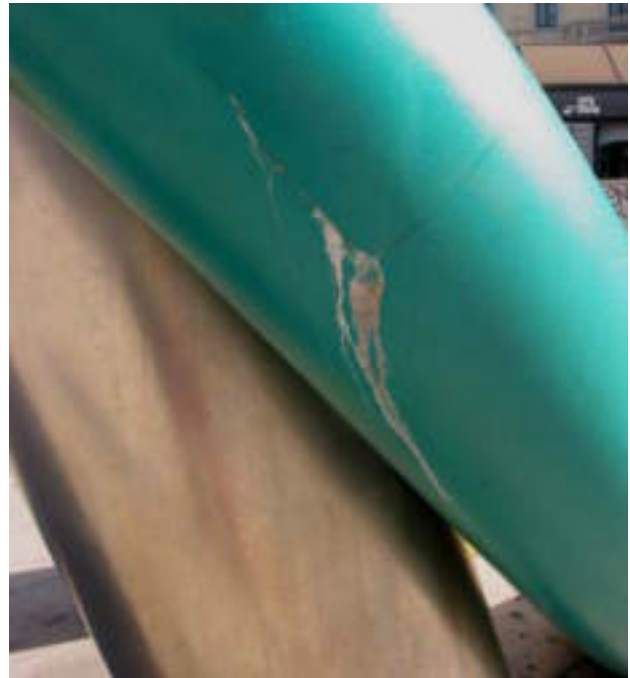
The worst degradation, however, is in the Fibreglas structure, in the parts where the various sections join: dilatation caused by thermal expansion has led to the formation of some crevices. Even though the cracks are, at this stage, clearly visible, they are still not numerous or large; one of them, at the bottom of the

'thread', shows a layer of calcium carbonate, caused by the rainwater periodically stagnating in the fracture.

Crevice with drippings

Fibreglas is one of Oldenburg's favourite materials: the artist has used it in many of his works as it allows to erect structures which, in spite of their huge dimensions, are complex, colourful and relatively light. However, Fibreglas degrades rapidly outdoors, especially when it is exposed to UV-rays and thermal expansion.

The experience about other Oldenburg works, like 'Shuttlecocks' in Kansas City (Benson, 2004), shows that periodic maintenance is required; in particular crevices need filling as they tend to widen, thus allowing the penetration of considerable quantities of water, which leads to further major degradation.

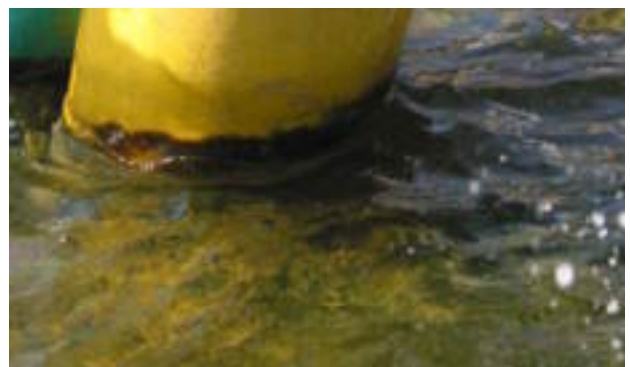
The algal growth
'PERTINI MONUMENT'

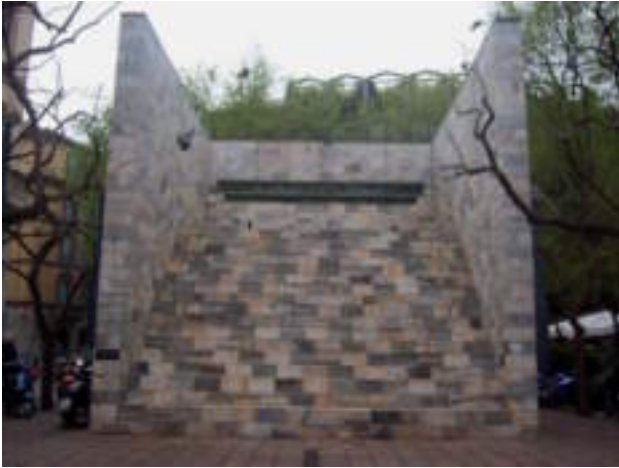
The side marked by the flight of steps

This is the work of Architect Aldo Rossi, who chose traditional materials for his project: Candoglia marble, an explicit homage to the Milanese cathedral, and bronze. The monument was inaugurated on 1st May 1990.

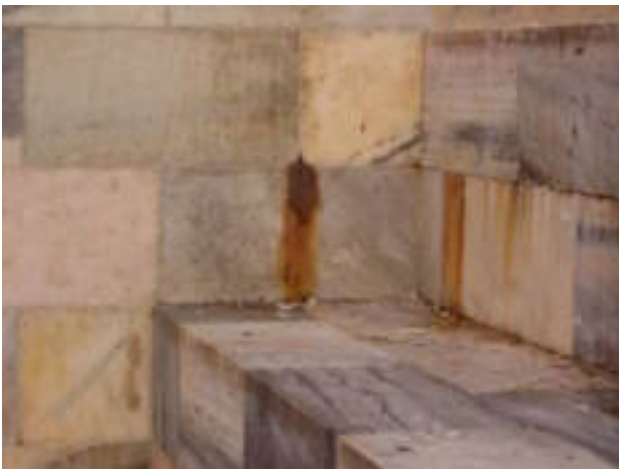
The executive project of the company entrusted with the building of the memorial shows that zincate iron bars were used for joining the slabs. Now, especially on the steps, rusty marks can be seen, probably caused by the oxidation of these elements.

Rusty marks

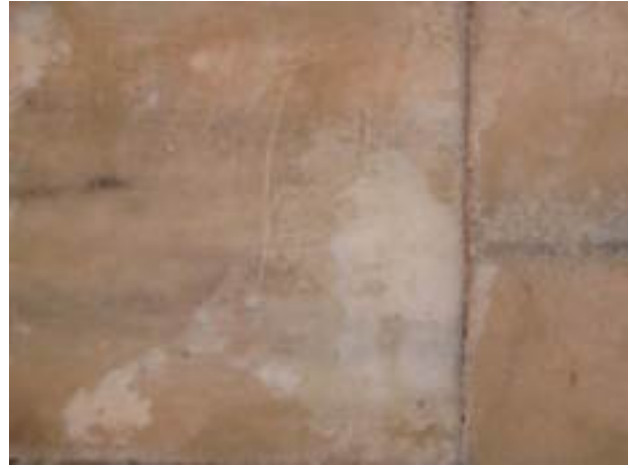
The layer of synthetic resin applied to the marble has not protected it; most of the coating has been washed away by the rain, and the few traces left are dramatically discoloured.

Traces of discoloured synthetic resin

A negative role has been played by the installation techniques and the use of a coating which has not provided any insulation; it is also evident that periodic maintenance would have better protected the structures. In fact, nothing has been done, even rubbish and birds' droppings have not been removed.

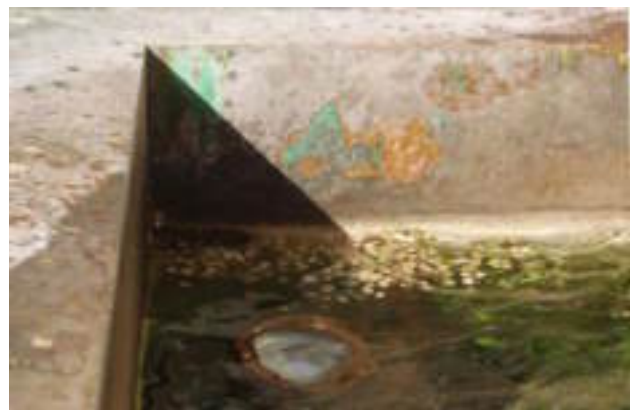
The choice of bronze for the internal lining of the basin is unusual. A thick calcareous layer insulates the copper from the water, leading to the proliferation of algae (Petrini, 1995), which cannot usually develop owing to the biocidal action of cuprous oxides.

Calcareous layer on the bronze

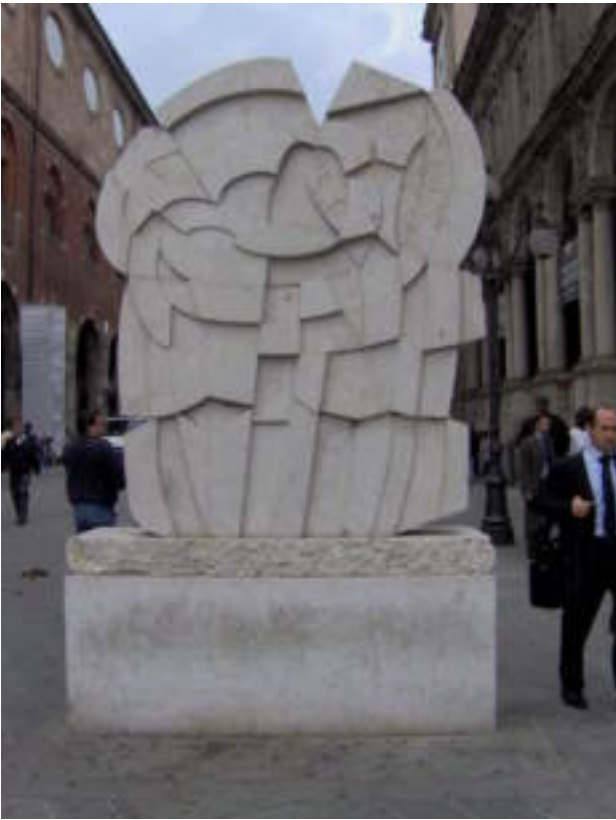
Rose Nembro Bifrontal

After fifteen years, the two sculptures have nearly lost their original colour, which used to be one of their most striking features, and are now a dull grey.

It is clear that the use of some protective coating would have slowed down the fading of the colour.

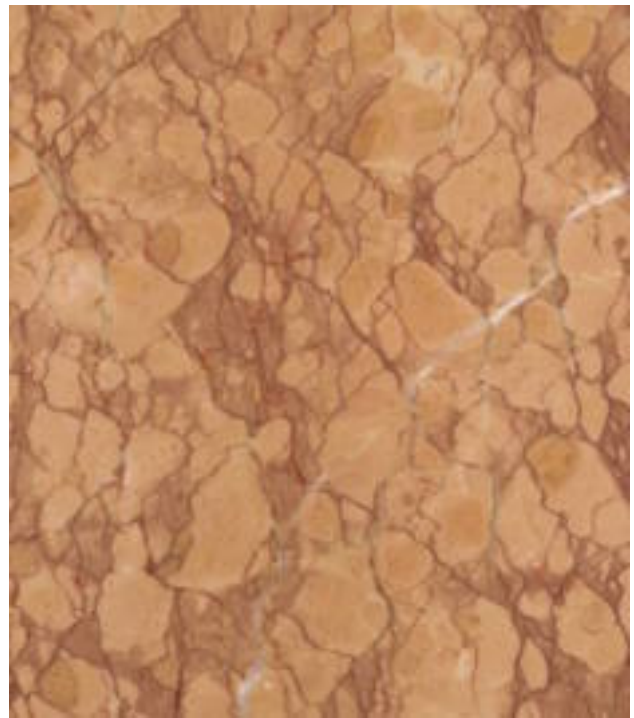
Polished *Nembro Rosato*

The bright colours, however, are due to ferrous hydroxide, which, outdoors, is gradually washed away by the rain (Pieri, 1964).

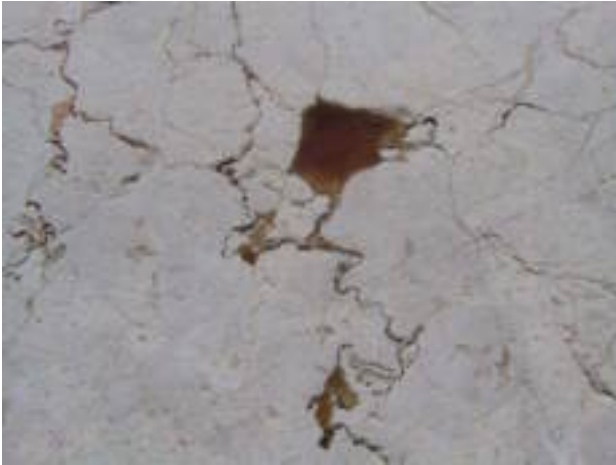
The marble, which originally shows veins and lacks homogeneity, has now been filled with a synthetic resin, the so-called 'marble-carver filler'. This is a common maintenance procedure which, when the marble is kept indoors, leaves no really visible signs.

Outdoors, the resin has dramatically altered, owing to the action of UV-rays and humidity: the filled areas are yellowish and visible - so much so that a clear interpretation of the sculpted forms is now impaired.

Altered filler

Besides, also in this case, maintenance involving new fillings and the monitoring of the crevices would help to protect the sculptures for a longer time.

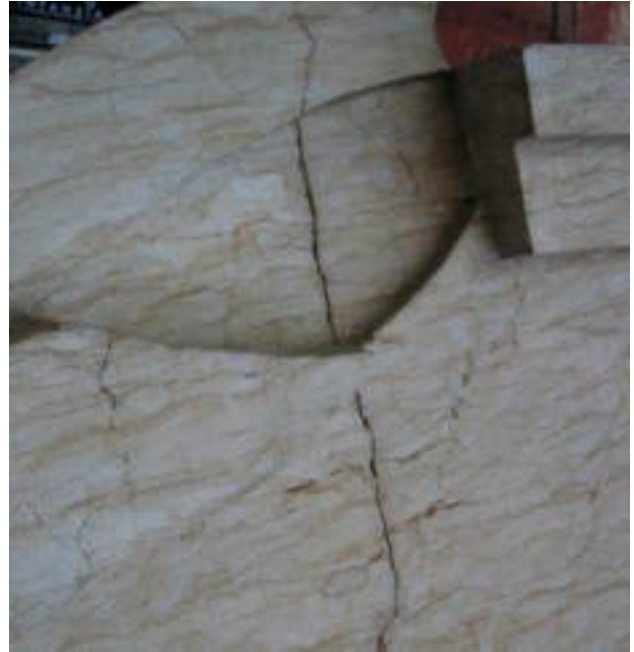
Crevice in *Nembro rosato* marbre

The author also chose to use very thin slabs. This characteristic has made his works of art more vulnerable to thermal stress and to rain penetration. These phenomena, combined with the constant underground trains vibrations, have caused the formation of crevices.

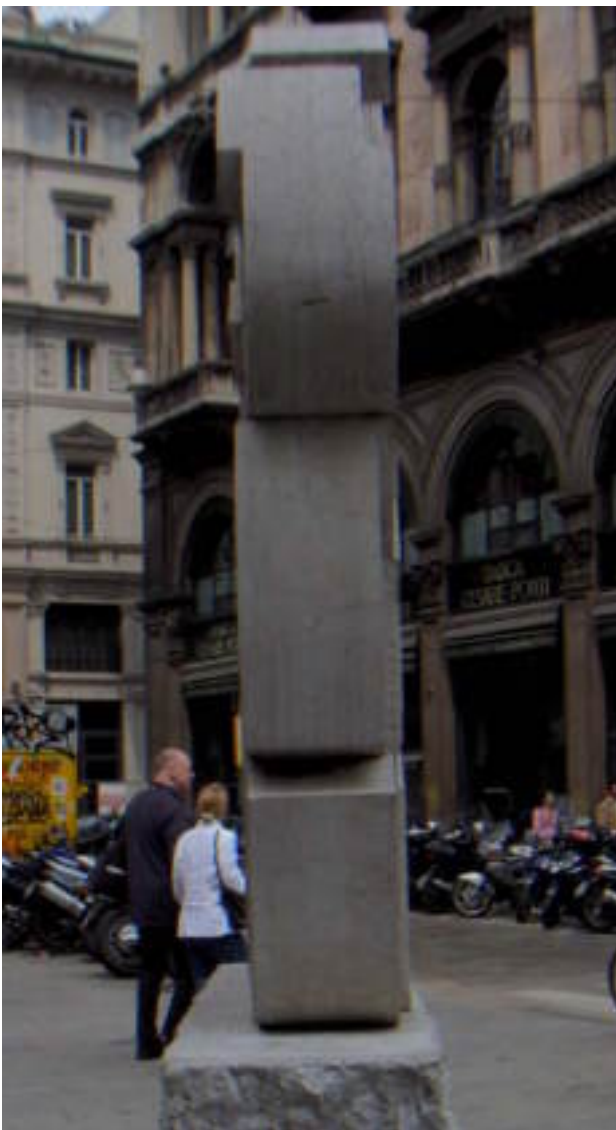
The alteration, in this case, is due to the artist's choice, as he decided to exhibit outdoors works made of a rock whose structure requires indoor display.

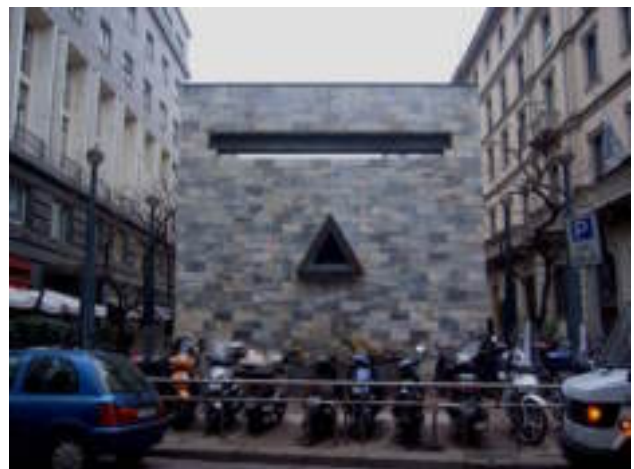
Pertini Monument: the fountain on the front
The little square is nothing but a park
