PROJECT OF THE RESTORATION OF DRETEA CHURCH, XVIIth C

O. Ciocsan^a, S. Ciocsan^b, F. Rogneanu^c, D. Bogdea^c, V. Iasinschi^c

^a S.C. CONS – ART S.R.L. Arh. Dan Nicolae St. nb. 28 B, Craiova, ROMANIA – ociocsan@yahoo.com

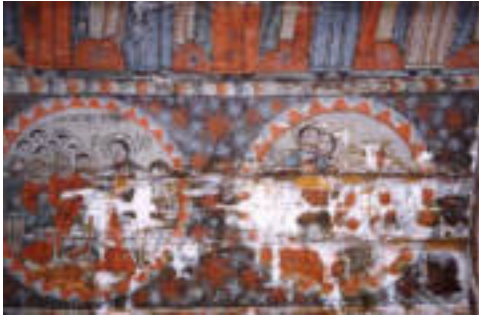
Detail – Nave
(before the movement of the church)

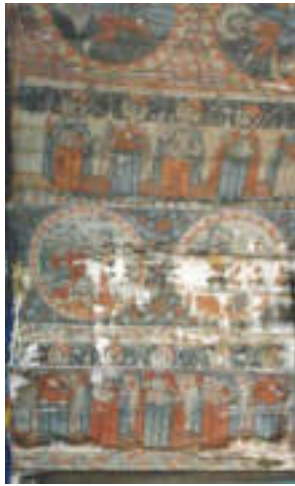
Detail – Nave – Southern Wall
(before the movement of the church)

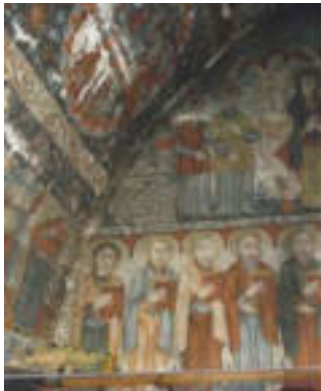
Detail - Iconostasis
(before the movement of the church)

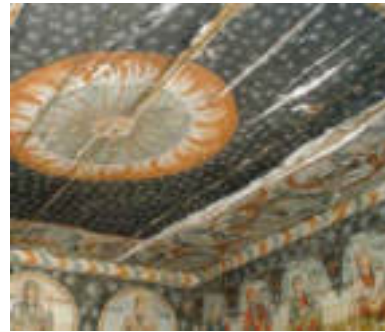
Detail Narthex (wall and ceiling) –
before the movement of the church

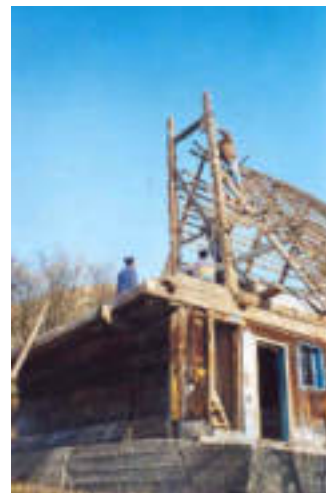
Dismantling of the roof

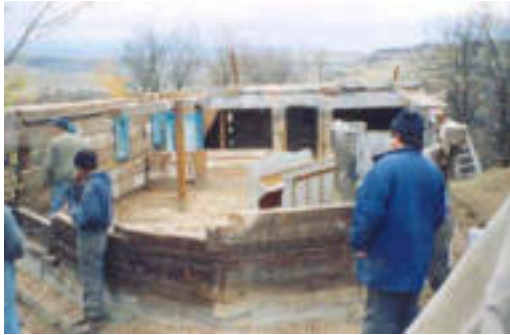
Dismantling of the walls of the church

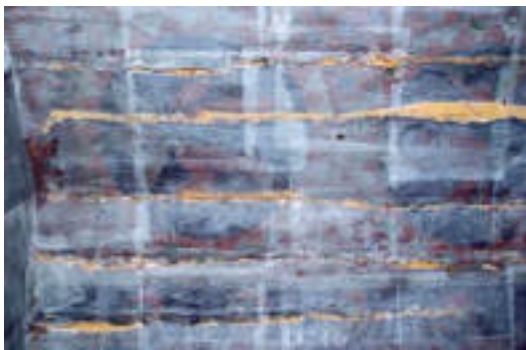
Nave (vault) - strengthening with fish gelatin and thin Japanese paper

The first step of this complex process was the strengthening of the existing painting coat with fish gelatin and thin Japanese paper.

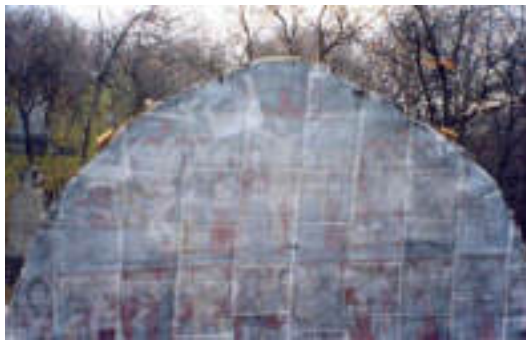
Iconostasis Ensemble – strengthening with fish gelatin and thin Japanese paper

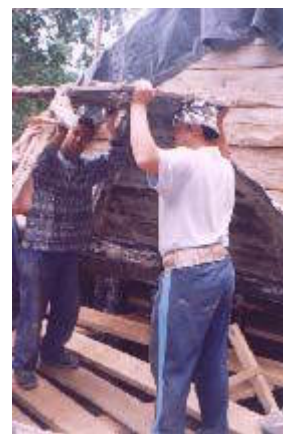
Rebuilding of the church after the transport

When the investigation was finished and the right place was found, they started the erection of the church. The first step was the removal of the thin Japanese paper from the painting coat and then all the elements of the church were reassembled in the reverse order than that used when the church was dismantled.

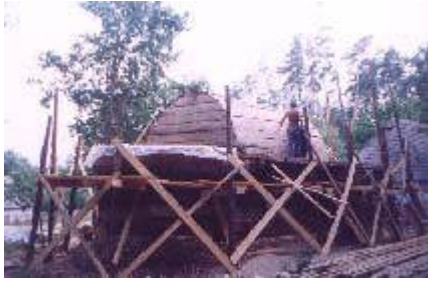
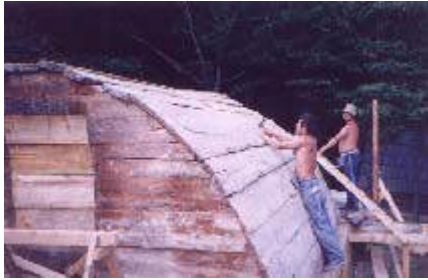
Rebuilding of the vault after the transport

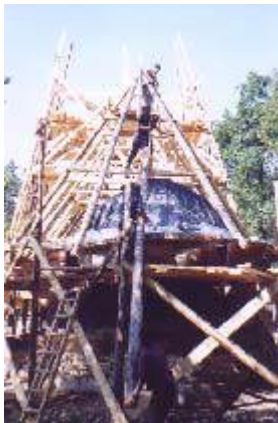
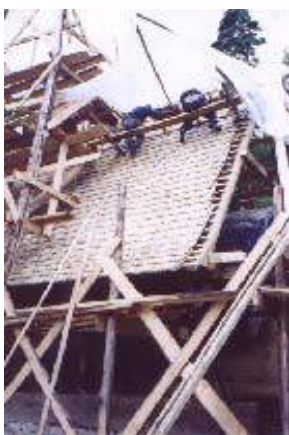
Rebuilding of the roof after the transport

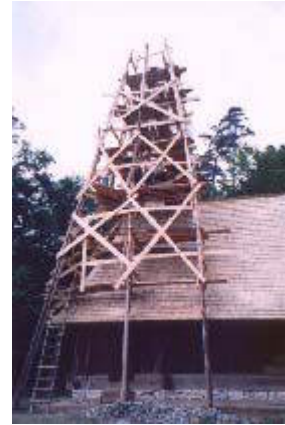
Rebuilding of the spire after the transport

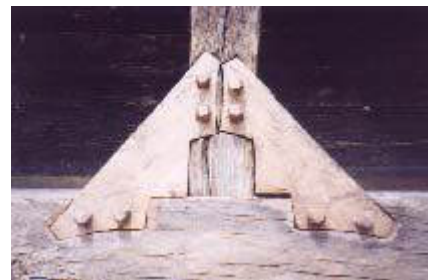
Wooden nails, used for the fixing of the pillars to the foundation

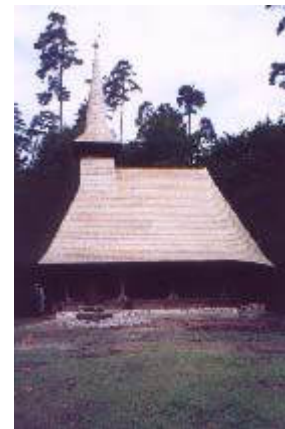
The Dretea Church, after it was moved and rebuilt
