RECOVERY OF A BUILDING WITH RECEPTIVE TOURIST PURPOSES IN THE ANCIENT CENTER OF ZUNGOLI. THE ACTUATION PROCESS OF THE INTERVENTION PROGRAM FROM THE CITY TO THE BUILDING.

M. Cristiano

University of Studies of Naples Federico II – Department of Building Engineering, Pzzle Tecchio n. 80 Naples – Italy cap 80100.
mcrastia@unina.it-

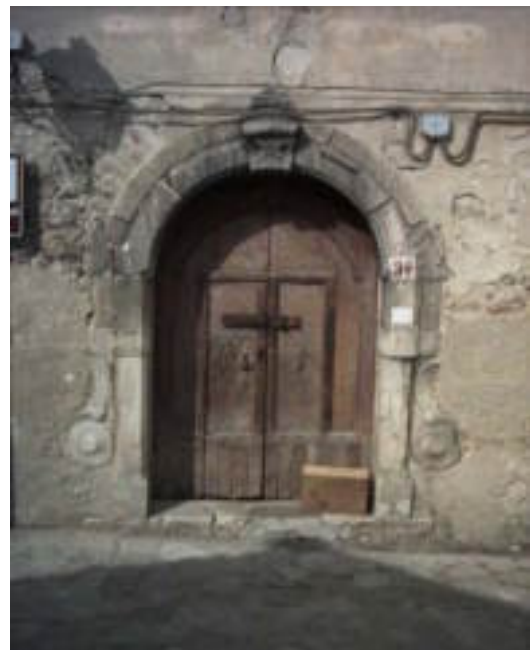
Figure 3. Main entrance.

The front façade has just one original balcony, above the stone entrance archway, and has a series of openings without order and in part different from the original configuration. The side view presents as well chaotic positioning of the openings and volumes elevated in the last decades. The openings were transformed, as we can see from the stone windows closed on the front facade, even if it's not evident from the outside.

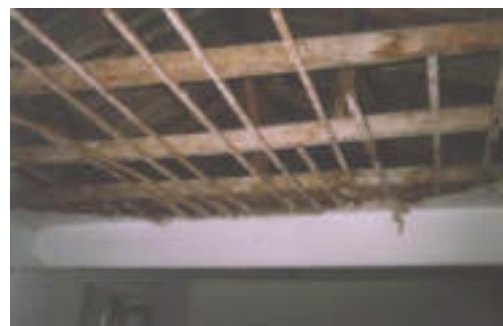
Figure 4. The wooden trusses

The internal vaults are of particular artistic and historical value, barrel vaults, cross vaults, cloister vaults, pendentive domes, all in ashlar masonry. The ceilings present today are hourdis ceilings, with steel beams and small brick vaults, the wooden trusses with king posts are the bearing elements, the secondary frame rests on them.

These phenomenon are contained trough the reconstruction of the fallen in roof, the creation of gutter eaves and the use of waterproofing resin injected at the base of the walls. The concrete curb at roof level will need to be created on the inside of the façade walls, without interfering with or removing the characteristic and pre-existing eave frames. For structural soundness the connection of the trusses with the concrete curb will be achieved with metallic stilts.

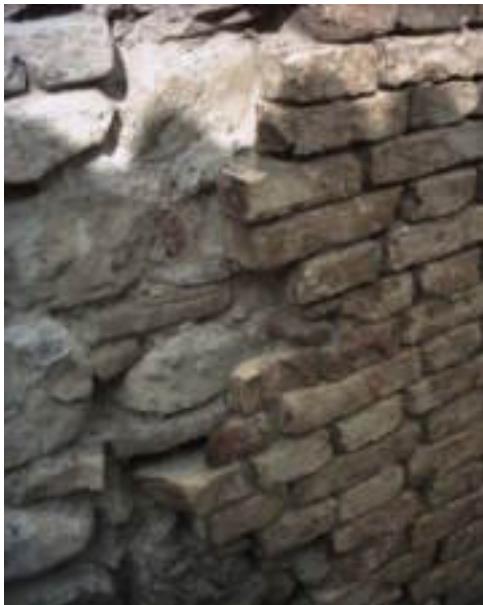
Figure 5. Detail of the sandstone wall

The conservation state of the masonry presents severe lesions caused by seismic effects, static effects of the vaults and the absence of perimeter load repartitions crubs. To better the static response of the building the insertion of concrete curbs and grout mortar injections.

Eventual accessory elements like structural iron sections to connect ceilings and crubs are created within the walls to preserve the architectonic elements.

The outer stone elements will be cleaned with abrasive sand blast, some vegetation is present and has produced damage, it will should be removed.

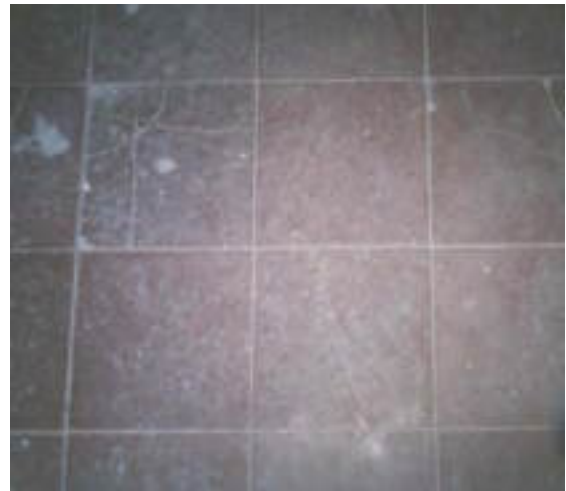
Figure 7. Paving

The paving damaged by natural infesting agents will be restored and if necessary replaced with compatible materials.
