USE OF MULTI-RESOLUTION LASER SCANNING/WHITE LIGHT SCANNING AND DIGITAL MODELLING OF THE HISTORIC HUTS OF SCOTT AND SHACKLETON IN ANTARCTICA.

Paper category: B-2: 3-D Modeling, animation, reconstruction and visualisation of cultural heritage

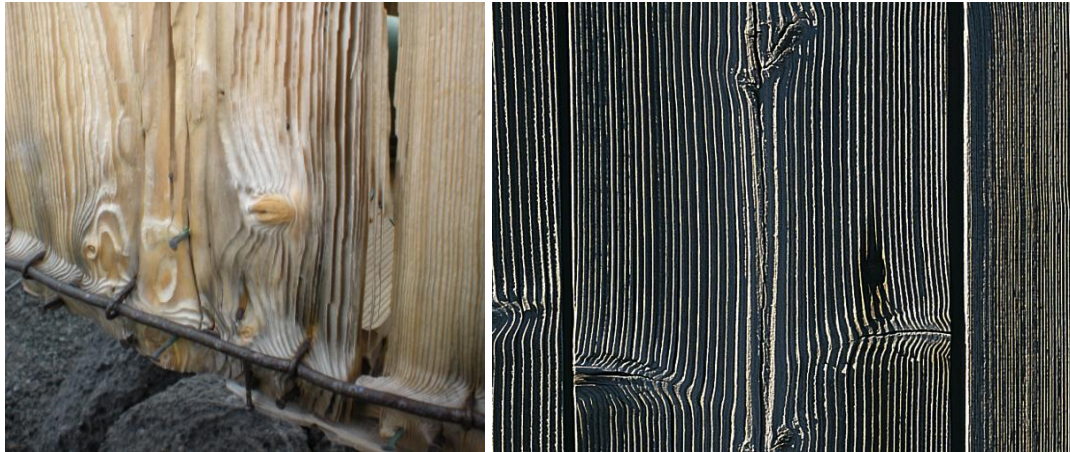
Figure 3: Differential ablation on exterior timbers.

Wood deterioration on the huts occurs differentially, determined in part by exposure to the attributing environmental conditions and the density of the affected timber. Godden, Mackay and Logan [16] note that timbers with a density greater than 800 kg m^3 have good abrasion resistance characteristics [17]. Patterns of differential ablation are best characterised by dense knots in the wood eroding at slower rates than the surrounding less dense areas. The process of timber erosion evident on Antarctic structures has been described by Blanchette et al.[12], where erosion occurs when areas around rings (earlywood cells) are eroded before highly lignified latewood cells. This process generally results in timber surfaces forming what is best described as a crenulated form when looking at a cross section of the surface (Figure 3).

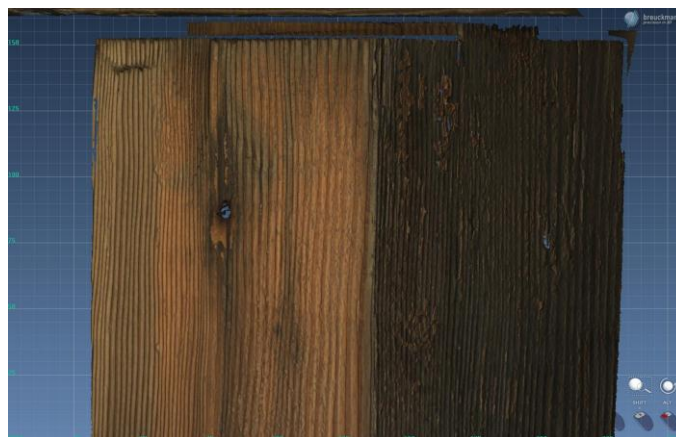
Figure 6: Section of an ablated veranda post from Discovery hut recorded with the smartSCAN^{3D}-HE. Remnant paint flakes can be seen on the right hand face.

Surveys were undertaken from January 16-28 starting with Discovery Hut before moving on to Terra Nova (Figure 4) and then Nimrod huts (Figure 5). Further high-resolution recording of ablated surfaces was undertaken on the exterior of Discovery on return to Scott Base from the field. Scanning at Terra Nova was restricted to the recording of all exterior surfaces and associated curtilage and the localised topography due to the presence of Antarctic Heritage Trust conservators working inside the hut. One small internal area of fungal growth was recorded as well as several artefacts. At Nimrod detailed recording of the exterior, interior and topography was completed, along with high-resolution recording of ablated exterior surfaces (Figure 6)

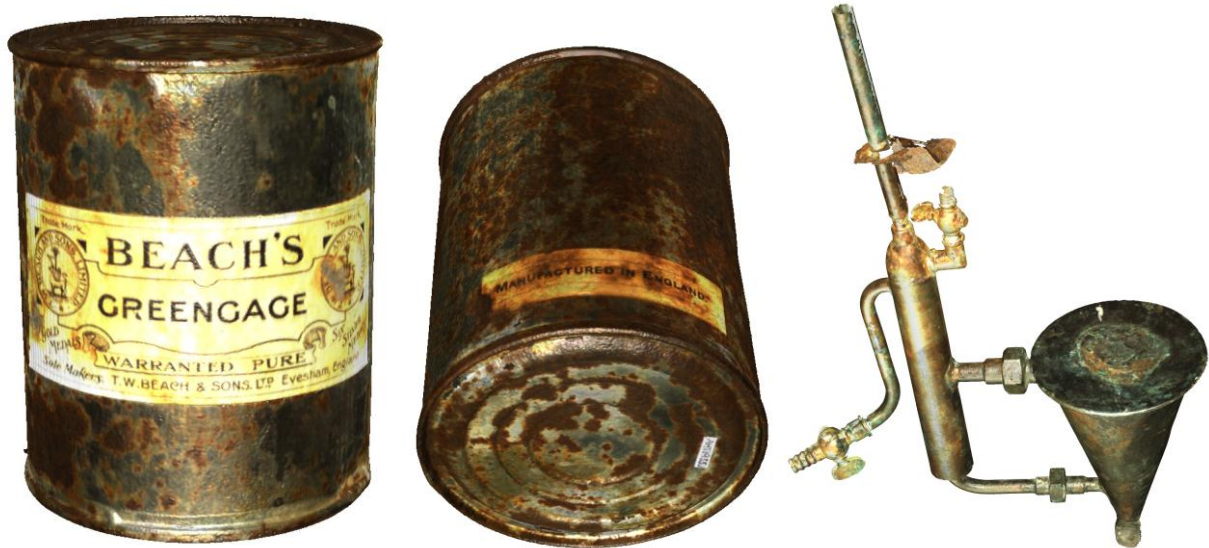
Figure 7: Greengage can in unconserved state (left, centre) and metal scientific instrument (right) recorded with the smartSCAN^{3D}-HE

The recorded artefacts at Terra Nova included two metal food cans (one of which had been conserved, and one which had not) (Figure 7), a complex scientific instrument and a coal chisel. The cans were selected as a control study to monitor material conservation and the others were selected to test the ability of the structured light scanner to record surfaces with different form, detail and reflectivity values, while operating within a cold environment.
