DAMAGE DETECTION ON BUILDING SURFACES WITH MULTI-SPECTRAL TECHNIQUES

M. Hemmleb, F. Weritz, Ch. Maierhofer

BAM, Federal Institute for Materials Research and Testing, Unter den Eichen 87, D-12205 Berlin, GERMANY
(Matthias.Hemmleb, Friederike.Weritz, Christiane.Maierhofer@bam.de)

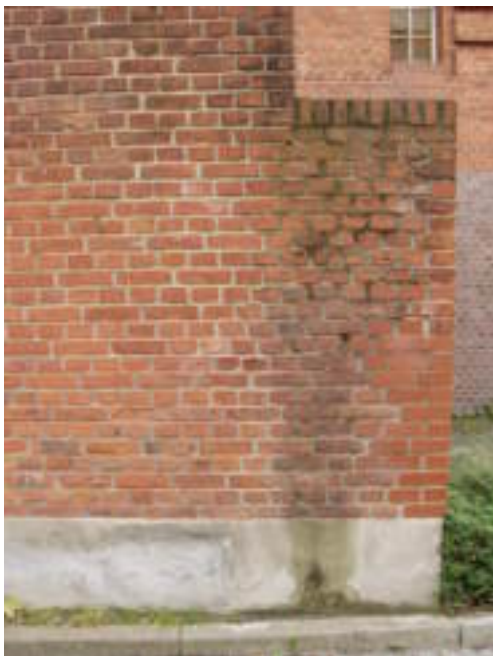
An evidently affected masonry wall was selected for the investigations. Damages like moisture and biological cover (moss) are clearly seen on the building surface, shown in figure 1. The region, selected for image acquisition, contains old and new bricks, dry and wet areas.

Figure 1. Test object: Masonry affected by moisture and biological cover

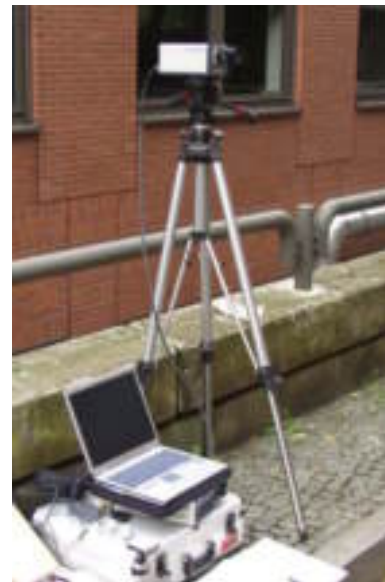
Figure 3. IR-Vidicon-camera with controller and notebook

For the digitisation a commercial frame-grabber was used. It allows the connection of the camera with a notebook (see figure 3). During image acquisition attention was paid to have diffuse illumination, ideally given by a cloudy sky. Using a lens with a focal length of 23 mm, the object distance was about three meters.

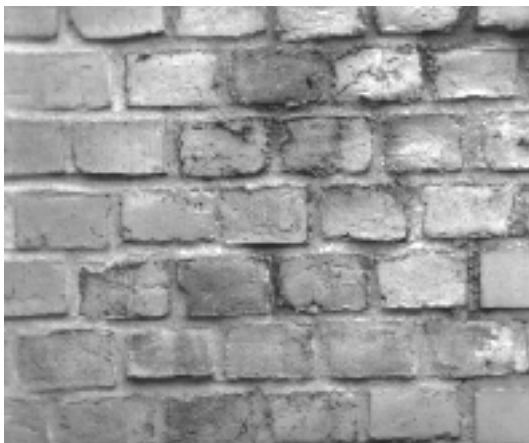
Figure 4. Infrared image acquired with Vidicon-camera (without filter)

Figure 4 shows a near infrared (NIR) image of the selected region, acquired with the Vidicon-camera without filter. The image shown in figure 5 was captured in combination with the band-pass filter at 850 nm wavelength and differs significantly from the image captured without filter. Due to the minimal chlorophyll absorption in this wavelength region, intense reflections of areas covered with moss are visible (figure 5). Such differences between images taken in different wavelength regions are the basis for multi-spectral imaging.

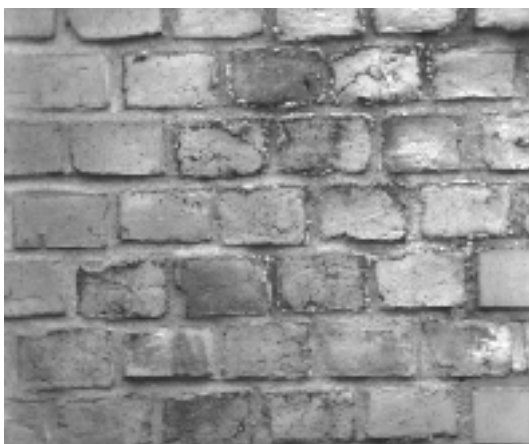
Figure 5. Infrared image acquired with Vidicon-camera (with 850 nm band-pass filter)
