LASERSCANNING FOR CASTLE DOCUMENTATION

T. Křemen¹, B. Koska¹ and J. Pospíšil¹

¹Czech Technical University in Prague, Faculty of Civil Engineering, Department of Special Geodesy
Thákurova 7, Prague 6, Czech Republic
tomas.kremen@fsv.cvut.cz

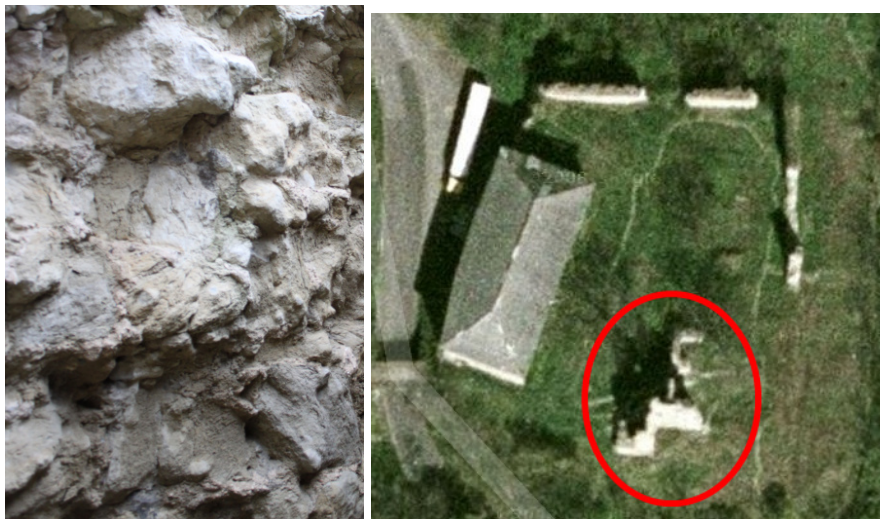
Figure 2: Erosion of aggregate (on the left) and air photo of the Dražice Castle with outlining of the main palace (on the right)

The Dražice Castle is a ruin of a medieval castle overhanging on a rocky point on the right bank of the Jizera river in the middle of the village called also Jizera near Benátky nad Jizerou in the central-Bohemian. The castle was founded in the first half of the 13th century. The goal of the project was to record as detailed as possible state of the Dražice castle ruin, concretely measurement and creation of a space model of the rest of the main castle palace (Figure 2). The reason is strong erosion of the castle walling caused by acid rains and aggregate of poor quality. Erosion of aggregate reaches up to several centimeters per year (Figure 2).

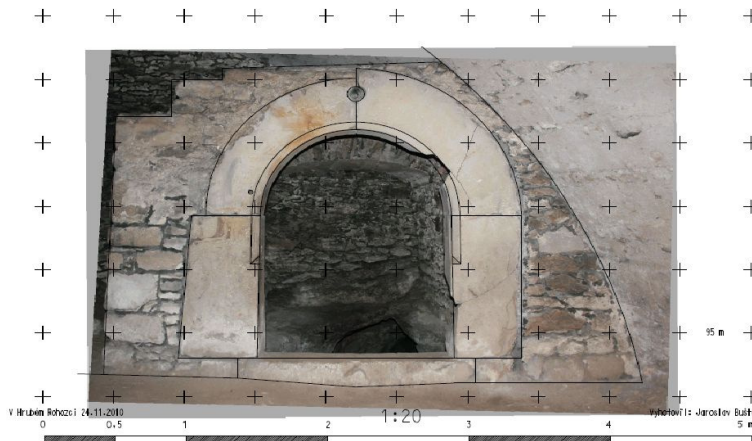
Figure 8: Photomap and plan of the portal

The result of the photogrammetric measurement was a file of 17 photomaps of the individual portals from both sides on a scale 1:20. Design documentation on a scale 1:50 was done afterwards for each portal. The designs contain view from the front, view from behind, a section and a ground plan. A register of photomaps and designs was created as well see Figure 8.
