THE DIGITAL RECONSTRUCTION OF A LARGE-SCALE CONSTRUCTION SIMULATED BY USING 3D LASER SCANNING TECHNOLOGY – A BRICK KILN’S CHIMNEY IN KAOHSIUNG CITY OF TAIWAN AS AN EXAMPLE

Keywords: 3D Laser Scan, 3ds max, Digital Simulation Preservation

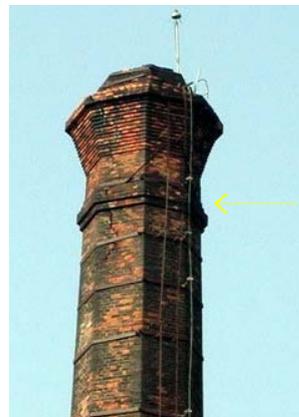
Figure 3: Damage extent of the south chimney top portion before and after earthquake [6]

Recognizing its historic, economic and technological contributions towards the Taiwan history, the entire factory complex, comprised of the Hoffman kiln, the north and south brick chimneys, an administrative office and all the related ancillary building structures, were eventually listed as a National Historic Monument in 2005 [2] (Figure 2). First time repairs urgently in the same year by April, including: 1) north chimney support reinforced; 2) the Hoffman kiln cavity interior protection support and the top-level scaffolding and protective support; And 3) The south side of the chimney of the openings flue by thick 1.5cm, width 50cm plate, produced opening location coating welded by steel plate reinforced. A series of Research and Investigative work and the subsequent reinforcement repairs had been conducted between 2006 and 2007 [3]. Unfortunately, a 6.4-magnitude Chia-hsien earthquake hit the vicinity of Kaohsiung area on 4th March 2010, thus created significant damage to most of the buildings in the factory. Of which, the damage impact of the south chimney was the most serious as part of the top chimney portion collapsed during the shake (Figure 3).

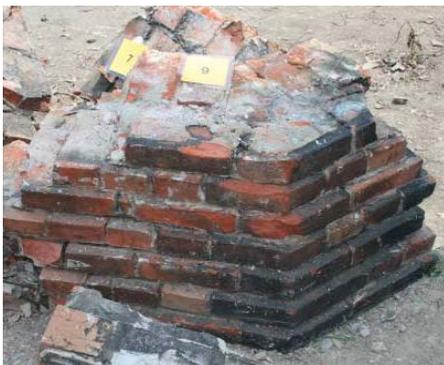
Figure 5: Numbering of fallen brick pieces prior to laser scanning

In this emergency rescue work, the south chimney was subjected to three times of laser scanning, focusing mainly on the scanning of the existing chimney ruin condition, aerial scanning of the chimney's top portion and the affected surrounding area. The ruin chimney was numbered systematically (Figure 5) prior to the scanning exercise, so as to provide ease of reference for the later model simulation stage.

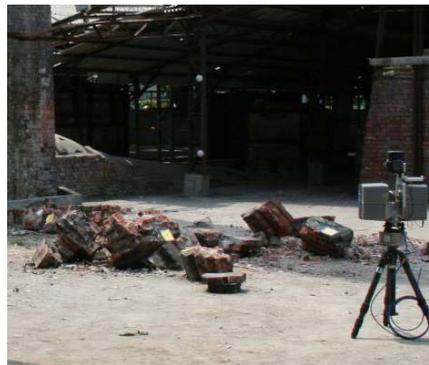
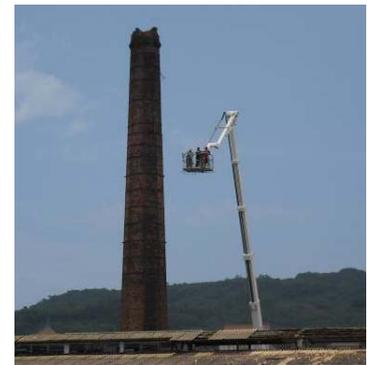
Figure 6: ground level scanning (left) and high level scanning (right)

As the total height of the chimney is 34m, hence on-site scanning exercise was divided into two parts: (1) ground level scanning, and (2) high level scanning so as to effectively cover the entire chimney scanning range (Figure 6).

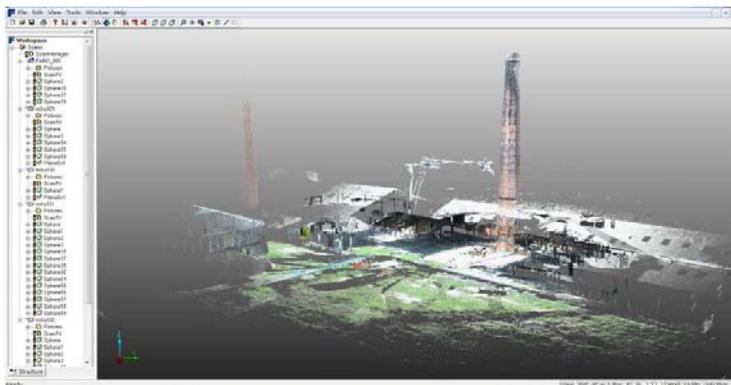
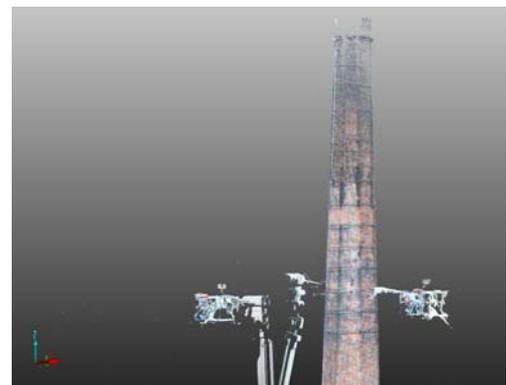
Figure 11: Rapid digitalisation scanning technique was used to obtain the 3D surrounding site view

In order to obtain a 3D view of the surrounding site condition, rapid digitalisation technique for 3D scanning was used to achieve large scale data within a short period of time. With the help of tri-axes orientation, the exact positioning of the ruin south chimney and its fallen bricks could be reconstructed accurately. Besides conducting an overview scanning of the surroundings, a detail scanning of those fallen bricks found on-site was also carried out. During the scan, our team was able to identify and re-trace back the original positioning of the fifteen pieces of ruin bricks once reconstructed on the chimney top portion. All these information were then fed into the simulation model software to generate a realistic 3D recovery model of the south chimney (Figure 11).

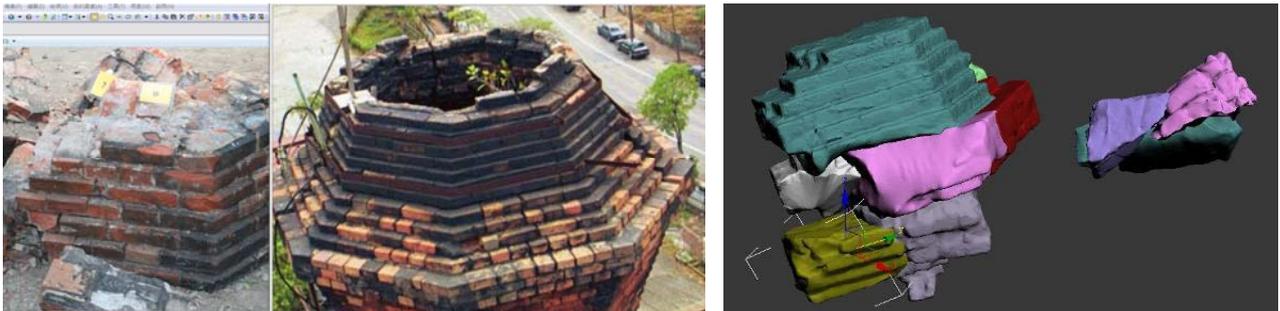
Figure 16: Simulated model of reassembly is achieved by cross-referencing with the existing pictures

Upon successfully completed the reassembly of the fifteen ruin bricks models, these models were transferred to the overall site model for another round of reassembly. With reference to the existing on-site photographs and measurements recorded during the 2005 investigation, and the point cloud data obtained previously, the exact reassembly of these ruin bricks onto the damage chimney portion was achieved (Figure 16).
