## INTRODUCING EDM SURVEY FOR RECORDING VERNACULAR HERITAGE AND SITES IN PAKISTAN

KEY WORDS: Vernacular, REDM, Conservation, Recording, Image rectification, Topographical Survey

The case study of 200 years old *Khaplu* Palace will present the outcomes and issues of recording of an outstanding example of vernacular monument with EDM device and related software for the first time in a very remote and mountainous area of Pakistan.

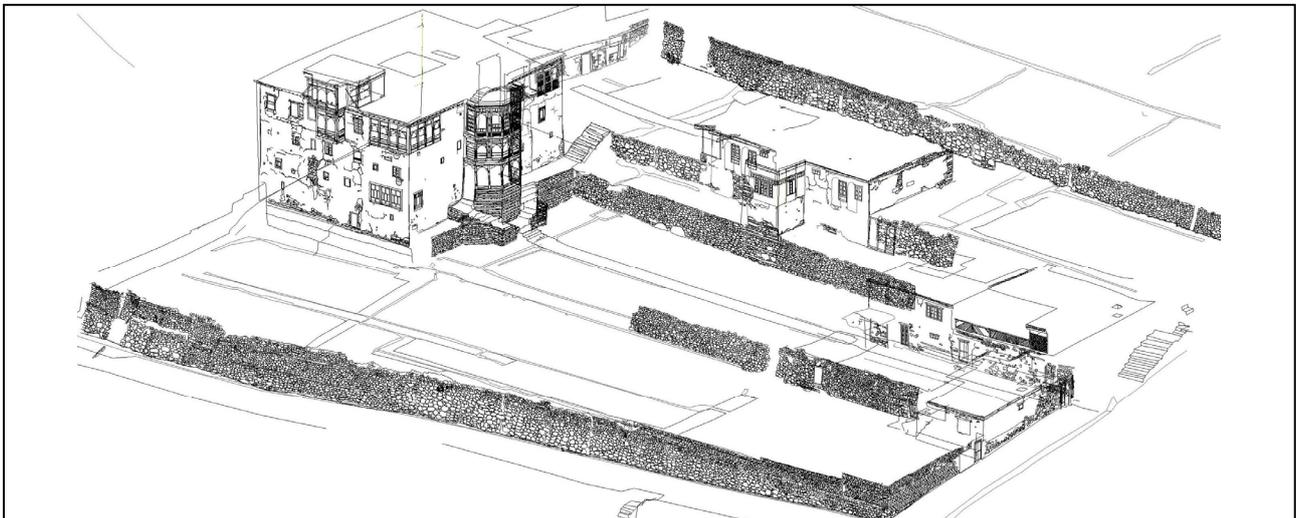
Fig. 1. 3D wire-frame model of *Khaplu* Palace Complex. Hundred years old historic agricultural walls and buildings documented using measured drawing technique, EDM (total station) survey and rectified photography. This drawing is an AutoCAD drawing developed from 3D wire-frame.

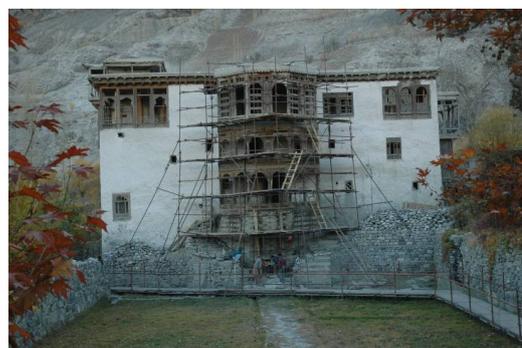
Fig. 3. North view of *Khaplu* Palace with main entrance wooden loggia under restoration

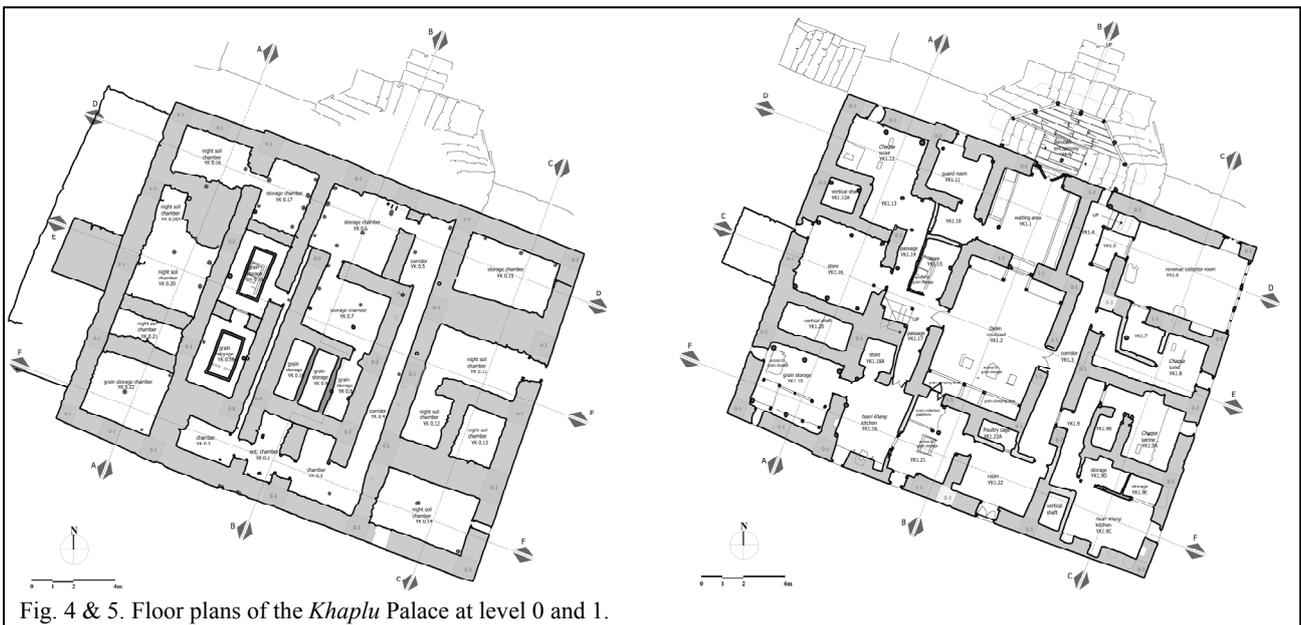
Fig. 4 & 5. Floor plans of the *Khaplu* Palace at level 0 and 1.

Since 2006 most of the architectural documentation has been completed in the form of floor plans, reflected ceiling plans, structural plans, detail elevations of each room, cross sectional drawings, building elevations and a complete 3D wire frame model. Most of the major elevations and elevation features in the cross sectional drawings were completed with the help of image rectification software combined with EDM survey. Rectified photography has been used to map the condition of external and internal elevations of the monument which was later converted into vector form.

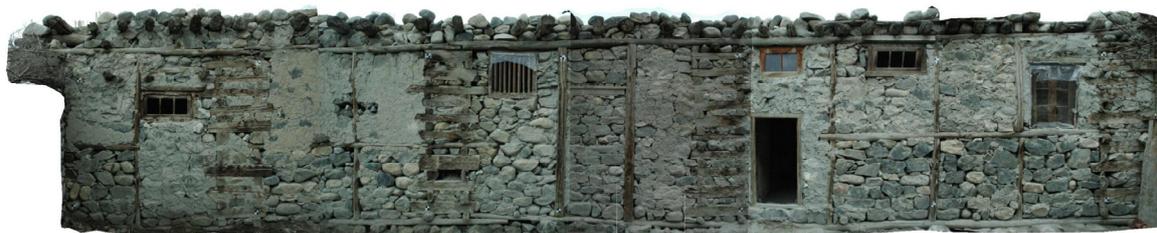
Fig. 6. Rectified photography of western elevation of 100 years old *Darbar Khang*

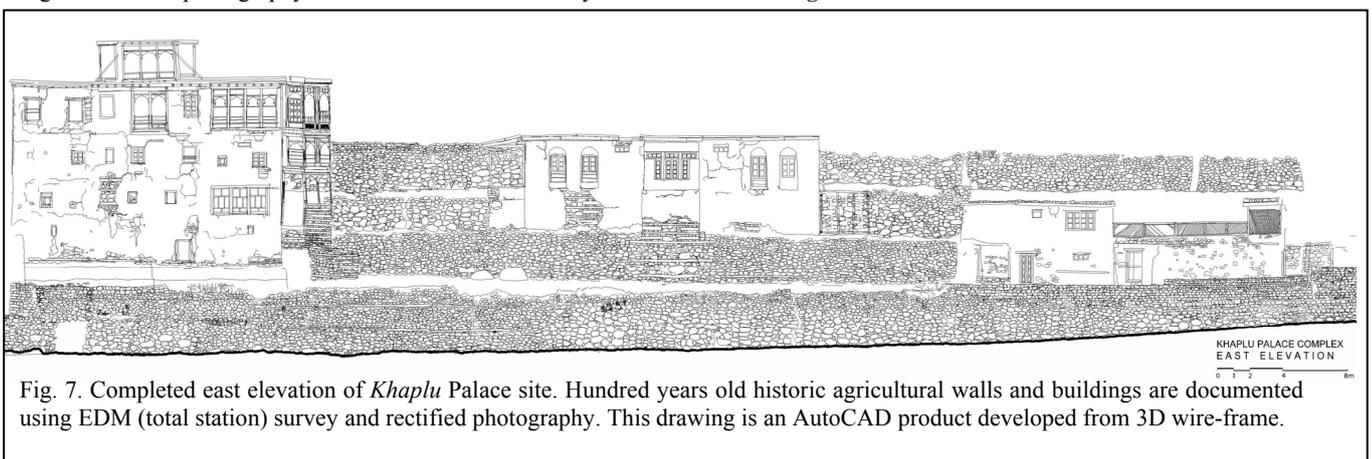
Fig. 7. Completed east elevation of *Khaplu* Palace site. Hundred years old historic agricultural walls and buildings are documented using EDM (total station) survey and rectified photography. This drawing is an AutoCAD product developed from 3D wire-frame.

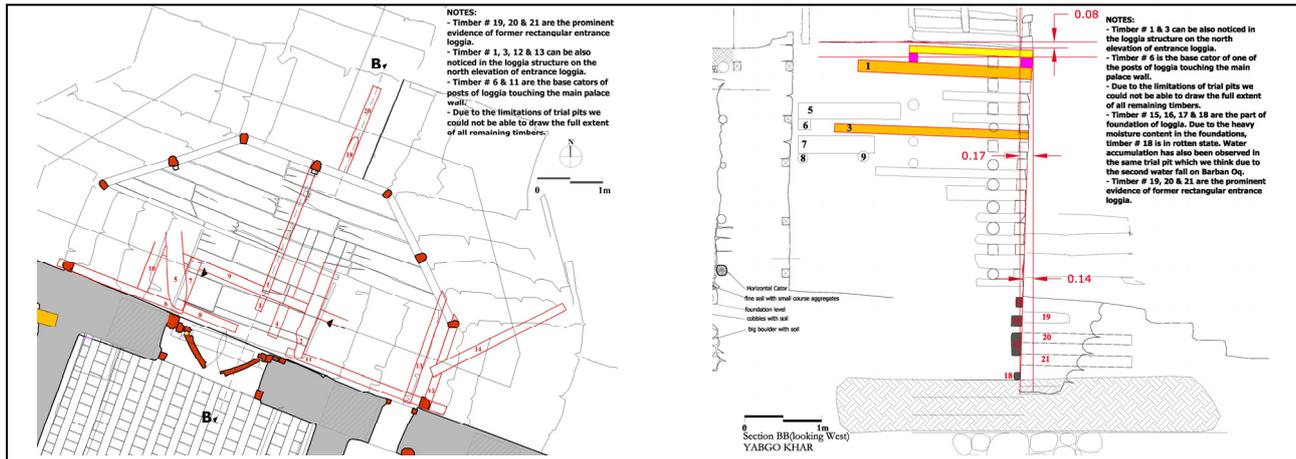
Fig. 8 & 9. Set of drawings produced for the restoration of wooden entrance loggia about 10 meters high. This set of drawings shows the structure and location of timber elements in the plan and section. Additionally, the sectional drawing shows the subsidence and bulge in the structure

Primarily, the data in form of CAD drawings produced with the help of EDM survey has been used to study the monument and its adaptation for reuse. Secondly, the data was key to identify and study the dilapidated parts of the monument. Total station has been extensively used during the investigations of the structure of the main entrance loggia of the palace. The abnormal tilt and the subsidence obtained from EDM survey of the loggia at the floor level of level 1

revealed that this part of loggia was not structurally connected with the main building of the palace. The investigations showed the tilt of 14 cm and subsidence of 8 cm in the structure. Based on other such structural connections in the palace, the intervention proposal was implemented. A new connection and additional wooden beams were proposed. In order to remove the tilt and subsidence in the structure, hydraulic jacks and turning buckles were used. The process of lifting and pulling back of structure to a satisfactory position was closely monitored with the help of total station and allied software.

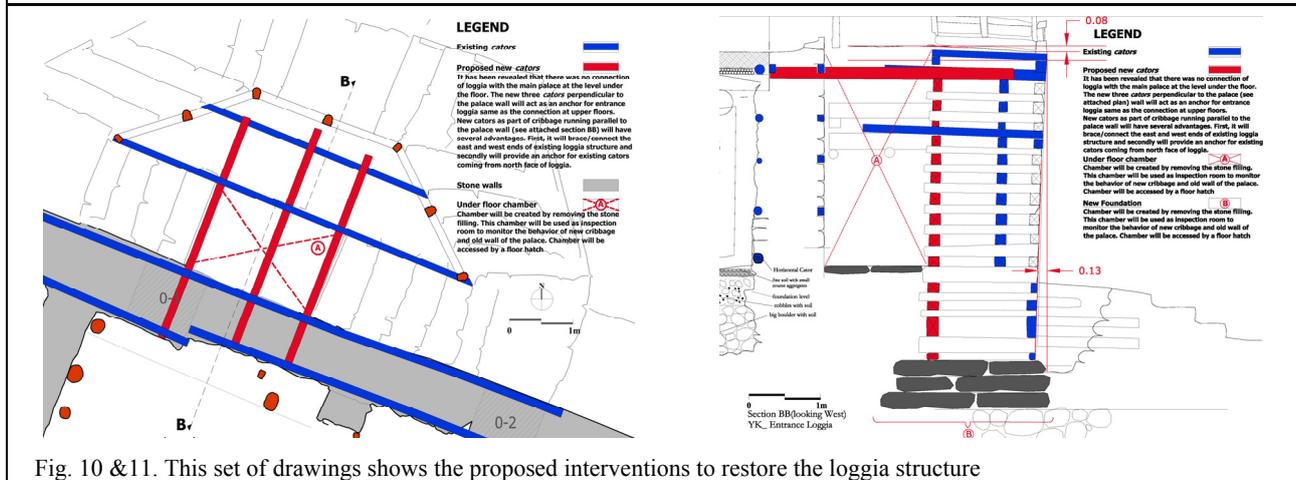
Fig. 10 & 11. This set of drawings shows the proposed interventions to restore the loggia structure

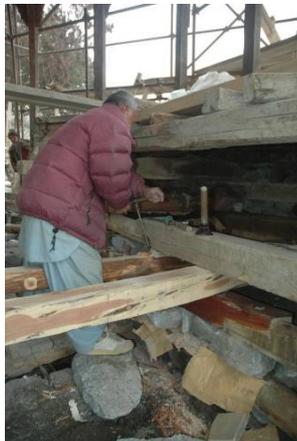
Fig. 12. Traditional construction techniques are being implemented during the restoration of loggia

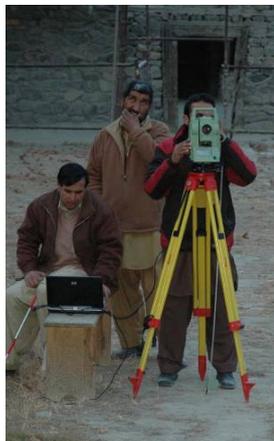
Fig. 13. Lifting and pulling back the loggia to a stable state is being closely monitored with total station

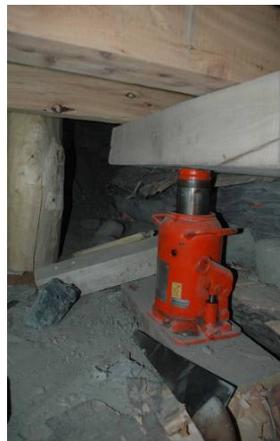
Fig. 14. Lifting of loggia to a stable state with the help of hydraulic jacks

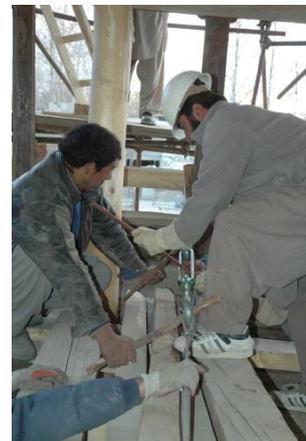
Fig. 15. Turning buckles are being used to pull back the tilted loggia

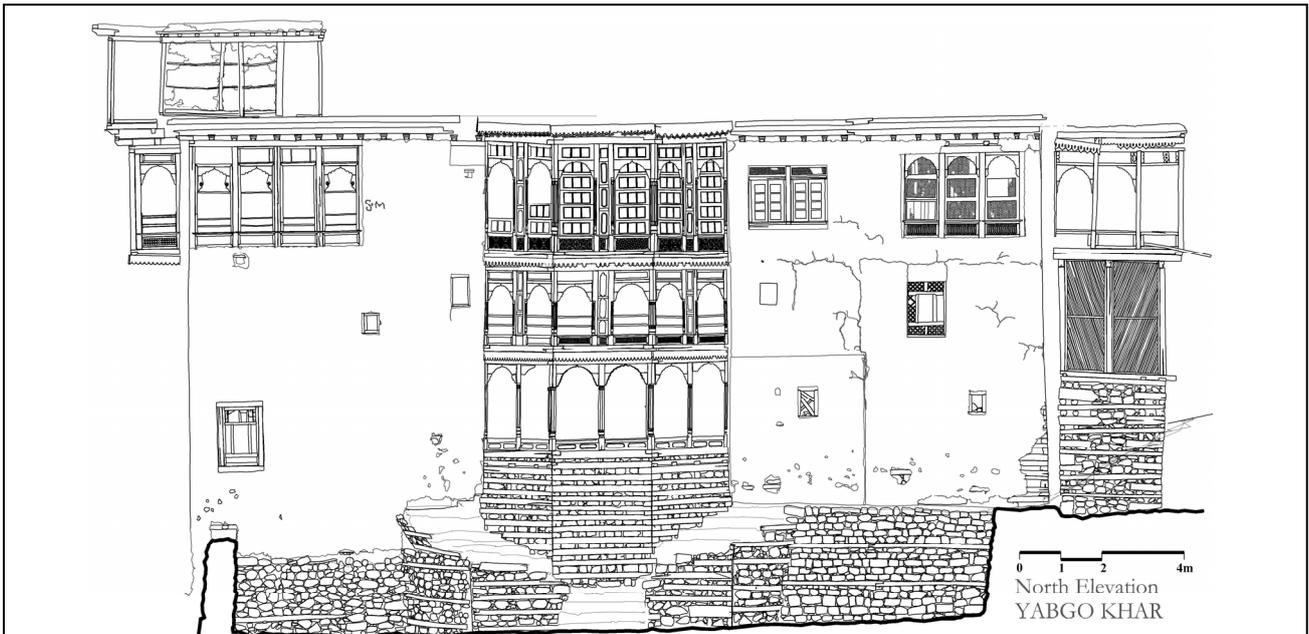
Fig. 16. North façade of *Khaplu* Palace. The wooden entrance loggia at the centre was the subject of major conservation activity in 2008. This restoration is very closely monitored with total station.

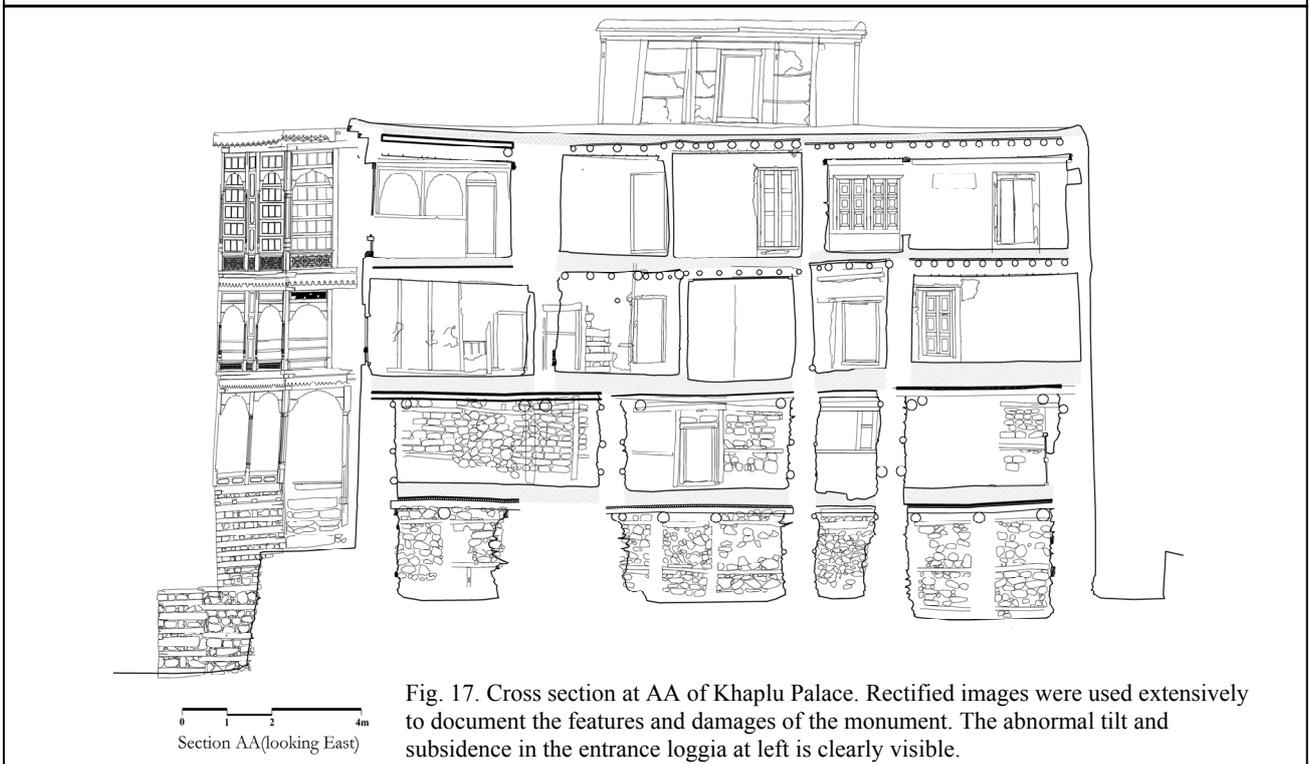
Fig. 17. Cross section at AA of *Khaplu* Palace. Rectified images were used extensively to document the features and damages of the monument. The abnormal tilt and subsidence in the entrance loggia at left is clearly visible.

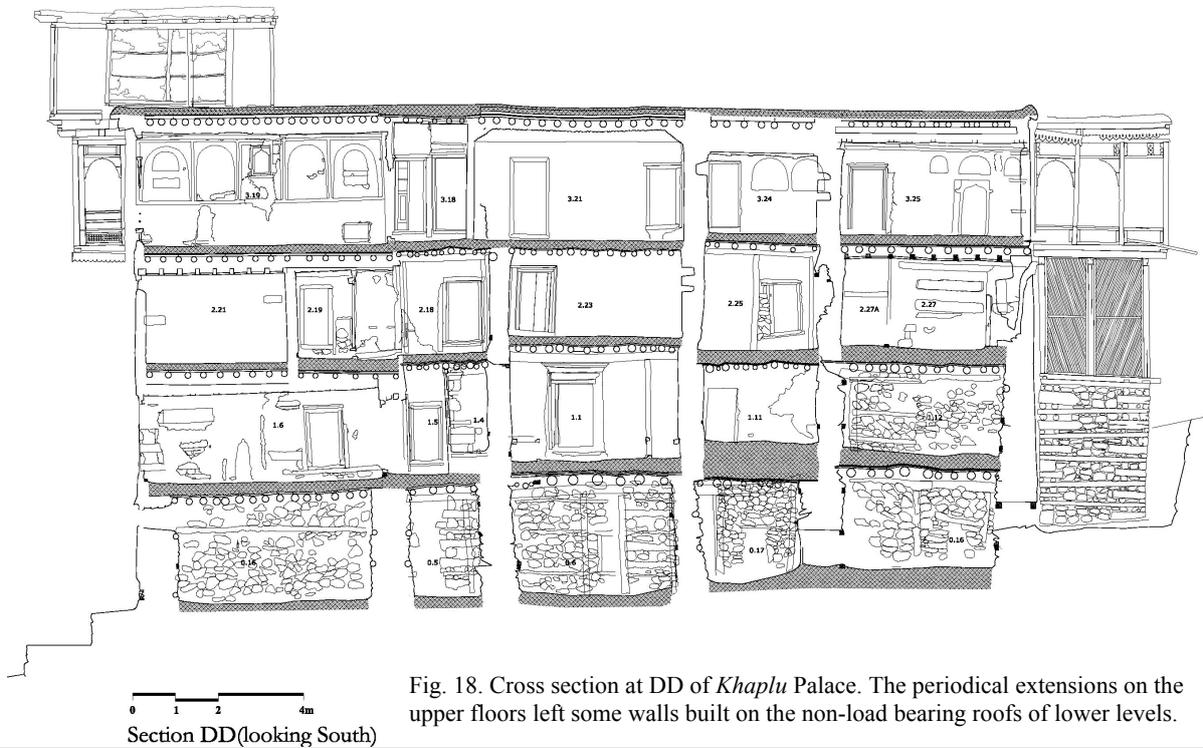
Fig. 18. Cross section at DD of *Khaplu* Palace. The periodical extensions on the upper floors left some walls built on the non-load bearing roofs of lower levels.

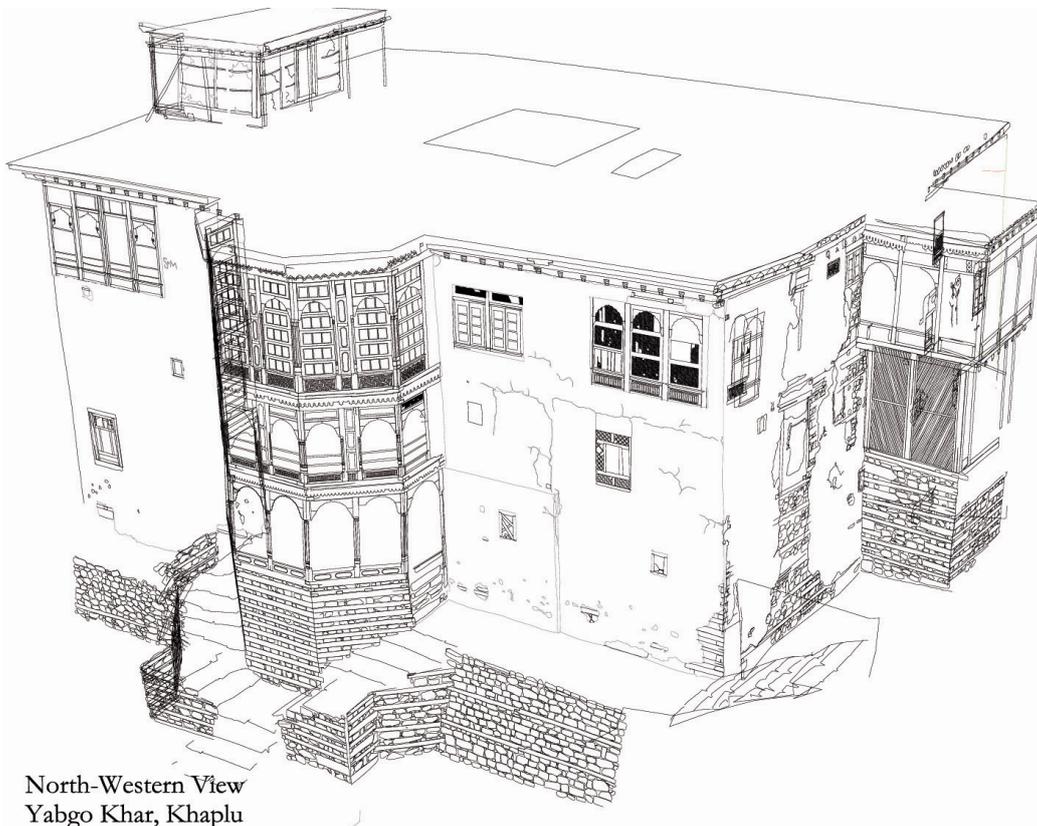
Fig. 19. A complete 3D wire-frame model of *Khaplu* Palace. North-western view of the Palace shows the swerve damages on western façade.
