## THE ROLE PLAYED BY THE SCIENTIFIC TECHNIQUES USED IN THE EXAMINATION AND ANALYSES OF THE MURAL PAINTING OF WOODEN ROMANIAN CHURCHES

The paper presents the analytical examination of colour samples taken from the frescoes of “Pogorarea Sfantului Duh” wooden church (sec. XVII), Dretea Village, Cluj County, Romania. The pigments were investigated through FT-IR spectroscopy, completed by UV – VIS – NIR spectroscopy, by ICP – AES and by observations of the optical microscopy. Was determined the whole palette of colours used by the popular masters, the pigments having mineral nature (red lead, blue ultra-marine, yellow ochre).

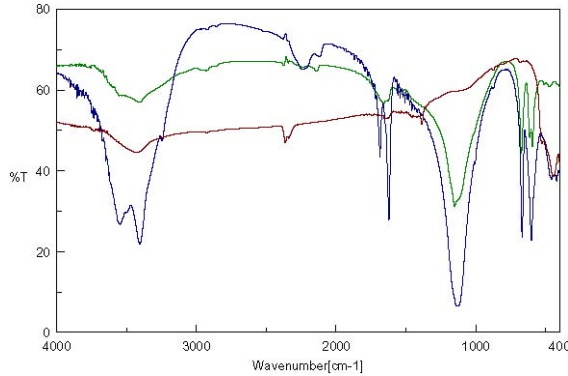
When examining the sample **P 1**, in the IR spectrum (Fig. 1), we observed the predominant presence of the priming (based on CaCO<sub>3</sub>). Besides the above mentioned chemical compound, the sample contains also a compound based on Pb<sub>3</sub>O<sub>4</sub>, situated in the wavelength of 455 cm<sup>-1</sup>, 530 cm<sup>-1</sup> and 1680 cm<sup>-1</sup>. [4]

Figure 1. IR spectra of sample P 1

— P 1  
 —  $Pb_3O_4$   
 — First layer of paint

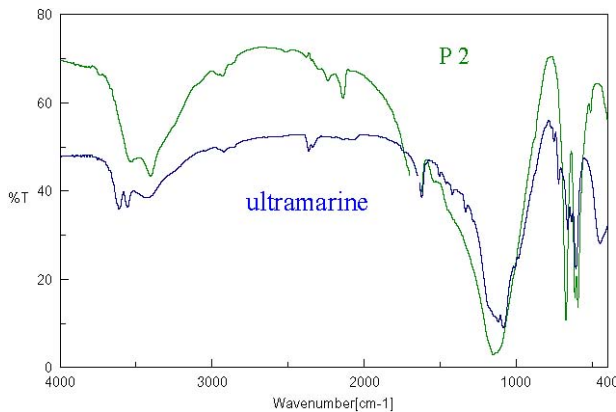
The IR spectrum of the P 2 sample (Fig.2) indicates the predominance of the  $CaCO_3$  based priming. Besides this in the sample there are bands at  $3626\text{ cm}^{-1}$ ,  $3440\text{ cm}^{-1}$ ,  $1110\text{-}1088\text{ cm}^{-1}$ ,  $1016\text{-}1010\text{ cm}^{-1}$ ,  $610\text{ cm}^{-1}$  and  $504\text{ cm}^{-1}$ , that indicates the presence of the ultra-marine pigment. [4,5]

Figure 2. IR spectra of sample P 2

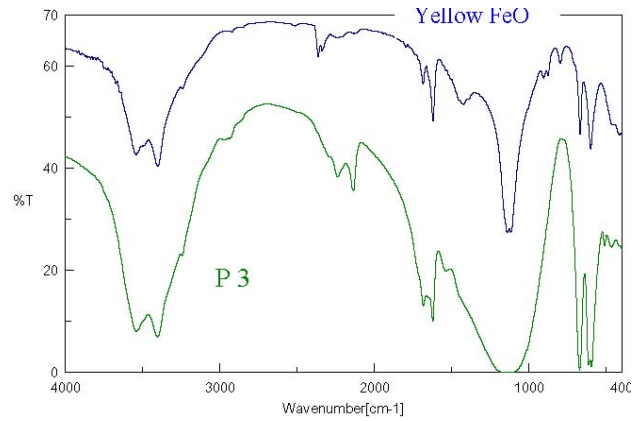
For the P 3 sample the IR spectrum reveals the presence of the yellow pigment, with FeO component. (Fig.3)

Figure 3. IR spectra of sample P 3

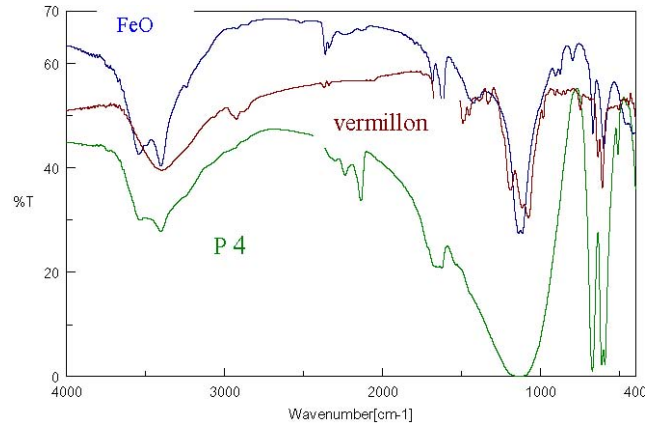
At the sample P 4, the IR spectrum (Fig.4) indicates the presence of a pigment, based on FeO, marked by the  $520\text{ cm}^{-1}$  band, derived from the pure pigment.

Figure 4. IR spectra of sample P 4
