DOCUMENTATION OF A HISTORICAL STREETScape WITH CLOSE RANGE DIGITAL PHOTOGRAMMETRY

G. Saygi*, M. Hamamcioğlu-Turan

Izmir Institute of Technology, Faculty of Architecture, Department of Architectural Restoration,
35430 Urla İzmir, Turkey - (gamzesaygi, mineturan)@iyte.edu.tr

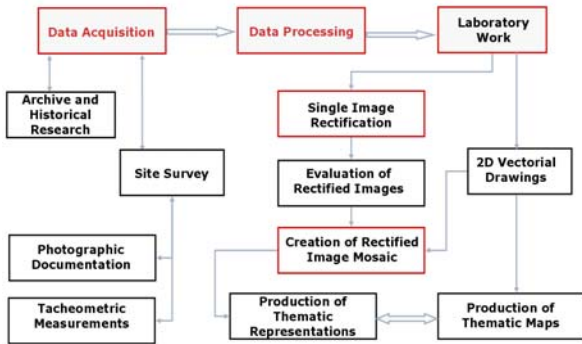
Figure 1. Information flow chart

The proposed guidelines can be discussed under two headings as data acquisition and data processing (Figure 1).

Firstly, photographic documentation considering the principles of single image rectification was carried out. The photographs of each plane of the façades were taken as parallel to the facade as possible. A tripod was used to increase the quality of the photographs and to align the camera accurately. The upper parts of the façades were photographed from the buildings at the opposite side so that the vertical tilt could be minimized. Totally, 96 photographs were taken for the eastern facade of the Necatibey Boulevard. At the same time, tacheometric measurements were made with a reflectorless total station. The distance to the object, the height of the station and the plane are important parameters in the photogrammetric documentation. The surveying network had been adjusted in a local reference system. Approximately seven control points were measured for each photograph. Natural points such as a window corner, end of a crack or a corner of a casing, etc. were used as control points. Archive and historical research was carried out as the second part of data acquisition. In turn, the historical timeline of the street would be determined. The historical research focuses on 19th and 20th centuries in which the present buildings in the case study area were constructed. The information on the buildings which are not present today was gathered from the written documents.

After all the data needed had been collected; they were evaluated in the laboratory. Single image rectification was made with Pictran photogrammetric evaluation software as the first step of data processing. Afterwards, the rectified images were evaluated. At the same time, 2D graphics were produced in order to complete the skyline curvilinear surfaces such as domes and towers which can not be rectified. As the result, the rectified image mosaic showing the present conditions of Necatibey Boulevard was produced. Moreover, themes were represented on the rectified image mosaic. Both the rectified image mosaic and thematic representations were vectorized in order to obtain conventional 2D drawings. The result descriptions were compared with each other and the advantages and disadvantages of the proposed methodology are discussed.

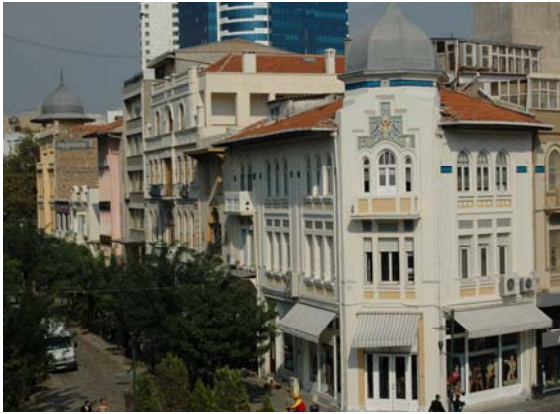
Figure 2. Necatibey Boulevard as viewed from Mimar Kemalettin Street

Today, the selected streetscape and its surrounding consist of commercial buildings dating 1920s, which represent the architectural characteristics of Early Turkish Republican period, and then 1950s onwards (Figure 2). Especially the ones constructed in 1920s are valuable with their architectural characteristics; however, some alterations and conversions are identified on the façades because of the unconscious usage and the change of the lifestyles.

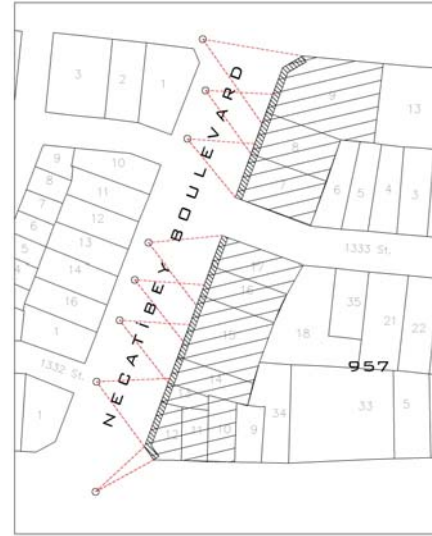
Figure 3. Station points used during tacheometric measurements

during tacheometric works: Electronic tacheometer should be set up in appropriate position according to façade planes. To have an accurate result, minimum 4 control points for each photograph of a single plane must be measured. Natural points such as a window corner or end of a crack or corner of a casing can be used as control points. Special importance should be given for homogenous distribution of these control points. The surveying network should be adjusted in order to create a local reference system (Figure 3).

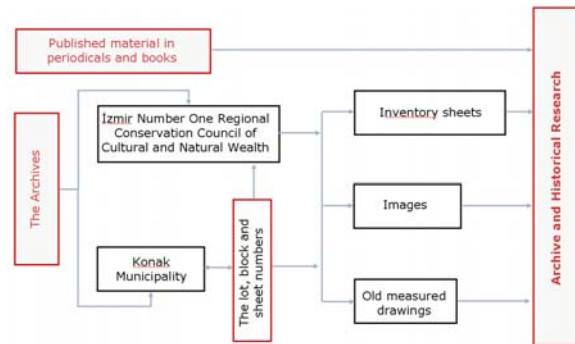
Figure 4. Information flow of archive and historical research

The second part of the data acquisition is archive and historical research. The history of the single buildings on the selected streetscape and historical evolution of the case study area must be investigated. In this context, following steps were followed within the study. Published material in periodicals and books were gathered. The Archives of the İzmir Number One Regional Conservation Council of Cultural and Natural Wealth, and Konak Municipality were used to reach historical documents such as inventory sheets, images and old measured drawings.

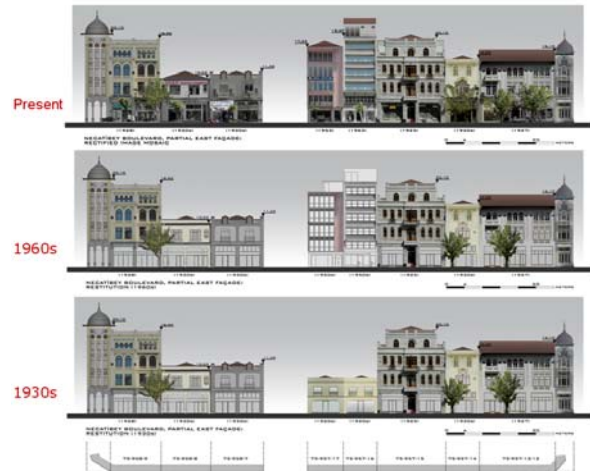
Figure 5. The timeline of the streetscape

Within the light of the alteration analysis, and archive and historical research, historical reconstructions of the streetscape are generated. So, the timeline of the streetscape can be defined in three phases as; Today, 1960s and 1930s (Figure 5).

These historical reconstructions show that the buildings constructed in 1920s and at the beginning of 1930s are mostly two or three storied ones representing the characteristics of First Nationalist Architectural Style. In 1950s and 1960s, the ones in lots numbered 16 and 17 in block numbered 957 were demolished and modern multi-storey ones were constructed in these lots. It can be said that the element alterations mentioned before have taken place after 1960s in the recent years.

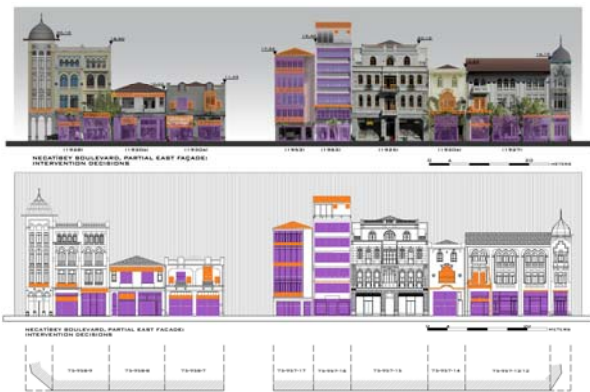
Figure 6. Comparison of the thematic representation of intervention decisions with 2D thematic drawing

Comparison of the rectified image mosaic with 2D elevation proved that the visual information comprehended in the mosaic is realistic data. The architectural details, materials, colors and textures are presented in rectified image mosaic while 2D elevation has an abstract description. The thematic information illustrated on the rectified image mosaic gives way to the better perception of the themes (Figure 6). At the same time, the timeline of the streetscape can also be better understood with the realistic media that is produced.

The result representation of today; namely, the rectified image mosaic includes qualitative information such as architectural details, color and texture. 2D scaled drawing is also provided by vectorization of the rectified image mosaic. This vectorization is made for comparison. It has shown that the 2D scaled drawing is only an abstract description of the streetscape. Thematic representations are visual documents in which the data gathered by site survey, historical and archive research are systematically illustrated. In this framework, these were produced in order to analyze and decipher the studied streetscape. These representations, when evaluated together with archive and historical research results have given way to the following assessments: The proposed themes in this study provide better perception of the timeline of the street and demonstrate clues prior to conservation decisions. The representation of alteration analysis and conservation interventions on the rectified image mosaic proved a stable and realistic image of today. The documentation of the alterations of the Necatibey Boulevard has provided useful insights for succeeding preservation decisions. Thematic maps on 2D elevation were also produced. The comparison of the thematic maps on the 2D elevation with the thematic representations on the image mosaic have pointed out that the latter is a realistic way.
