CONDITION SURVEY OF THE LAST JUDGEMENT MOSAIC ST. VITUS CATHEDRAL, PRAGUE

Keywords: condition survey, conservation, photogrammetry, Last Judgment Mosaic

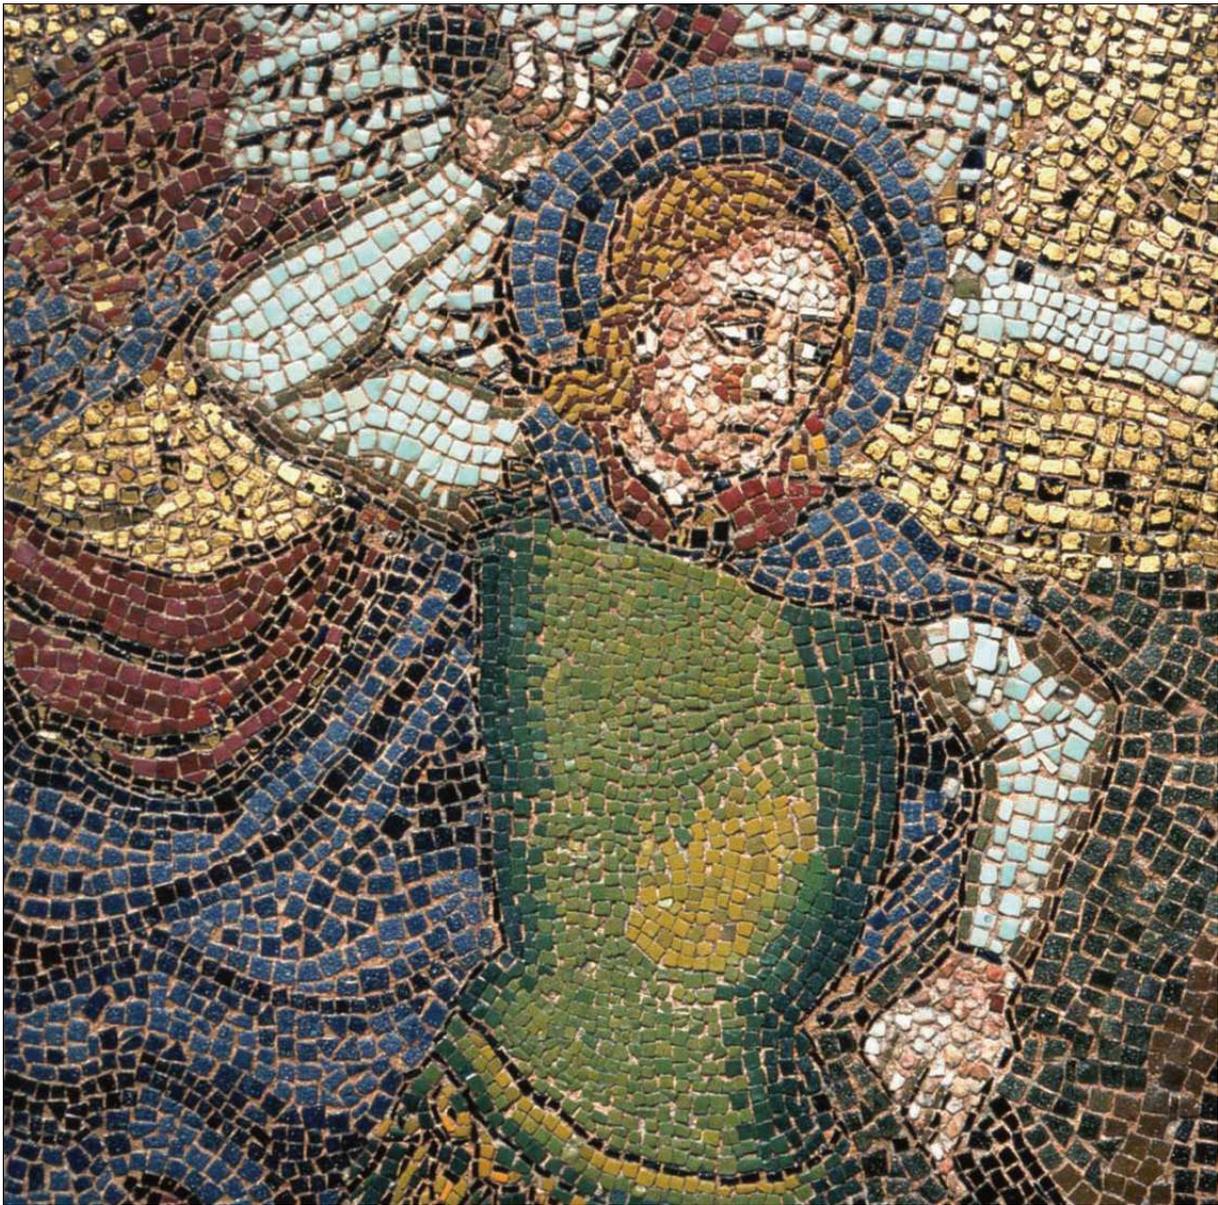
Figure 1: Detail of an angel, shown after cleaning, in the Last Judgment mosaic, above the entrance to St. Vitus Cathedral, Prague.

After the record was complete, the final phases of the project were carried out. A suitable method for removing the crust was tested and used. The mosaic was cleaned using compressed air and microscopic glass particles that were harder than the crust but softer than the tesserae. After cleaning, the surface was prepared with a solvent to remove any remaining residue. Each tessera was then treated with a complex protective coating that consisted of several layers. The outer layer is sacrificial and needs to be replaced every five years, whereas the inner layer is more durable and expected to last at least twenty-five years. This coating will shield the mosaic from the elements while allowing it to remain visible. The mosaic is inspected annually and photographed systematically in detail to determine if the coating is still functioning. Plans are in place to photograph and measure the entire mosaic every five years.

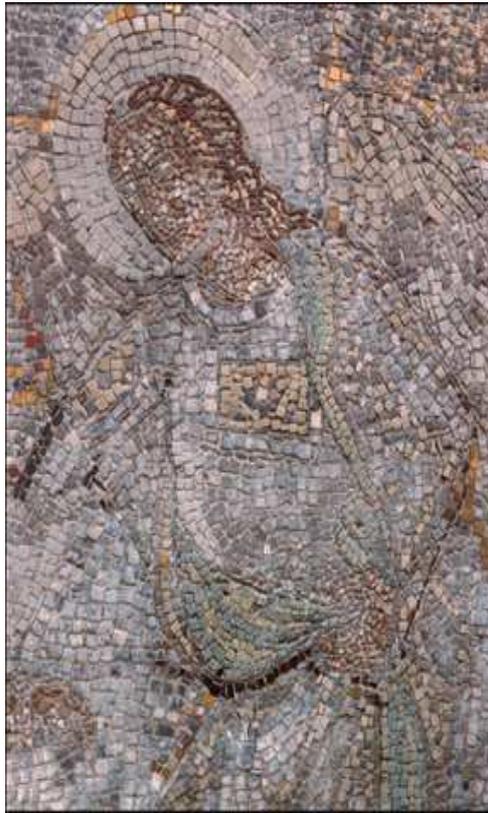
Jesus Christ, the central figure in the Last Judgment mosaic, is depicted passing judgment on the world, surrounded by triumphant angels above the patron saints of Bohemia. To his right, the dead are resurrected from their graves. To his left, blue devils welcome the damned. These dramatic scenes have become visible only recently. For hundreds of years, they were obscured by a chalky gray crust caused by the corrosion of the small glass cubes, or tesserae, that make up the mosaic. The corrosion was the result of rainwater interacting with the impurities of potassium and calcium within the medieval glass. When exposed to water, these minerals are leached out, creating alkaline salts that react with carbon dioxide and sulfur dioxide and crystallize on the surface.

Figure 2: Detail of the mosaic before cleaning

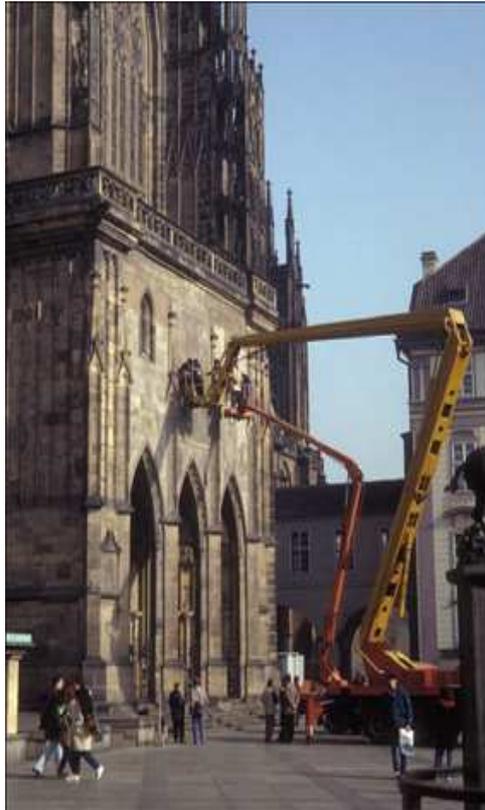
Figure 3: Conservators at St. Vitus Cathedral inspecting the mosaic, recording conditions on transparencies overlaid on rectified photographs of the facade. Photo: Dusan Stulik.

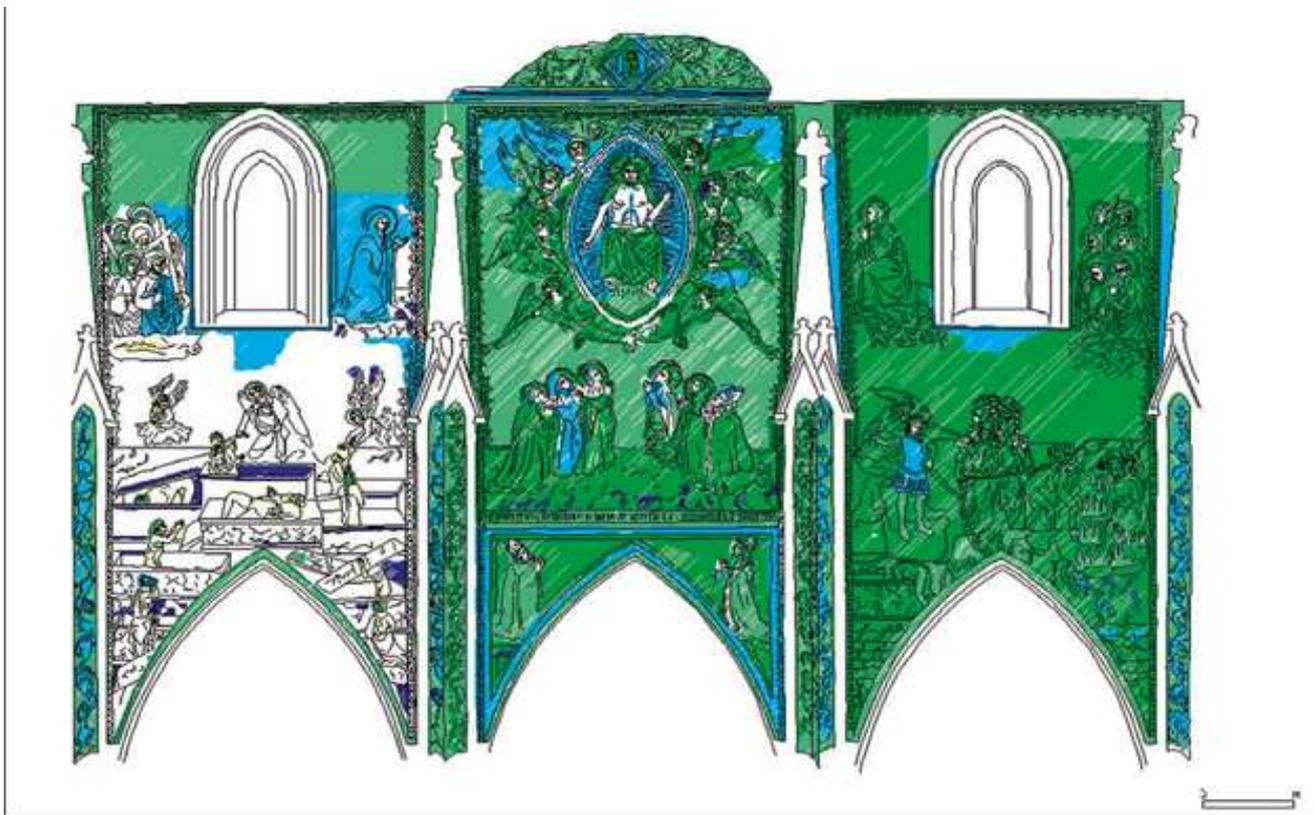
Information collected by conservators on the transparencies was scanned and imported back into the computer model. Prior to collecting information on the transparencies, it was found that certain colors—green, yellow, and other light colors—were not optimal for scanning. Therefore red, dark blue, black, brown, magenta, and orange were chosen for use. It was also important that only new markers were used. A condition legend was created that corresponded to each color. Red referred to cracks, magenta to traces of original gold, and blue to missing tesserae. In addition, extra transparencies were made available if the conservator made a mistake; no corrections were possible given that the transparency was

After the transparencies were scanned as bitmaps, they were converted into a form that could be included in a computer drawing program. Bitmaps (or raster graphics) are how computers and programs such as Adobe Photoshop record and display graphic images. The computer image created from the scan of the transparency is composed of millions of individual points (or pixels) of color. The number of points determines the resolution of an image. In this form, the information is not easy to calculate, combine, or separate into distinct divisions or layers; it is also of limited use at a large size. The individual points in a bitmap image can be seen if printed too large, resulting in uneven lines. The scanned data had to be converted into a different form—a vector graphic image. Vector graphics represent an image through numbers or mathematical models, and in this form it could be combined and manipulated more easily. Cracks could be measured and areas calculated because the graphics are based on numbers, not just on individual points. Vector graphics could also be printed at any size without a loss in resolution. A computer program, Adobe Streamline, was used to perform this conversion. Once complete, the data from each separate transparency were digitally reassembled on top of the image of the mosaic.

Figure 4: Scanned transparency of the mosaic, with graphic recording of corrosion levels.
Drawing: Rand Eppich. Corrosion forming a crust Heavy corrosion Medium corrosion Light corrosion

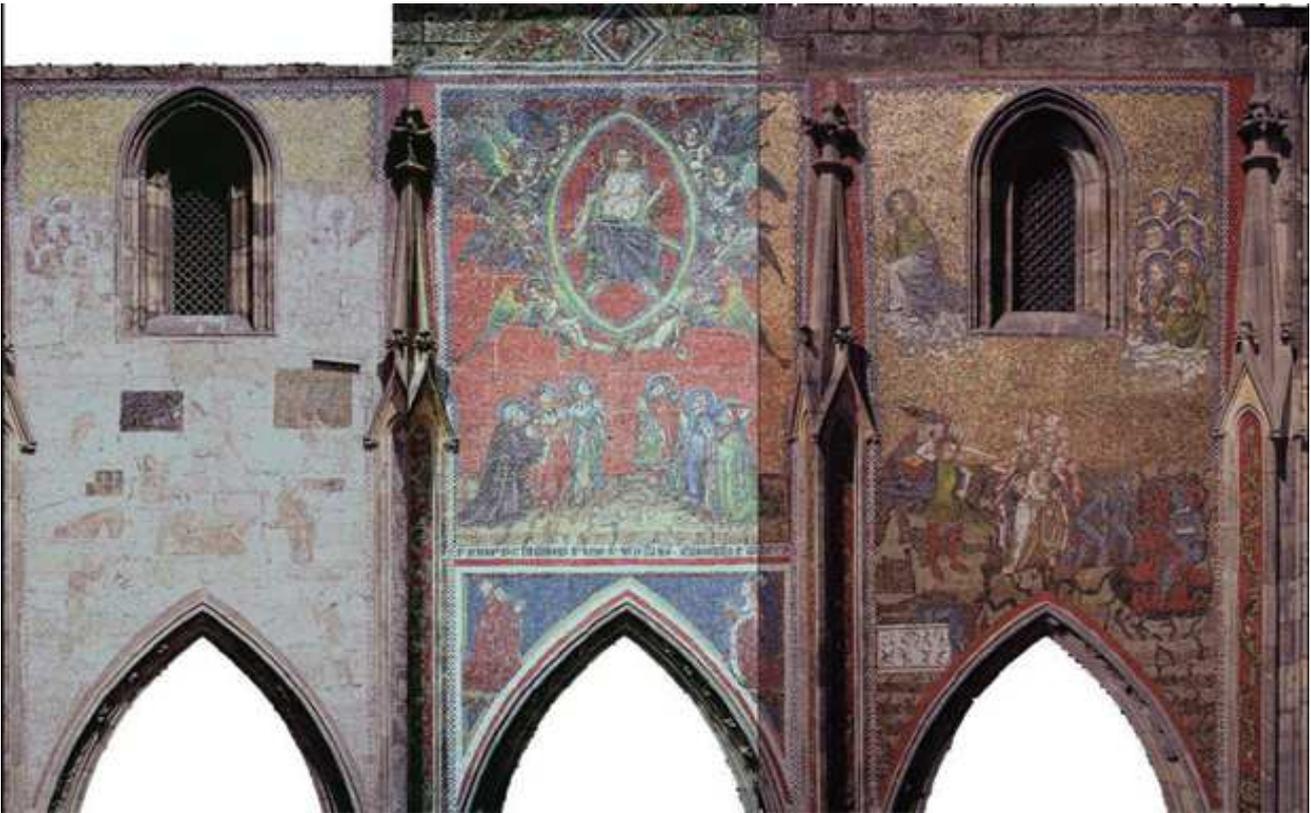
PhoTopoL, the digital images were then rectified, or transformed, and correlated to fit actual dimensions of the mosaic. The removal of distortion and the placement of the images to exact scale were crucial, as each of the three panels was photographed separately during different phases of the work. This allowed images taken before, during, and after conservation of each panel to align exactly.

Figure 5: Rectified images of the facade, showing its state before conservation (left), after treatment (center), and after gilding (right). Jaroslav Zastoupil.
