THE PREPARATION OF THE ARCHITECTURAL SURVEYINGS WITH PHOTOGRAMMETRIC MEASUREMENT TECHNICS OF EMIR ISHAK BEY TOMB AND 3D MODELLING

The present study reports on the documentation of Emir İshak Pasha Tomb using photogrammetric methods.

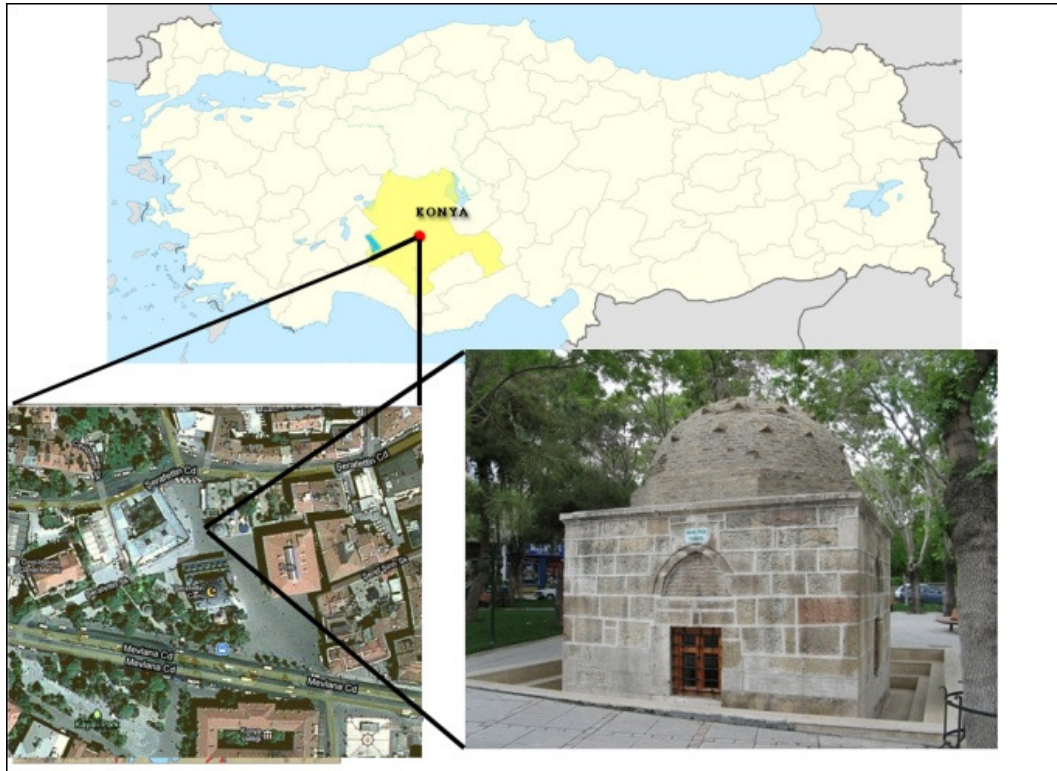
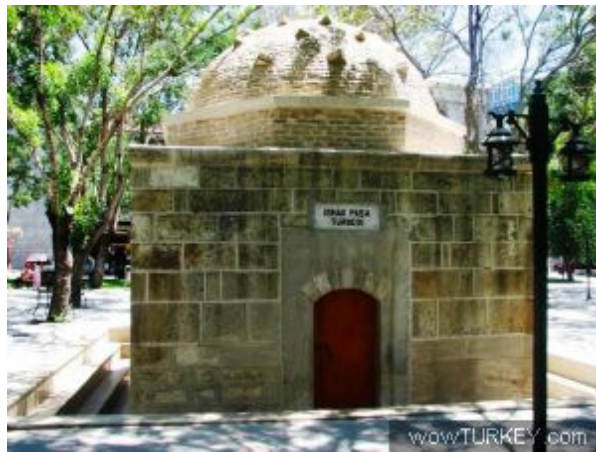
Figure 1. Emir İshak Pasha Tomb and its location

Emir İshak Pasha Tomb is located in Karatay, which is one of the central districts of Konya (Figure 1). The tomb is located in the north of Şerafettin Mosque and in Şems Public Garden, which was previously a cemetery. Şerafettin Mosque was first constructed by Sheik Şerafettin in 12th century, repaired by Karamanoğlu İbrahim Bey the Second in 1444, and was demolished and reconstructed in 1636 by Çavuşoğlu Mehmet Bey. It was repaired with the help of people of Konya and benefactors in 1881. The mosque is located in the east of Alaaddin Hill, north of a government office, south of Mahkeme Public Bath, and at the end of an avenue opening to government offices from City Hall.

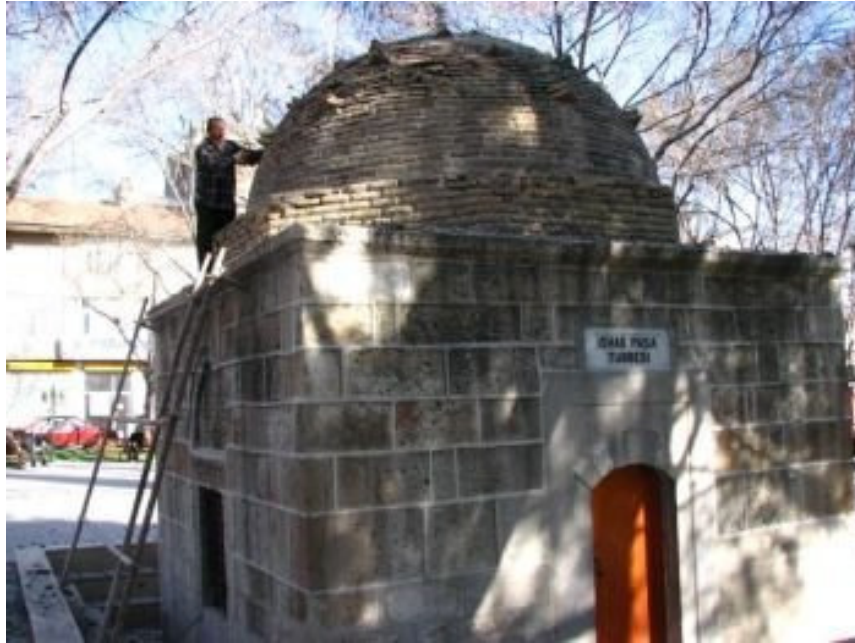
Figure 2. The restoration works on Tomb

It is necessary to use control points with known coordinates (X,Y,Z) on the object, to balance the photographs of the object and to bring them to the location where they are pictured. Therefore, the sketch of the tomb was superimposed over the photographs by sketching the 95 control points on the pictures of the tomb such that there were three points in each picture

After establishing the control points, coordination was given to the control points on Tomb with Topcom GPT 3007 geodesic measurement tool which can measure without reflector. The accuracy of the measurement tool used is $\pm(2 \text{ mm}+2 \text{ ppm})$. The accuracy of measurement was tested by coordinating the control points from two different traverses. Using control studies conducted in 17 points, quadratic mean error in control points was calculated as $m_x= 1.1 \text{ mm}$, $m_y= 1.0 \text{ mm}$ and $m_z= 0.9 \text{ mm}$.
