# MEASURED SURVEY AND DIGITAL PHOTOGRAMMETRY METHODS DURING THE RESTORATION OF THE MAIN DOME DECORATION IN THE PILGRIMAGE CHURCH OF ST. JOHN OF NEPOMUK AT ZELENÁ HORA IN ŽDÁR NAD SÁZAVOU

Jaroslav ZASTOUPIL <sup>1</sup>, Jiří VIDMAN <sup>2</sup>, Pavel HLAVENKA <sup>3</sup>

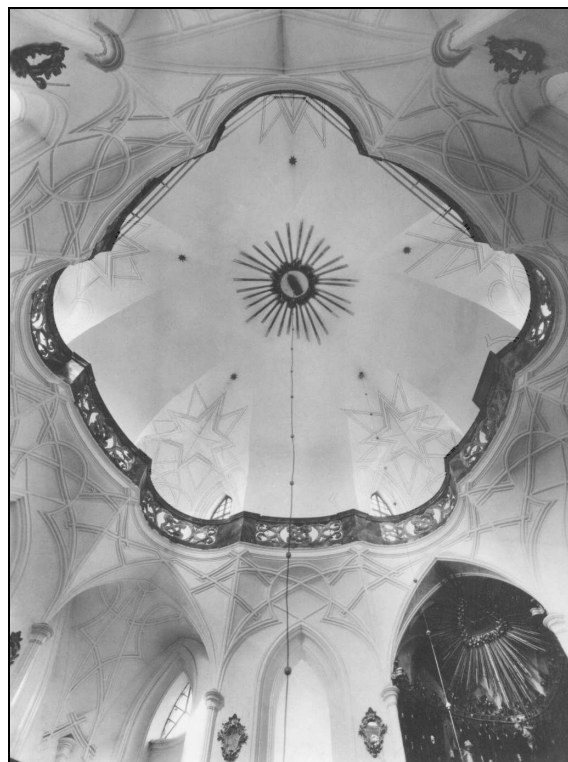
**Figure 1:** Main dome, 1953 (Image: archive of the The National Institute for the Protection and Conservation of Monuments and Sites, Brno, Photo: Čestmír Šíla)

On July 16, 1784 a fire destroyed the church's roof. In the same year, the monastery itself was dissolved. Threatened with ruin, the church was only saved through the care of local residents, guided by Father Matěj Josef Sychra (1776-1830), who eventually succeeded in winning permission for the church to be revived as a cemetery chapel. The roof of the church was rebuilt in 1792, along with the vaulting. However, by this time the ornamentation of the vaulting had long since been destroyed, and because of the limited funds available, the restoration in 1794-1802 only repaired the most necessary sections. This fact remains evident even in photographs from the 1960s (Figure 1), in which the bare vaulting over the main interior contrasts with the rich ornamentation on all other surfaces.

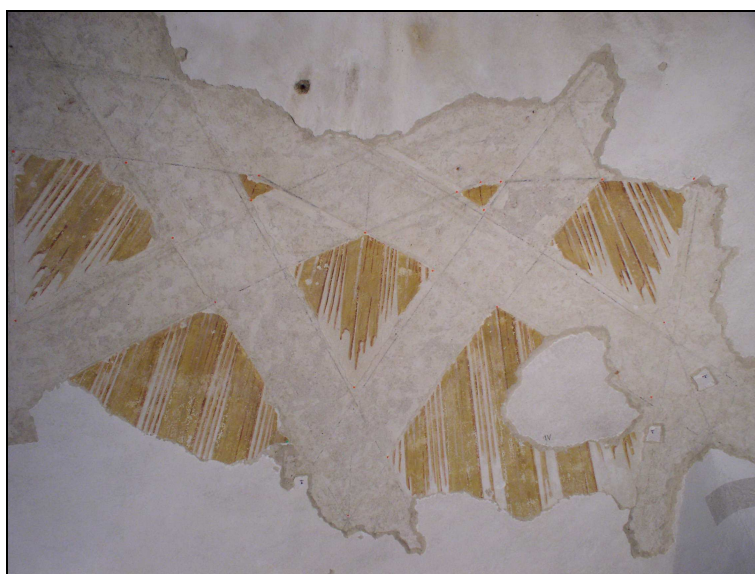
**Figure 2:** Part of the foundations of original stucco work from the period of Santini.  
(Photo: Jaroslav Zastoupil)

During restoration examination in 2004, traces were found in the cupola of the original ornament and even original stucco work from the period of Santini. These traces not only contained the outlines of the original ornament and fragments of the original frescoes, but even the original sketching lines in graphite (Figure 2). For the surveyors, the first task was to document these findings. Complicating the work was the fact that the space for measurements was divided into three sections by the surfaces of the scaffolding, between which there was only a gap of a few centimetres in width between the scaffold and the actual surface of the vault. A further complication was the impossibility of using tripods.

A spatial micronetwork was created, composed of fixed points stabilised by screws affixed to the stucco of the vaulting and free-standing points for the total station. Measurements were made with a Leica TCR. The network was rectified using the smallest-square method; the standard deviation was  $m_{xyz} < 3$  mm. From it, all of the discovered traces of the original ornament were measured. Additionally, a photographic plan was made of the findings, using the software TopoL.

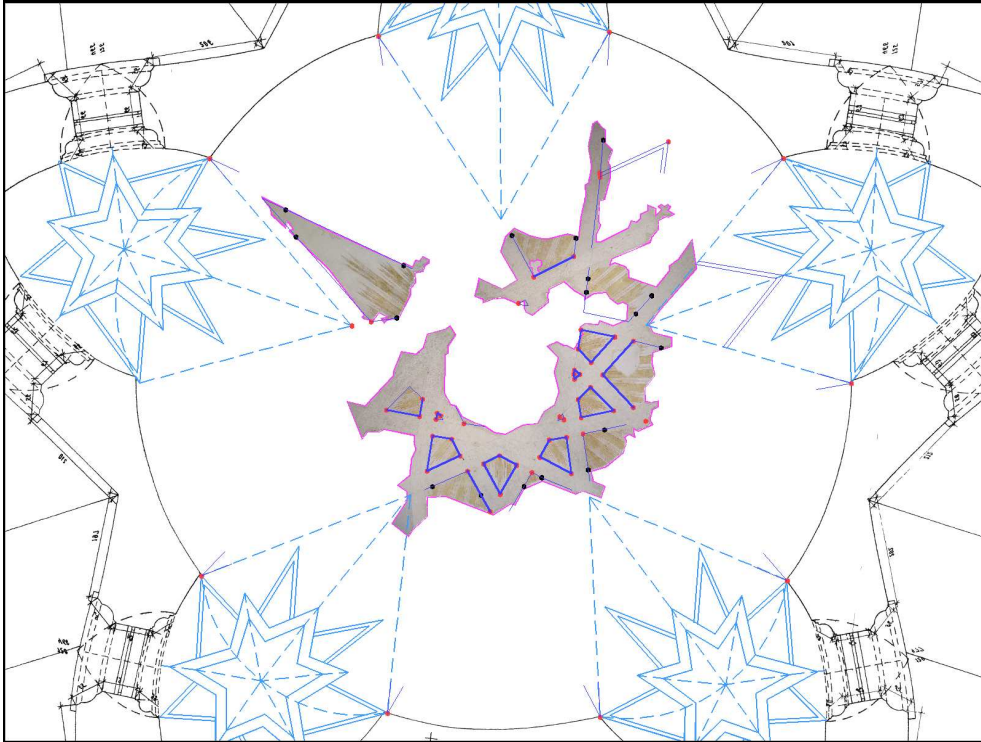
**Figure 3:** The foundations projected to the floorplan.  
(Image: Pavel Hlavenka)

The next step was analysis of the findings. Thanks to their extent, it was possible to undertake reconstruction of the original ornament of the cupola. For the final decisions of the art historians and preservationists, a visualisation was prepared of the extant state and the possible methods for reconstruction. On the basis of this data, it was decided to undertake a full reconstruction of the original ornament. (Figure 3 and Figure 4)

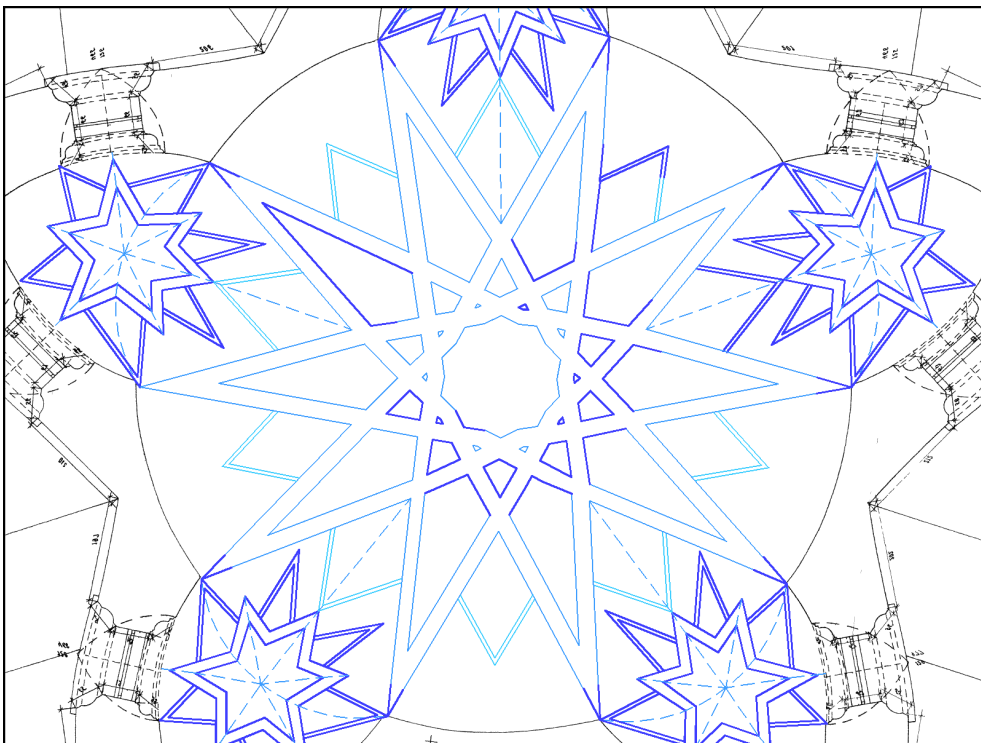
**Figure 4:** Analysis and reconstruction of the original ornament based on the survey.  
(Authors: Jan Vinař, Zdeněk Chudárek)

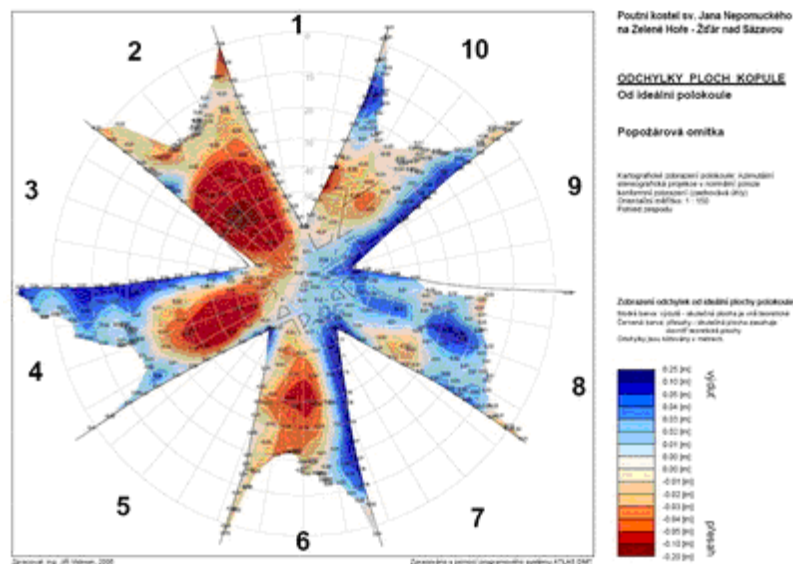
**Figure 5:** Analysis of the actual form of the cupola.  
(Author: Jiří Vidman)

Because the cheaply performed reconstruction of the cupola in 1794-1802 caused a deformation of its shape, for the work of the stucco artists it was essential to undertake an analysis of the current and actual form of the cupola, and determine its deviations from the form of an ideal spherical surface. This task was performed through the program Atlas DTM (Digital Terrain Model) and the deviations depicted using colour hypsometry. (Figure 5)

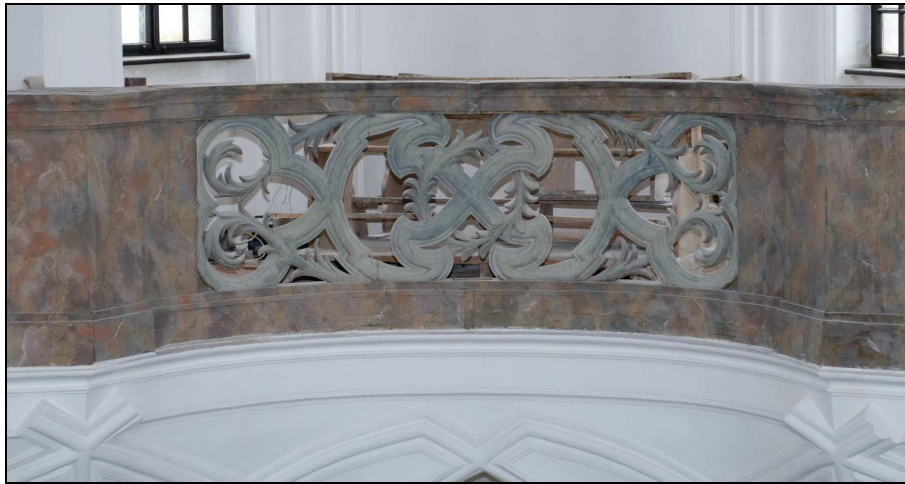
**Figure 6:** One of the ballustrade segments.  
(Photo: Jiří Vidman)

After repairs in 2007, documentation was performed of the wooden balustrade in the 2nd gallery in 1:10 scale. The balustrade is composed of 10 sections, with sections of radius 1.78 m alternating with sections of radius 5.00 m. (Figure 6) The metric images were shot using a calibrated Nikon camera. Each section of the balustrade was projected onto the surface of a substitute cylinder and unrolled flat. The photographic plans were then subsequently colour-treated, bitmapped and cropped. The size of the pixels in the resulting photoplans is 1 mm.
