# DETERMINATION OF OLD AND NEW DEFORMATIONS AT KÜCÜK AYA SOFYA (LITTLE HAGIA SOPHIA) MOSQUE IN ISTANBUL BY PHOTOGRAMMETRIC METHODS AND AN ATTEMPT OF THEIR INTERPRETATION

CIPA XIX<sup>th</sup> International Symposium Anatalya 2003

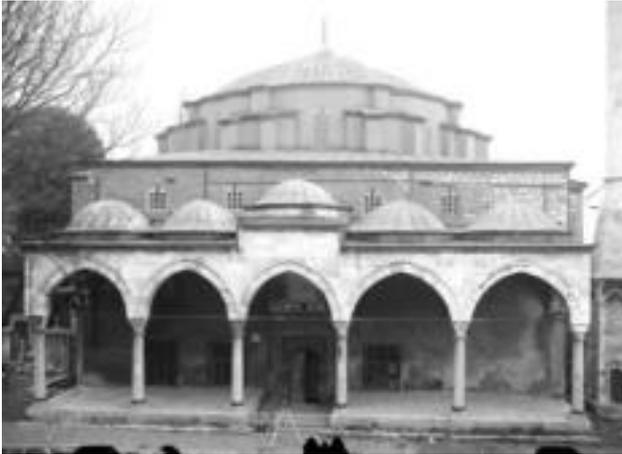
Figure 4. West side of KAM 1979

In the year 1979 the visitor could see the square (figure 4), but in the nineties he couldn't (figure 5). The utilization of the medrese had changed; some parts were rebuilt or reorganized. Today the medrese houses some tourist-shops. Due to these developments, a few new jobs were created on the one hand but on the other hand the architectural situation (the aesthetics of the ensemble) was disturbed completely.

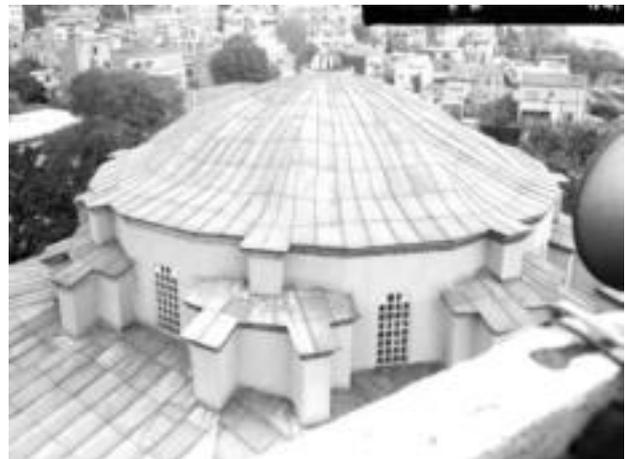
The growing of the cracks gave reasons for trying now to analyse the deformation of the whole dome of the KAM with existing photogrammetric images. To illustrate the cleverness of the construction we see in figure 12 a photogrammetric image of the roof of the dome taken from the minaret and in figure 13 the inside surface in form of visualized laser measurements.

Figure 12. Dome of KAM, image taken from the minaret

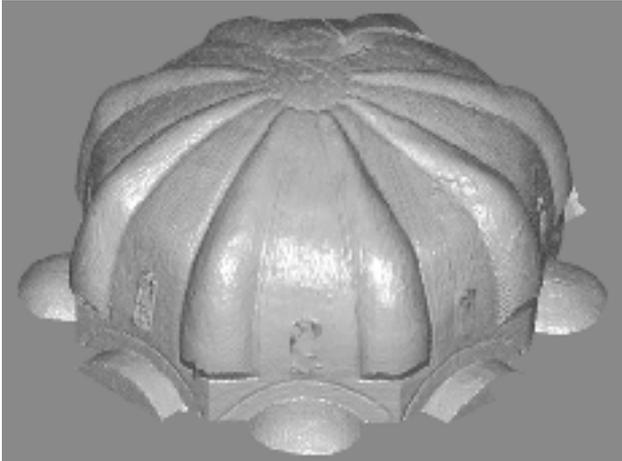
These laser measurements are taken from a campaign in early summer of 2002 where a complete laser-scan of KAM was performed. Some additional architectonic data: the dome built from brick masonry has an inside diameter of 16,5 m, the double curved segments have to pass the strength into the big pillars to get the static equilibrium, but only with the help of the deformations of the pillars. To get the searched information of the deformation of the dome we have measured and calculated 20 images of a bundle block taken in 1979 (camera TMK from

Figure 13: Surface of the dome inside, visualization of laser measurements
