TOPOGRAPHIC AND PHOTOGRAMMETRIC STUDIES OF THE BEARING STRUCTURES OF THE CAPPELLA DEI PRINCIPI OF FLORENCE

L. Bianchini, G. Bartoli, I. Chiaverini, F. Costantino, D. Ostuni
D.I.C. Dept. of Civil Engineering, University of Florence, Italy

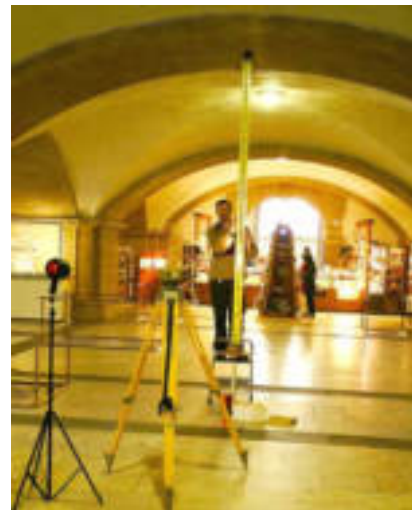
Figure . Crypt key stone monitoring with a modified 3 meters bar code levelling rod for the reading from the top.

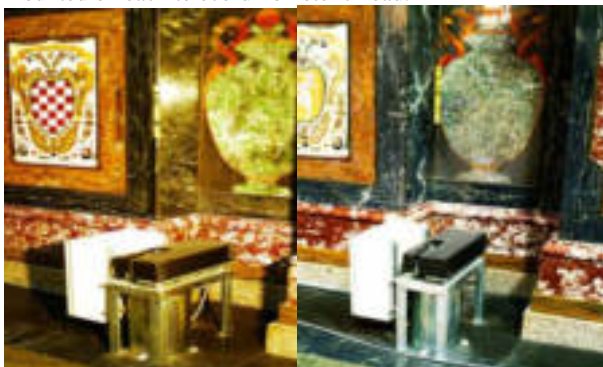
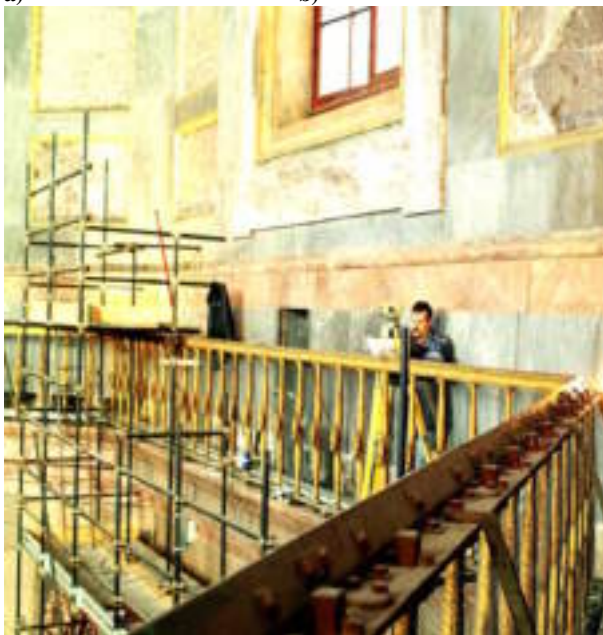
Figure . a) Chapel telecoordinometers with small bar code levelling rods c) balcony levelling instruments

In correspondence to these four points and around the balcony ring, other 20 bench marks control points were also installed (fig.9c); differential records between summer and winter on these bench marks offer a good reference point of the total vertical lengthening caused by thermal expansion. These specific acquisition data have been correlated to the temperature range of the invar telecoordinometer thread; not a negligible data for about 30 linear meters. Recently, the crypt arches zones seem to be interested by an additional load added on the upper floor for the restoration works and for some stone materials coming from the lateral *apses* actually lying on the paving of the *chapel*.

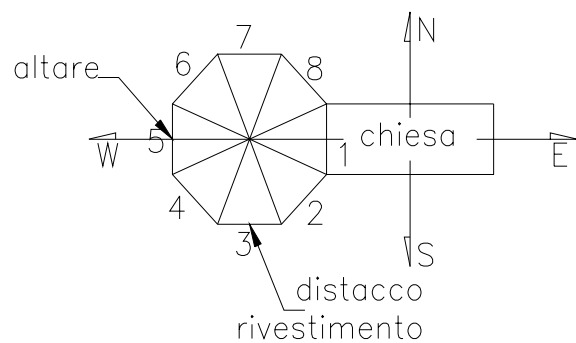
Recent inspections about the actual crack system status were focused to verify the *drum* and the *dome* situation; the fissures system appears regular and quite symmetric on the surfaces.

In the main structural septa of the *chapel* the fissures begin in the middle of the *gable roof* and stops on the *drum*; on the other empty structural zones the fissures on the *gable roof* are longer and continue just to the key of the *arconi*.

Figure . The dome sector identification numbers.

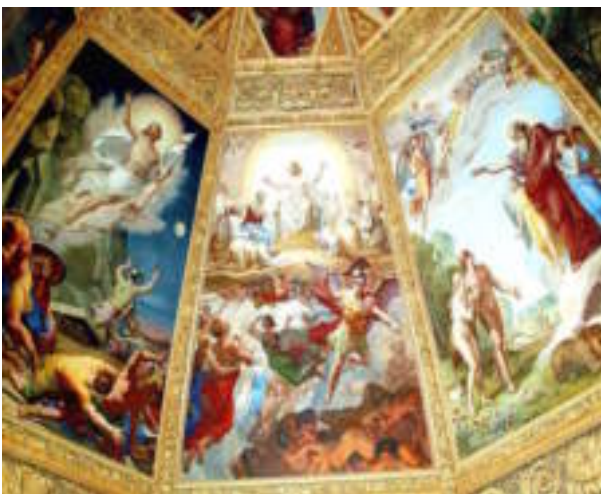
Figure 3. The Triumphant Christ fresco sector

To investigate other structural hypotheses a specific stereophotogrammetric close range survey was then planned in order to acquire the geometric cylindrical shape of the *gable roof* of the dome in the Triumphant Christ fresco sector. Resulting 3D data show only slight irregularity; no structural concavities or convexities were found. (fig.17)
