BASILICA OF SAINT PETER MARTYR FROM VERONA IN S. ANASTASIA (VERONA): STRUCTURES GEOMETRIC SURVEY AND PHOTOGRAPHIC CAMPAIGN FOR THE PRESERVATION PROJECT

C. Campanella^{a-b}, M. Tessoni^b, S. Bortolotto^c, E. Ciocchini^d, F. angheri^e

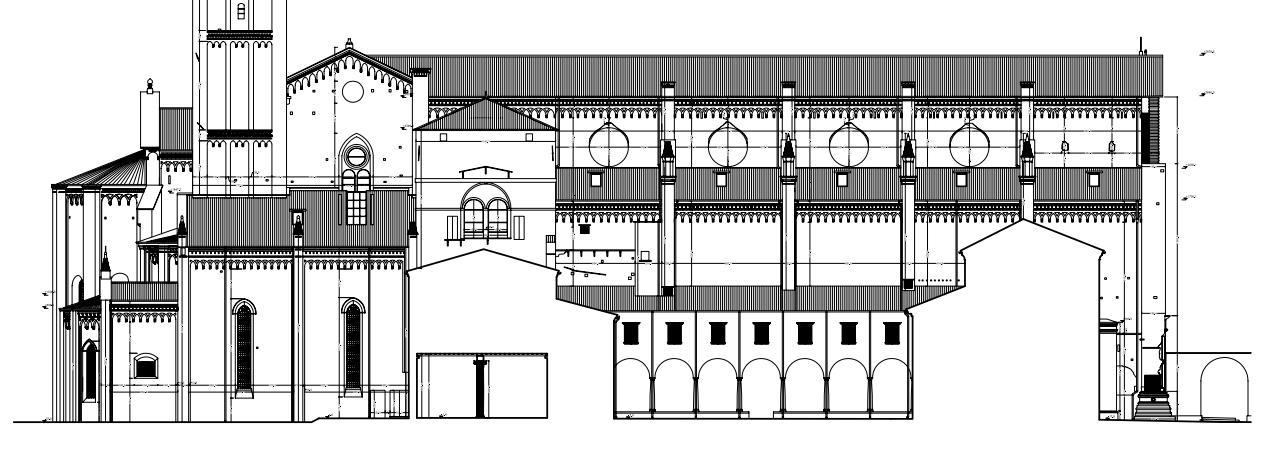
Figure 3. West elevation

Less alarming results come from the analysis of the data issued by the reading done to verify the facade's out of plumbs, where no noteworthy misalignments were found, especially in proximity of the cracks mentioned above.
