PHOTOGRAMMETRY AS A TOOL TO RECORD A HISTORIC BUILDING AT RISK

Tsioukas, V.¹, Alexandri, V.^{2*}, Karayannis C.G.², Chalioris, C.E.²

KEY WORDS: Architecture, Surveying, Photogrammetry, Close Range, Reconstruction

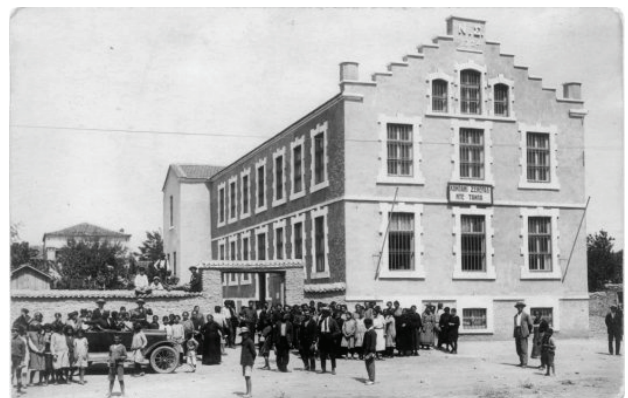
Figure 1. Vintage photograph of the tobacco warehouse. The building functions as a tobacco warehouse with the corporate name "Compagnie General de Tabac". At the top of the gable, one can see the date 1924, which is the year that the building began to function as a tobacco warehouse

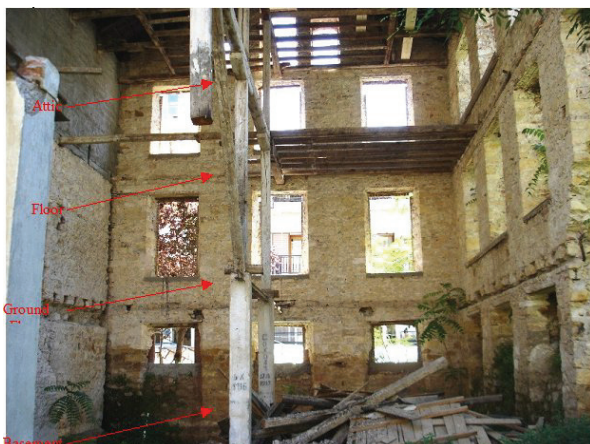
Figure 3. The inside of the building

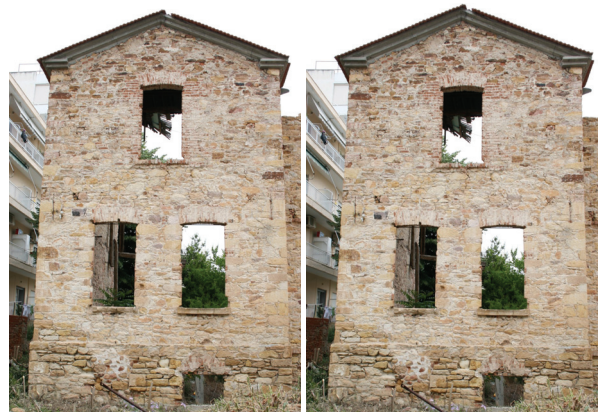
Figure 7. Original (left) and corrected (right) images.

The homemade software Calib was developed at the Dept. of Architectural Engineering of the Democritus University of Thrace for educational purposes. The software can also provide for every original image a new one that is free of radial distortion errors (figure 7). Thus the rectification images are better, the produced mosaics appear seamless and the succeeding digitization process is performed more accurately.

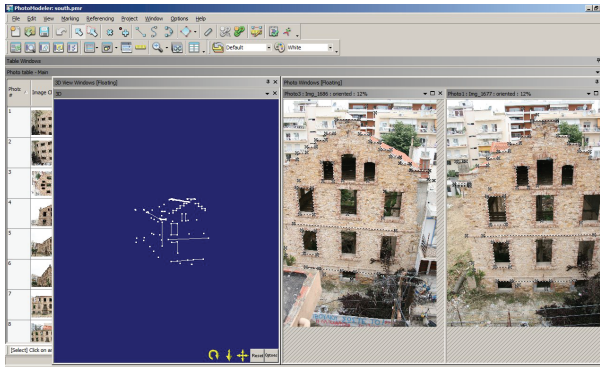
The photomodeler application provided the textured 3D draft model of the building (figure 8). The generated model has been used as the basis to provide a proper georeference of all the designs, rectified images and mosaics of the structure.

Figure 8. Photomodeler processing environment.

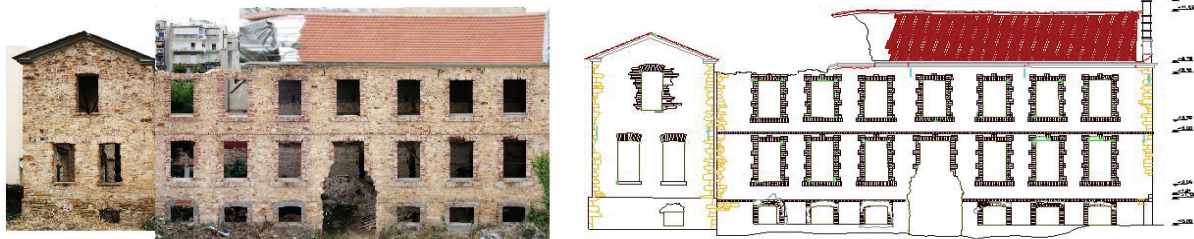
Figure 9. Rectified mosaic of images (left) and corresponding digitized façade (right)
