REPRESENTATION OF HISTORICAL STRATIFICATION IN A CHURCH CONVERTED INTO A MOSQUE

M. Hamamcioglu-Turan

Izmir Yuksek Teknoloji Enstitusu, Mimarlik Fakultesi, Urla, 35430 Izmir, TURKEY – mineturan@iyte.edu.tr

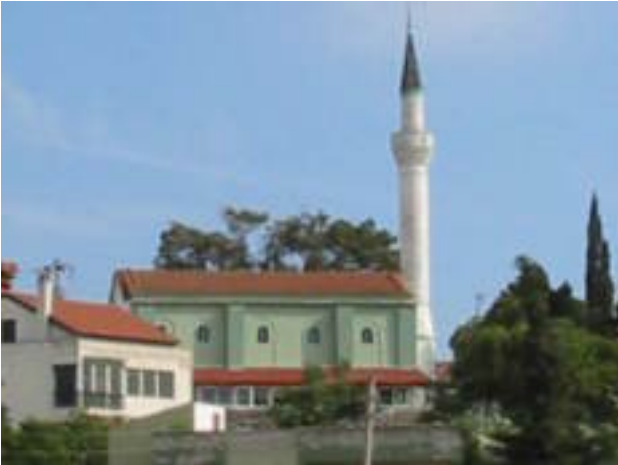
Figure 2. The monument viewed from the north (2005)

The courtyard of the church flanks the village square at its north. Two steps lead down to the courtyard. The mosque is at the east of the entrance. At the west, there are washbasins for cleaning before prayer and also toilets. A garden with monumental pine trees neighbors the courtyard at its north east. The north side of the courtyard is bordered by a retaining wall. The courtyard has a general view of the village over this retaining wall.

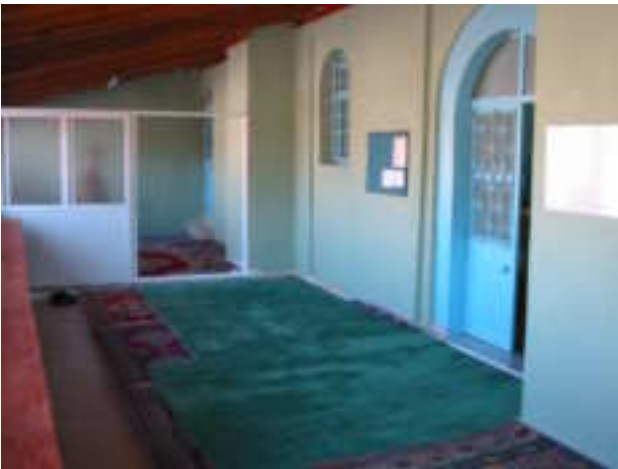
Figure 3. The entrance porch viewed from west to east (2005)

The mosque is flanked by the minaret at its west, the entrance porch at its north, the house of the imam and the office of the head man at its east, and a narrow garden, approximately 3.5 m in width, at its south. The minaret has an octagonal base, each side 85 cm, a cylindrical shaft, a balcony and a conical finishing. The entrance porch, 3 m in width, functions both as a foyer and as a secondary praying space for the late comers. Here, there are two doors leading to the main praying hall. Men's door is close to the center, 1.35 m in width and 2.65 m in height, and the women's door is close to the east corner, 85 cm in width and 3 m in height.

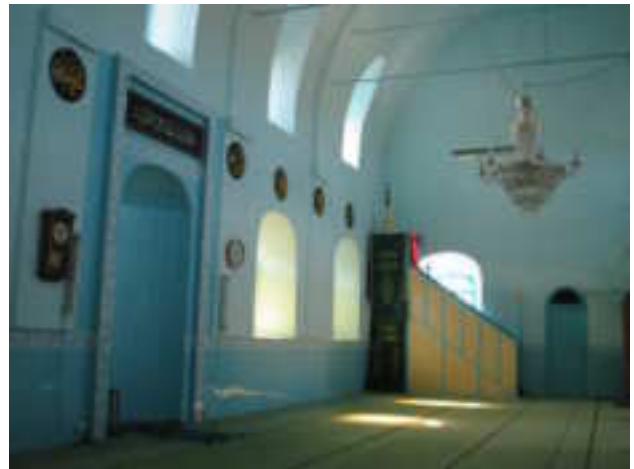
Figure 4. The praying hall viewed from east to west (2005)

The longitudinal praying hall (7.70 x 14.90 m), covered with a single barrel vault, is oriented to the 'mihrap' niche at the center of the south wall. The keyline of the vault is 8.30 m from the ground level. The timber pulpit is placed at the south west corner. The half storey, 2.75 m in width, added to provide privacy for women prayers creates a low entrance zone, 1.85 m in height, at the north side of the ground level. A small door at the center of the west side leads to the staircase in the minaret. At the east side, trace of a central wide arch can be observed underneath the plaster. Here, there is a cupboard close to the south corner. The small windows placed in two series at the bottom and at the top along the long walls, and two bottom windows at the west wall provide low intensity of daylight in the praying hall. All of the openings are wider and higher at the interior compared to the exterior. The bottom windows of long

walls are approximately 1.35 m in width by 1.85 m in height at the interior, and 90 cm by 1.35 m at the exterior. The top windows of long walls are 90 cm by 2.10 m at the interior, and 65 cm by 1 m at the exterior. However, the top windows at the east end of long walls are narrower at the interior: 85 cm by 2.10 m. The two bottom windows at the west are 1.35 m by 2.10 m at the interior, and 90 cm by 1.40 m at the exterior. Besides the additional electrical lighting elements; iron rings that seem to support oil lamps are observed at the key line of the vault. The masonry historical walls, 80 cm in thickness, and the vault are constructed with rubble stone, brick and mortar; supported with timber beams at various levels; covered with cement plastering, and painted at the exterior and white washed at the interior. The ground floor which is slightly elevated with respect to the entrance porch and courtyard, 45 cm, is timber covered at present, and reached by three timber steps. The half storey is constructed in skeleton system with reinforced concrete.

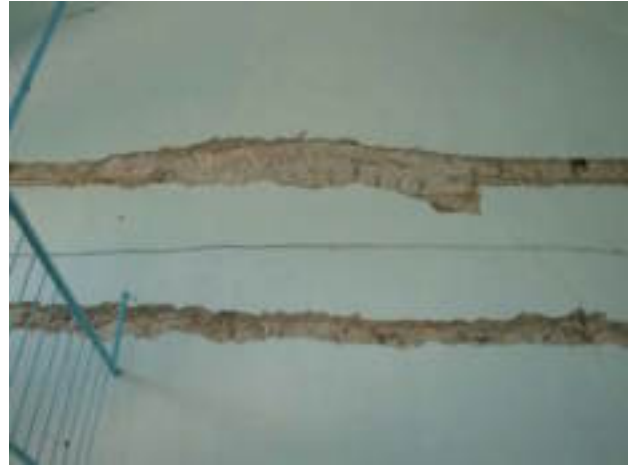
Figure 5. The trace of the central arch of the apse observed at the east wall (2004)

presence of a bottom window at the east end of the south wall should be questioned as well. In fact, it could have been filled in, after the addition of the office building. The original wall and floor covering of the interior cannot be observed. But no traces of mosaics or paintings were deciphered, when the plaster of the east and west walls were taken off.

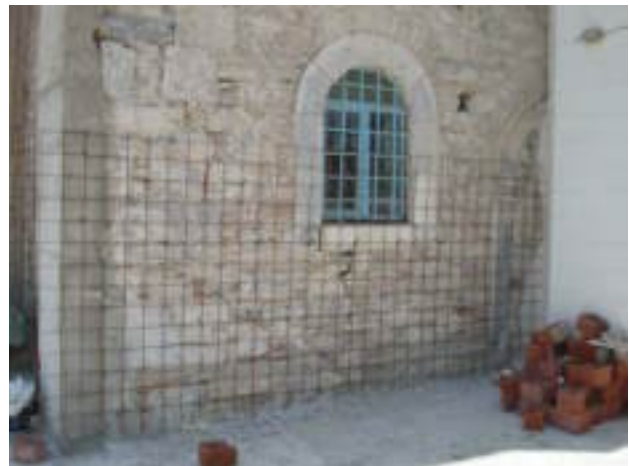
Figure 6. The traces of the church's entrance behind the minaret, documented during the strengthening in 2004.

After the earthquake in 2002, diagonal cracks 0.5 to 1 cm in width were observed, mostly on the narrow east and west facades. During the strengthening (Turan, 2003), the plastering on the exterior walls were taken off. Timber beams, posts and diagonals supporting the narrow walls, and filled in arches were documented at the west wall. During the partial cleaning of the plaster around the cracks at the interior, the trace of a large central arch out of stone was observed at the east wall. The cracks were filled in with cement mortar. In order to reduce seismic load on the East and West side walls, two reinforced concrete columns were erected along each of the long walls. Additionally, the east and west side walls were confined with corner columns. The West wall, which is thicker at the bottom and thinner at the top, was filled in with brick and mortar addition. Window and door openings that are close to the corners were proposed to be filled in, but they were left as they are. The present plaster on the historical walls was taken off and was redone with reinforced cement plaster.

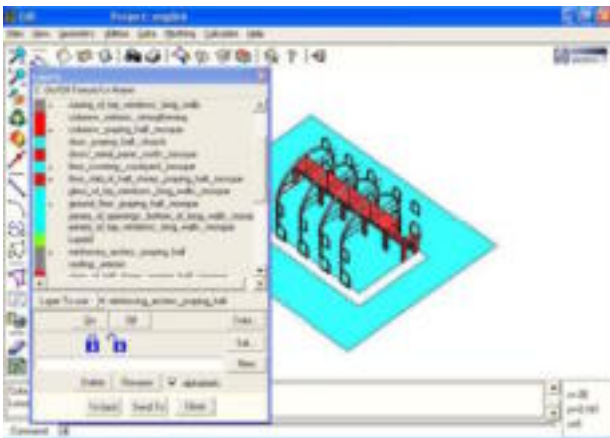
Figure 7. Organization of layers

Within this frame, the layers of the model were defined considering the building elements and their phases. For example, 'floor' is a building element. The terms such as 'exterior', 'praying hall', 'west', etc. provide information about the location of that specific building element. Consequently, the terms 'church', 'mosque' and 'strengthening' provide information about the phase of the building element. In the layer list, first the name of the building element, then its location and finally the phase are indicated. For example; 'columns: exterior: strengthening', 'columns: praying hall: mosque', 'door: praying hall: church', etc. If an element is present in all phases, then no phase name is to be stated.

In the determination of the color coding, alteration type has been the criterion. As stated in the beginning of this section, there are three types of alterations. The layers presenting added building elements were illustrated with red. The layers presenting modified building elements were illustrated with blue. The layers presenting removed building elements were illustrated with yellow. The layers presenting building elements

that have conserved their authenticity were illustrated with gray. Finally, the helping layers were illustrated with green.

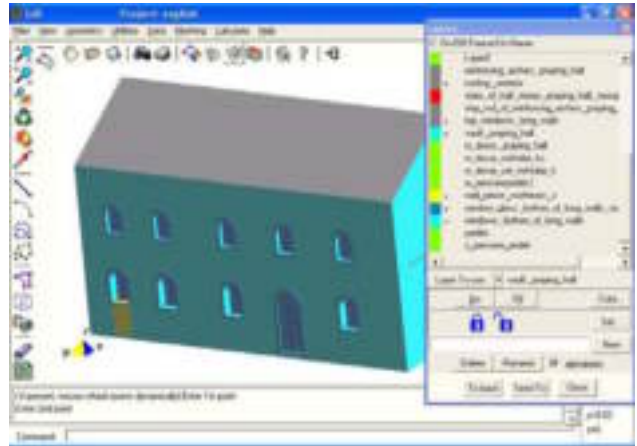
Figure 8. North view, church phase: The wall piece at the bottom of the left bottom window was removed to create women's entrance. Wall surfaces were modified via plastering. Joinery was modified. Tiles covering the roof are left authentic.
