# LEARNING FROM THE BUILDING: DIRECT SOURCES FOR THE PRESERVATION PROJECT. THE EXPERIENCE OF BESOZZO'S TOWN HALL (VARESE, ITALY)

*The Town Hall of Besozzo (Varese, Italy) is located in the city centre of the village and its first construction phase is dated back to the XIV-XV century. It shows a complex palimpsest which is the result of the numerous transformations occurred during its life: enlargements, super elevations, demolitions, inner spaces subdivisions and use changes. Currently a project has been issued for the reuse of the building which assigns new spaces for the town offices to the northern wing recently acquired. The aim of the research was to provide a diagnostic insight, useful for the development of the conservation project which will necessarily take into account the multitude of values registered on the building. Owing to a lack of meaningful archival documentation, the elevation's stratigraphic reading and the methods for dating historical buildings proved to be an invaluable resource for the comprehension of the building's transformations. Cross-referencing readings of indirect sources carried on the building with the results of the in-depth analysis made it po

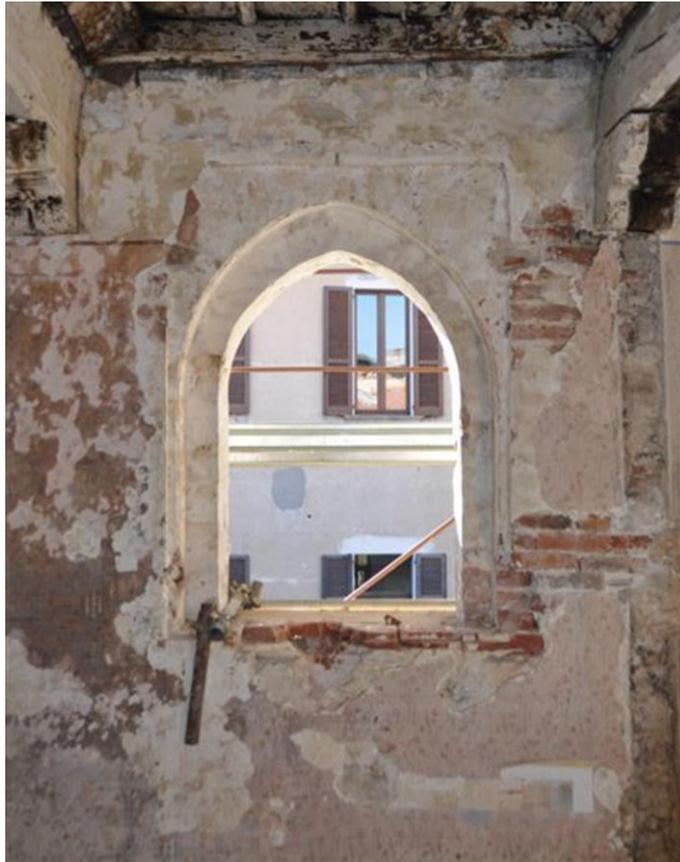
**Figure 2:** Particular of a ogive window (XIV-XV century) on the south front

Identification of different types of doors and windows and study of different construction techniques allows us to discover record and decode written information on the matter (Figure 2).

Doors and windows with shutters and screens were used for defence, lighting, ventilation and heating. This is more evident to the south, where ‘view’ windows (lancet windows) and ‘light’ windows (located on the ground floor, in a high position almost directly below the floor above) can be seen, small openings that allowed the lighting of the entrance halls with the door closed.

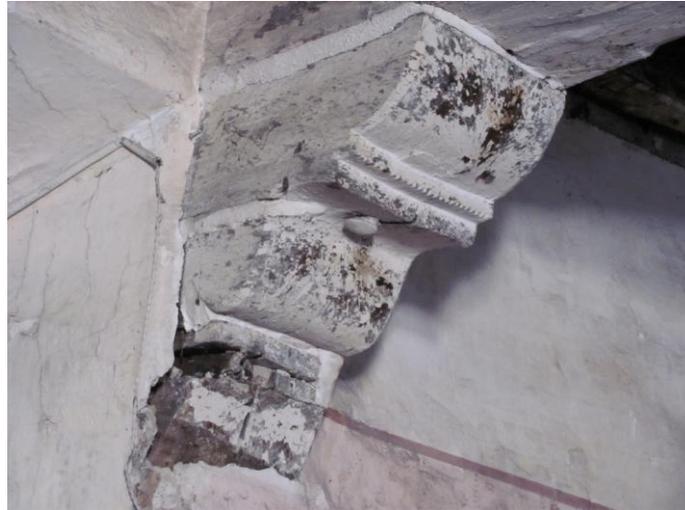
**Figure 3:** A wooden bracket of XV-XVI century.

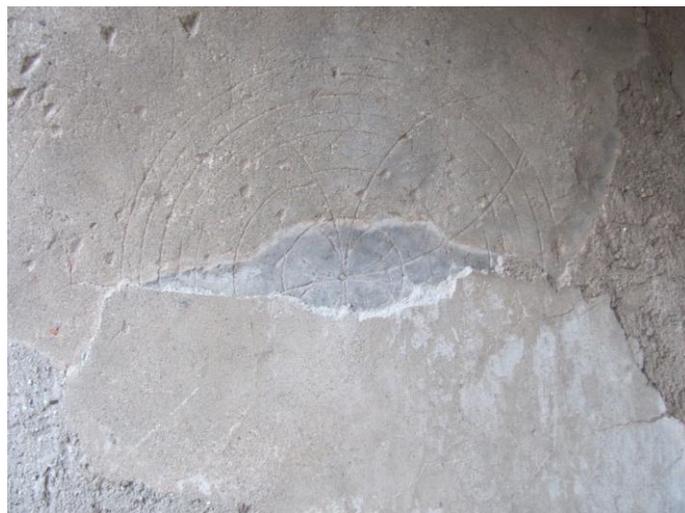
**Figure 4:** Particular of geometric patterns in the ancient plaster.

raising the ceiling of the ground floor, the walling-in of the old access and the opening in breach of a new entrance, of similar shape but larger in size. The coeval opening of a 'light window' above the new access door allowed for the hypothesis of a closing system with locks made of wooden support boards for the lancet 'view' windows. The entire southern façade was plastered and perhaps painted later, as proved by traces of blue and red and engraving with geometric patterns (Figure 4).

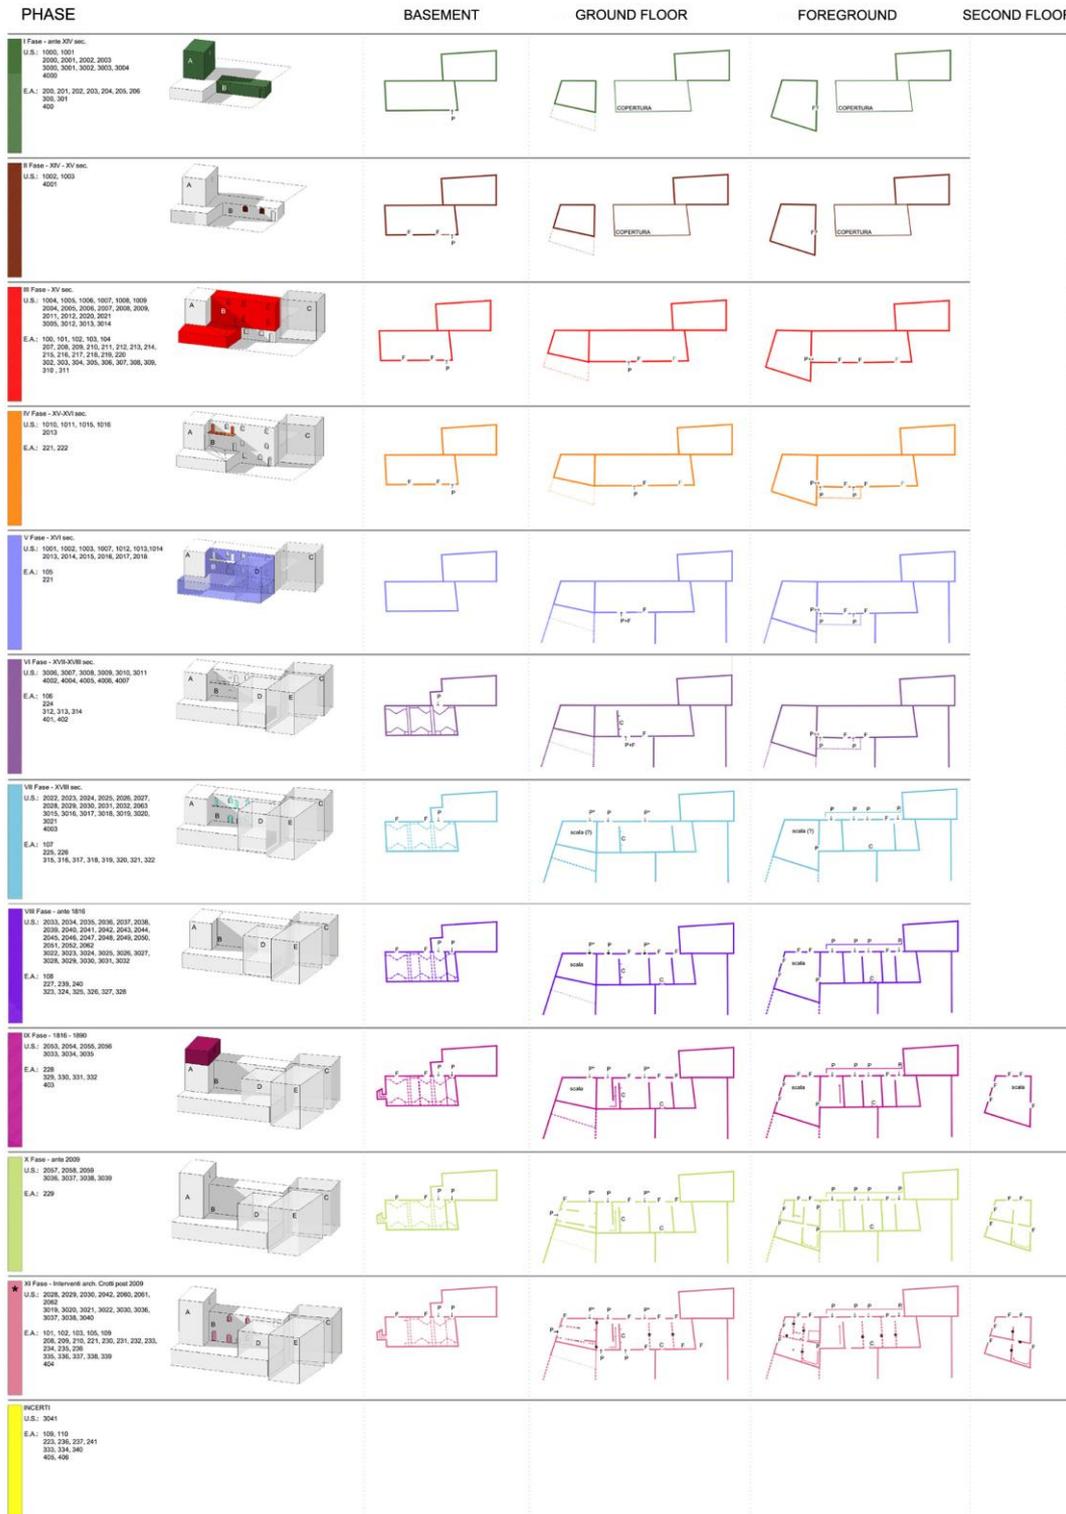
Figure 5: Schematic representation of the building's historical evolution on the different levels.

Between the seventeenth and eighteenth century (phase VI) the building passed hands from the Castelbesozzi to the Masnaghi family and was transformed into a genuine 'nobleman's home'. The ground floor room was decorated with a large framed fireplace, perhaps in Macchiavecchia, removed after 2005. During the eighteenth century (phase VII) the Masnaghi family filled in all the existing apertures on the southern façade of the building and opened doors and windows to the north. To the end of the eighteenth century the building, under the new ownership of Mazzola and Del Vitto, was home to a workshop and was internally divided, on the first and ground floors, into rooms to rent, to which access was provided by a stone walkway. By 1816 (phase VIII) further internal adaptations were made and, between 1816 and 1890 (phase IX), the complex was expanded by the construction, in the northwest corner of the courtyard overlooking the street, of a space used as shop/restaurant with an upper room and a porch with a shed, barn and hayloft above, pulled down in the late twentieth century. Until the sixties (phase X) the building remained in the hands of Del Vitto with no further modifications. In 2006 it was sold to the Town of Besozzo and between 2009 and 2011 studies and initial restoration work began (Figure 5).
